**Robe Obelisk**

## **Landslide Stability Assessment**

**District Council of Robe**

Ref No. 20181771

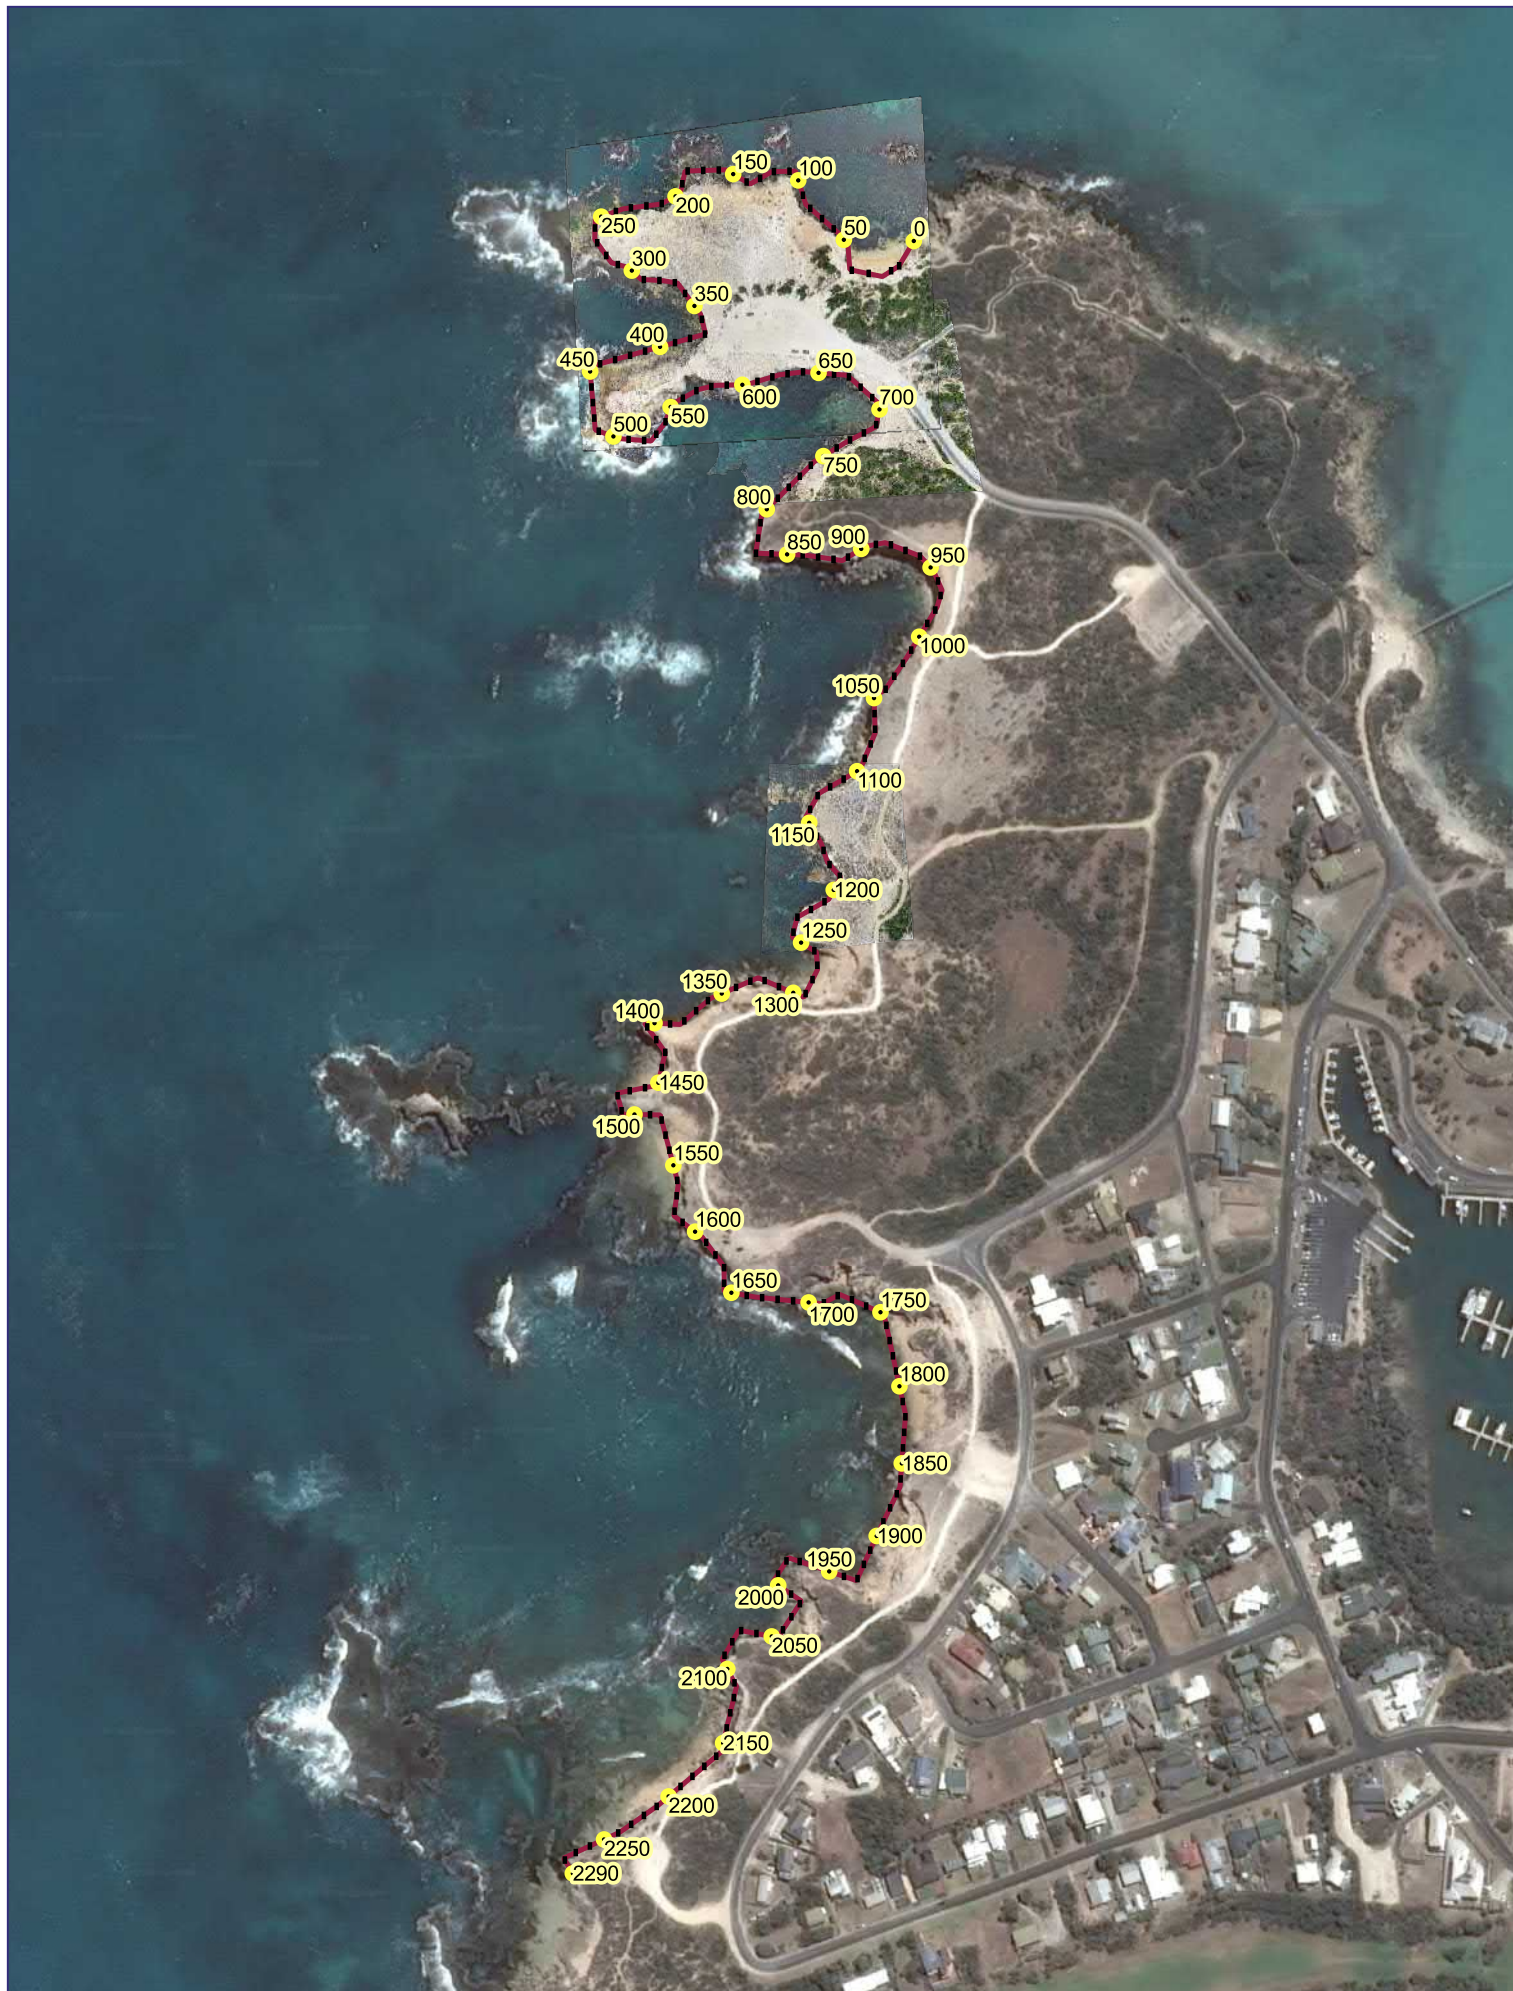
ID	Chainage (m)	Description	Ranking
RZ1	50	Cliff Overhang - Differential Erosion	Medium
RZ2	370	Obelisk Main Carpark - Cliff Undercutting	High
RZ3	630	Obelisk Main Carpark - Cliff Undercutting	High
RZ4	670	Obelisk Main Carpark Entrance - Cliff Undercutting	High
RZ5	825	Large Cliff Undercutting at exposure point	Medium
RZ6	1000	Cliff Undercutting -10m from nature walk	Medium
RZ7	1100	Cliff Overhang - Differential Erosion	Medium
RZ8	1200	Blow Hole - Sink Hole	High
RZ9	1220	Large Undercutting at exposure point	Low
RZ10	1330	Doorway Rock - Instability Potential	Low
RZ11	1580	Nature Walk Car Park 2 - Undercutting	Medium
RZ12	1750	Undercutting of Cliff Face with large soil mass above	Medium
RZ13	1900	Differential Erosion - Fenced Off Walkway	Low
RZ14	2150	Large Cavity under point	Medium
RZ15	2250	Nature Walk Car Park South - Large Undercutting	High

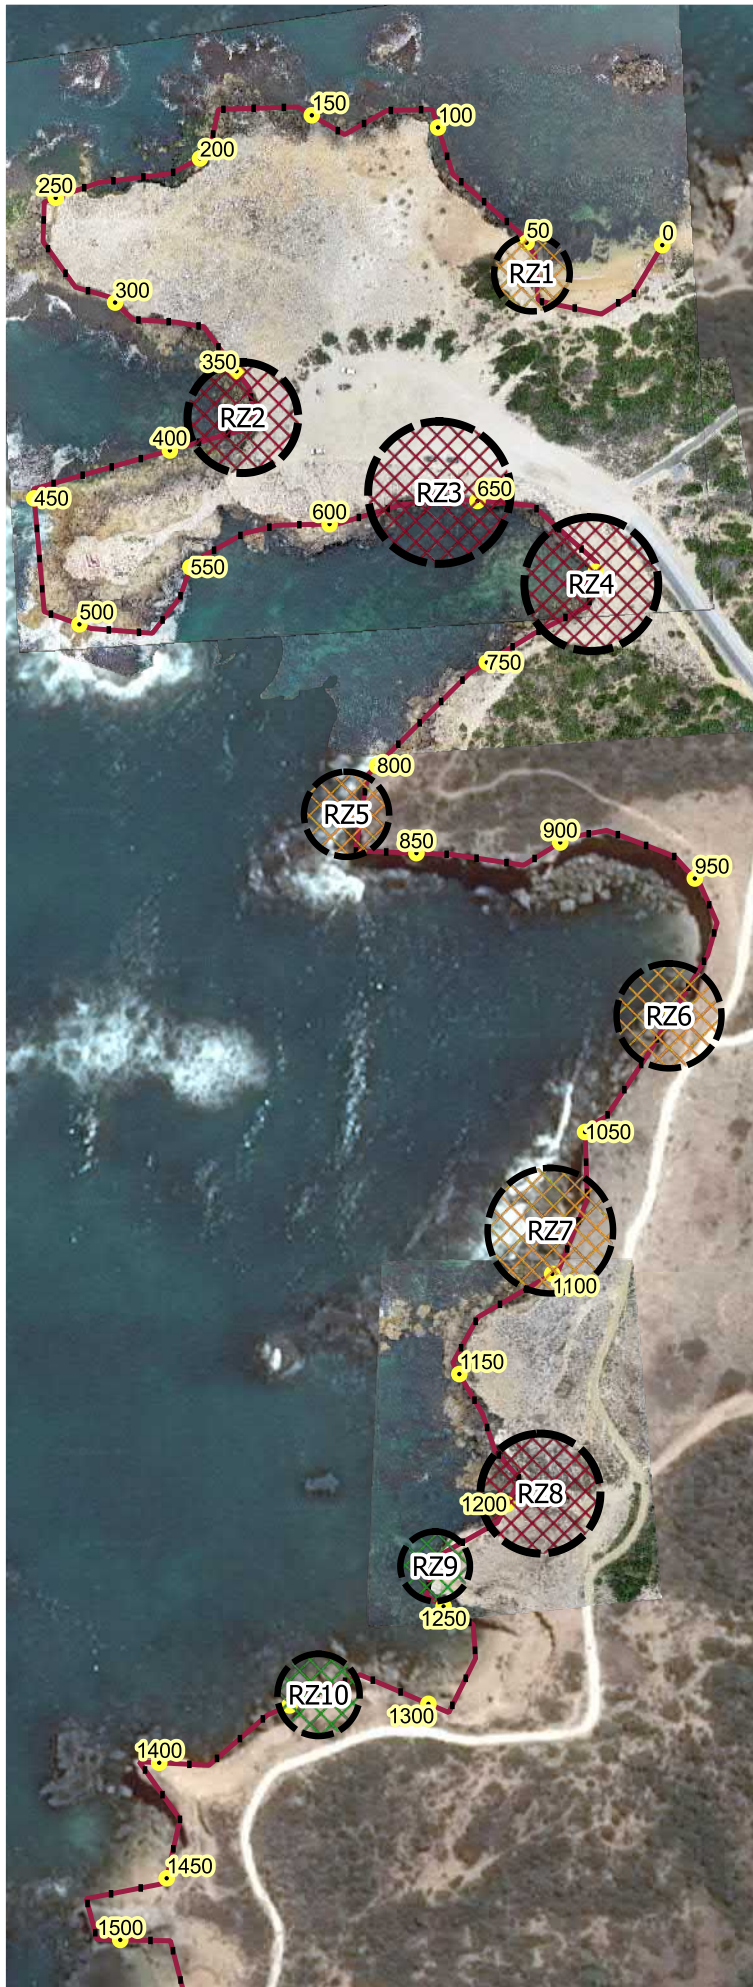
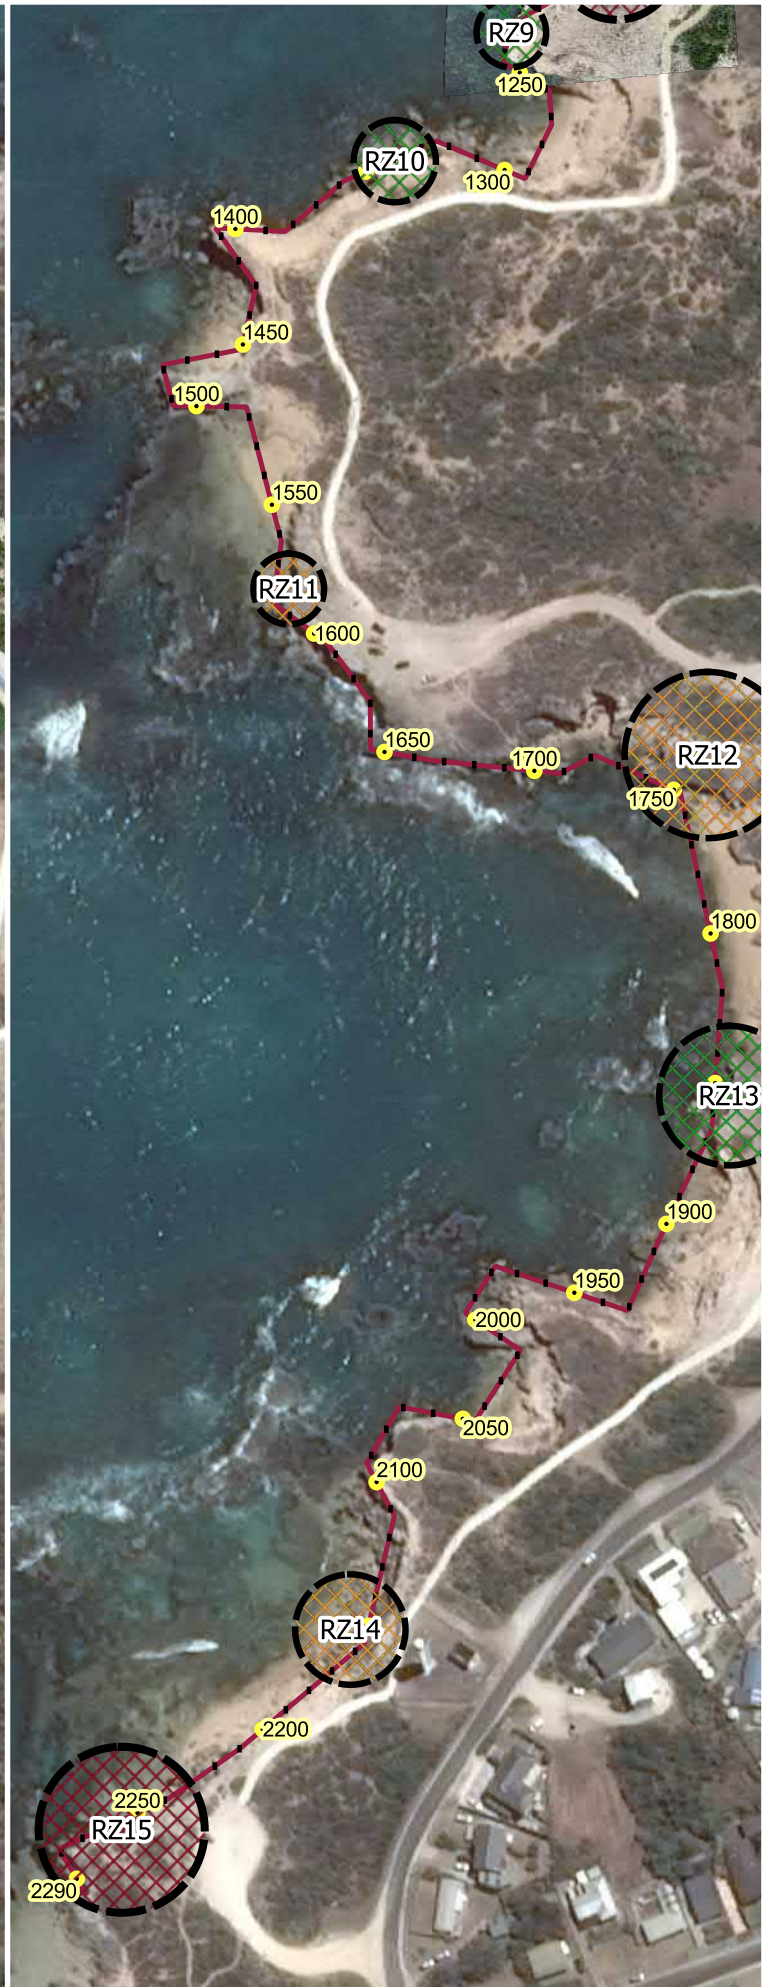
**Figure 2 CH 370 – Obelisk Main Car Park North Side – Undercut of Cliff Face**

As seen in Figure 2, Figure 3 and Figure 4 the cliffs around the Obelisk car park are undercut. The undercutting is caused by wave and water erosion and will be ongoing. Because the drone requires satellite coverage for navigation, and because its sensors limit how close it can come to solid ground, we were unable to fly below undercut areas to assess how far they extend under the carparks. However, our judgement based on our observations through camera zoom lenses and from the drone flying as close to the undercuts as we judged prudent suggest that they do extend to underlie portions of the carpark. This imagery is documented in Appendix B and C.

Any area of ground lying over an undercut will be less stable than if it were underlain by solid ground. The stability will decrease over time as a result of ongoing erosion of the undercut and eventually the undercut will collapse. It is impossible to estimate the rate of erosion on the basis of current data, although the attached photographs of the ground near the Obelisk suggests that it may be rapid in this vicinity (See Appendix B).

Based on the overview provided in Section 2.1.1 and again in regard to discussions with Council on their risk appetite, we recommend that Council controls public access to the present Obelisk carpark.

It might be assumed that the undercut extends 10 m in from the cliff edge at the observed (and video'd/photo'd) location on the northern side of the carpark, and 10 m from the whole of the cliff edge on the southern side. Our observations suggest undercutting for that whole length, but the undercut is so close to the water level along much of it that we cannot know how far back it goes. Where we could look into the 'caves' our observations suggest that the undercut extends more than 5 m behind the cliff face, possibly up to 8 m in places and potentially more.

If it is assumed that the undercut extends 10 m from the cliff face then an exclusion zone could be set out at that distance on the assumption that the failure would probably generate a vertical face in the cliff, consistent with our observations of the cliffs near the Obelisk generally.

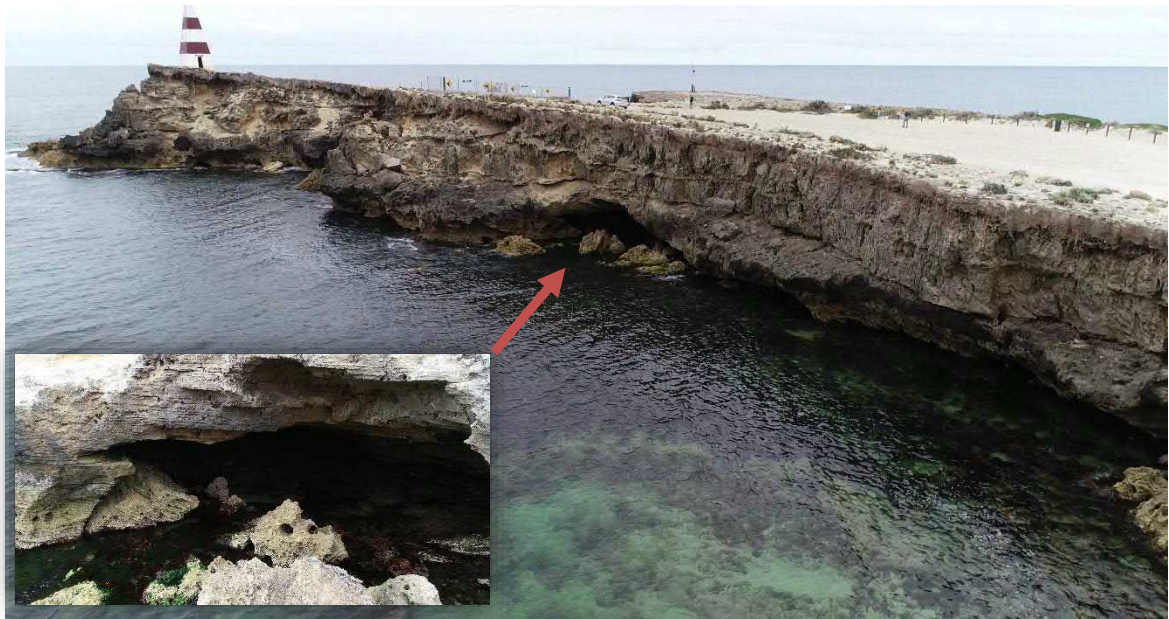
**Figure 3** CH 620 to CH 660 - Obelisk Main Car Park South Side – Undercut of Cliff Face

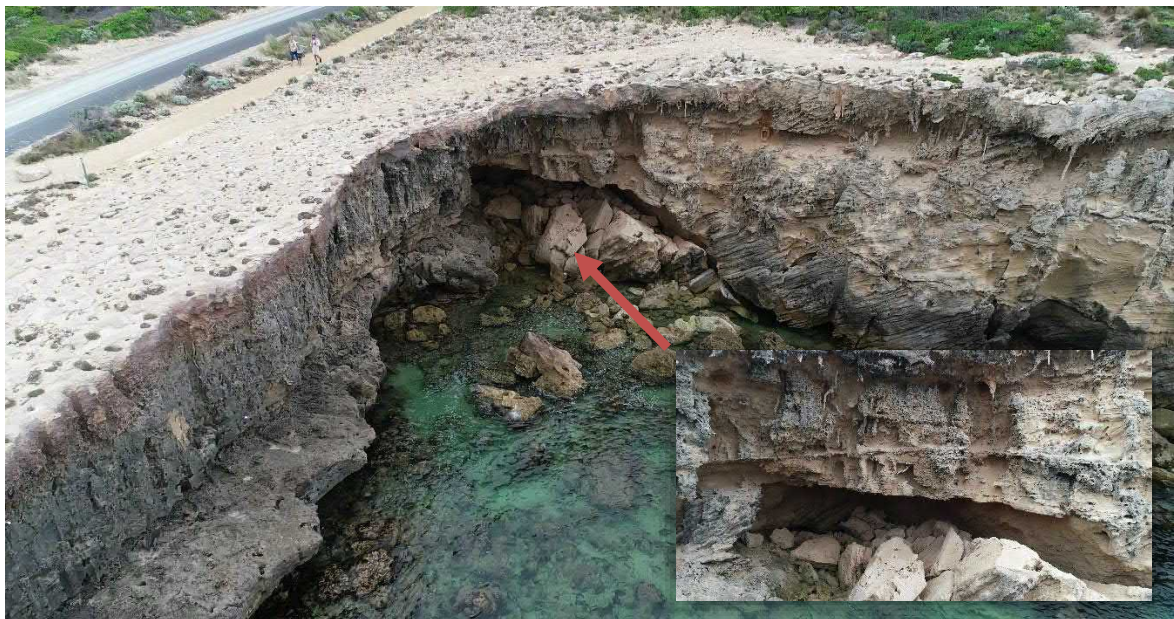
**Figure 4** CH 690 to CH 720 - Obelisk Main Car Park Entrance – Undercut of Cliff Face

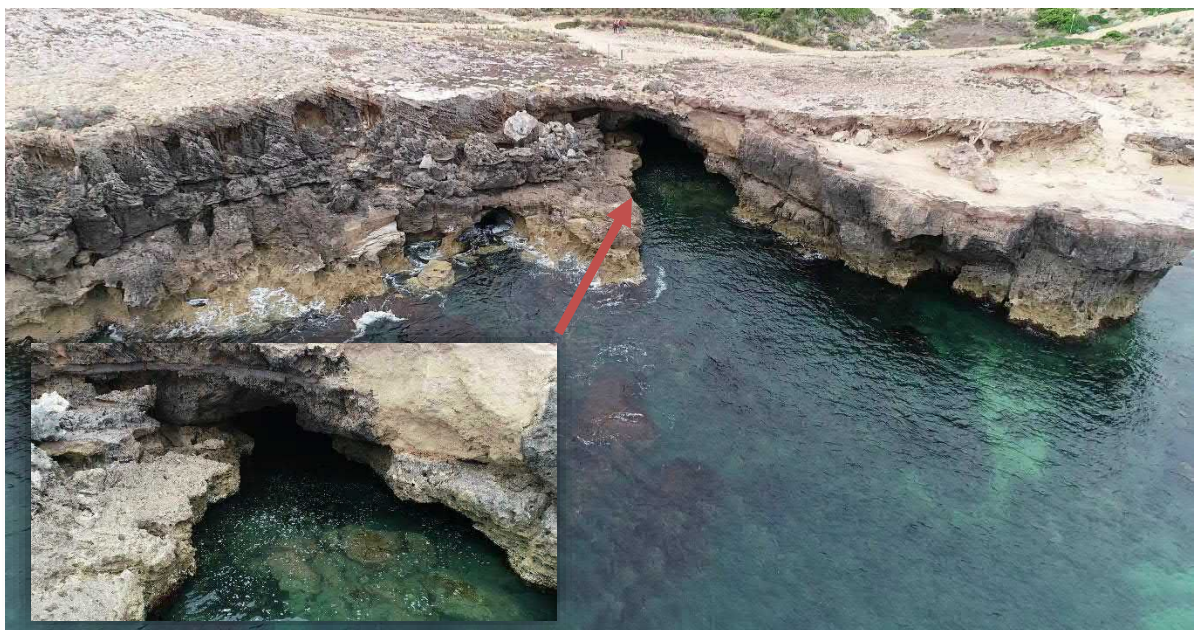
Sinkholes develop when soil infilling to cavities in the ground (these cavities generally develop as the limestone is dissolved by infiltrating stormwater) is eroded away, leaving only the cavity. The erosion proceeds from the base of the cavity and speeds up as material is eroded away.

Eventually, the infilling soil does not have sufficient strength to stand, the cavity empties and a sinkhole suddenly appears (over seconds to minutes, typically). It is not possible to predict when a sinkhole will appear.

**Figure 5** CH 1200 – Obelisk Nature Walk Blow Hole – Undercutting Beneath Blowhole

Based on discussions with Council on the 29<sup>th</sup> November, we understand that the risk of sudden sinkhole development in this public area would not be acceptable to Council. We recommend that Council implements practicable measures, to as far as practicable prevent public access to the area of the incipient sinkholes. It may also be prudent to install signage describing the inherent risks of access to the area. As the path currently skirts the area of highest risk, it would be sensible to provide signage at both entrances to alert the public.

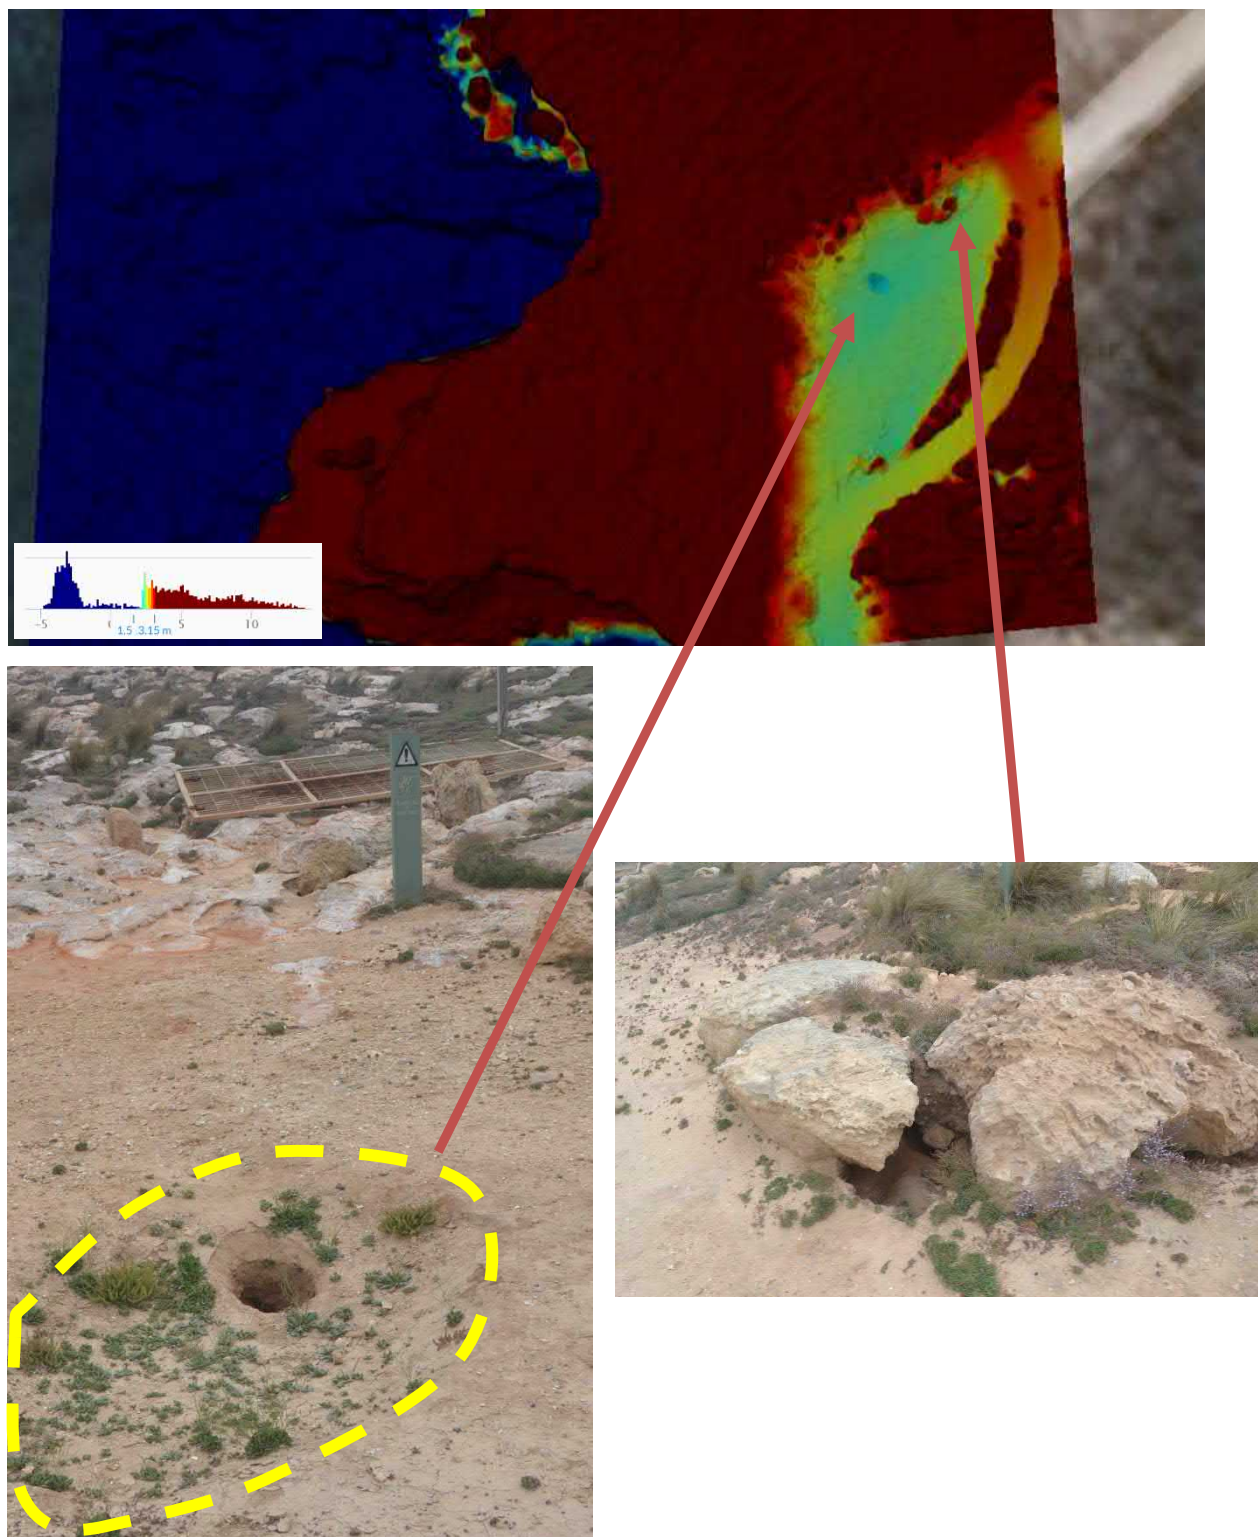
**Figure 6** CH 1200 – Obelisk Nature Walk Blow Hole – Sinkhole Heat Elevation Map (Top) and Sinkhole Locations (Bottom)

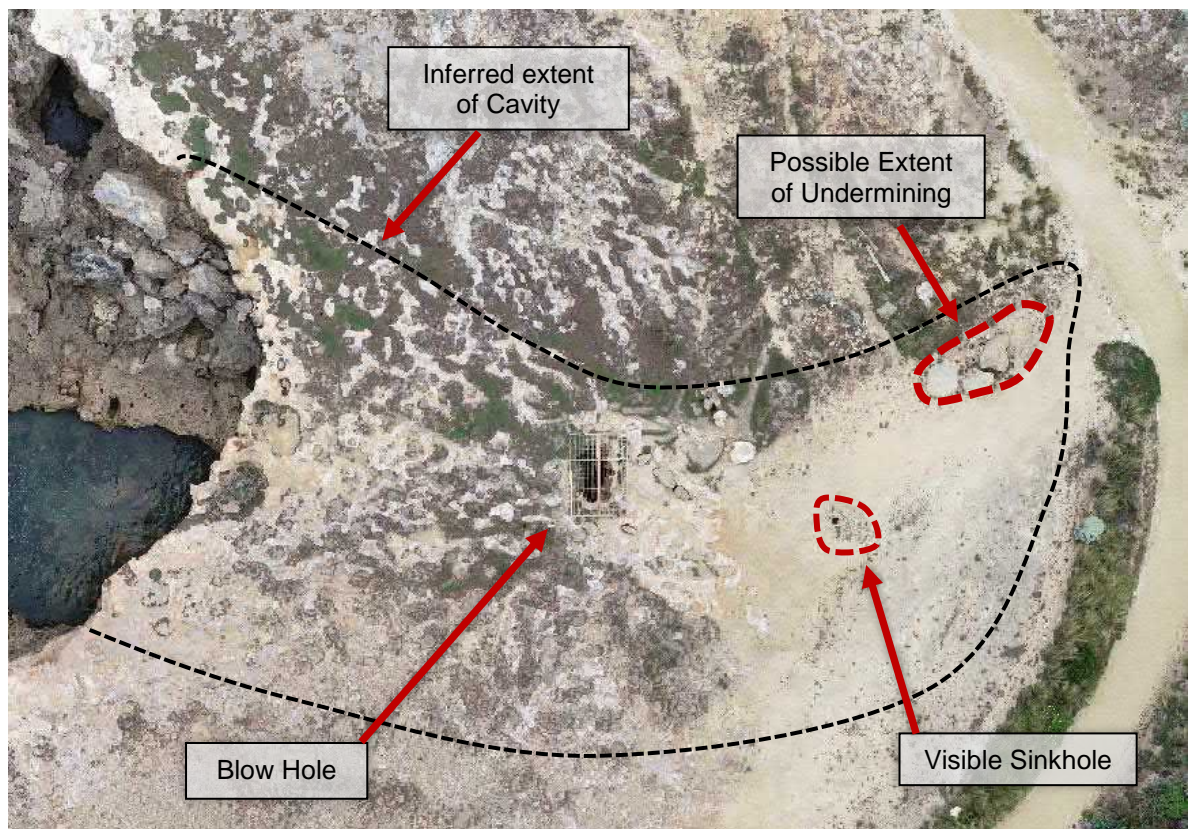
**Figure 7** CH 1200 – Obelisk Nature Walk Blow Hole – Sink Hole

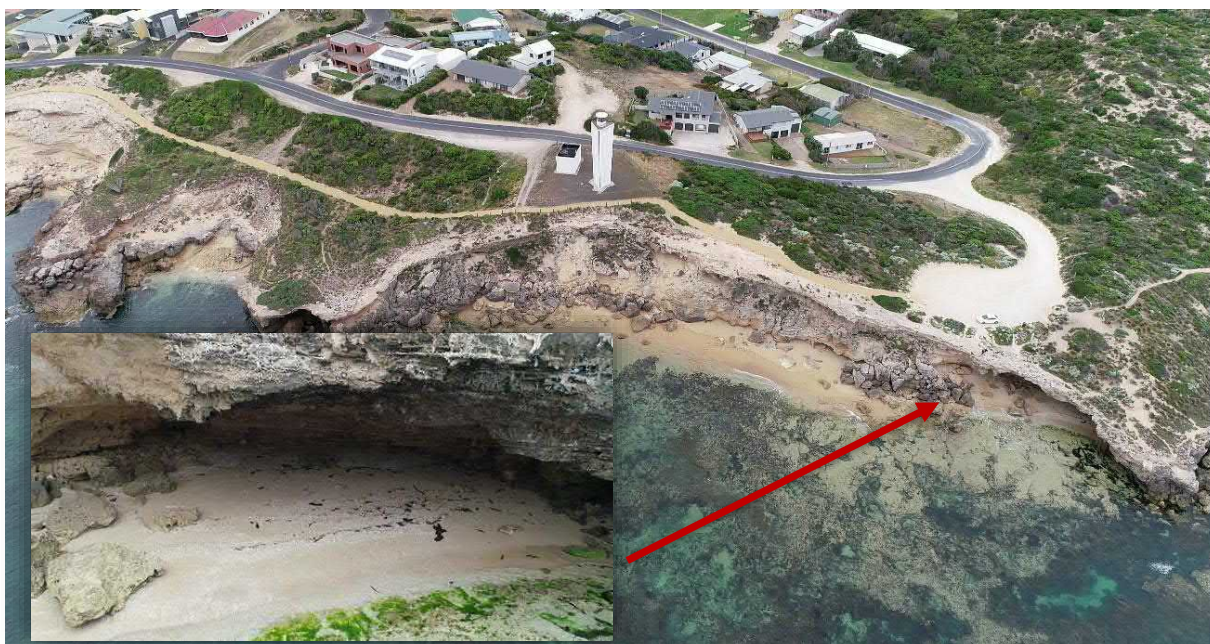
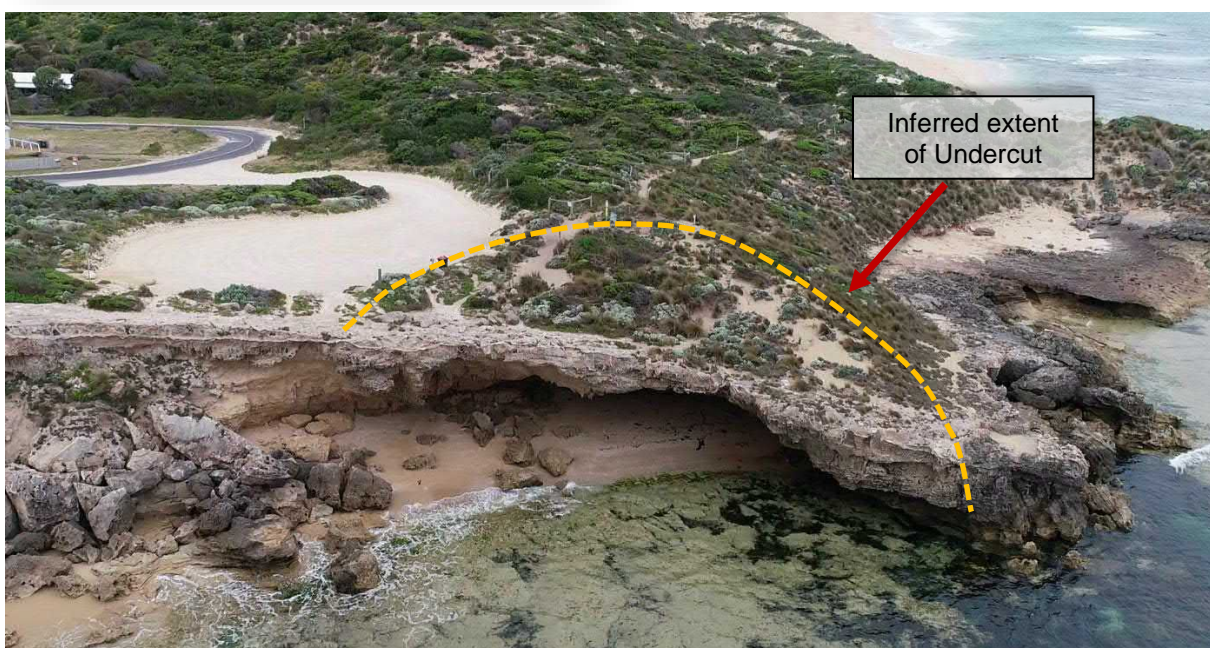
Figure 8 shows an aerial view of the carpark near the southern end of the Coastal Walking Trail. The nearby cliffs are undercut. There are indications (debris heaps) to the north of the existing undercut suggesting the relatively recent collapse of a previously undercut area. As far as we can tell, the existing undercut does not extend below the Southern carpark. However, we estimate the thickness of the rock arch over the existing undercut to be no more than about 1.5 m in places. Sightseers can be observed standing on top of that arch. (Figure 9)

**Figure 8** CH 2250 – Southern Carpark – Undercutting of Cliff

We recommend that Council take practicable measures to restrict, and if possible prevent, public access to the area of the arch near the Southern carpark. It may also be prudent to install signage describing the inherent risks of accessing the area. At present there would appear to be not justification for closing the carpark, although it would be useful to obtain survey to demonstrate how far the undercutting extends as the footage from this site visit is hard to determine how far this extends.

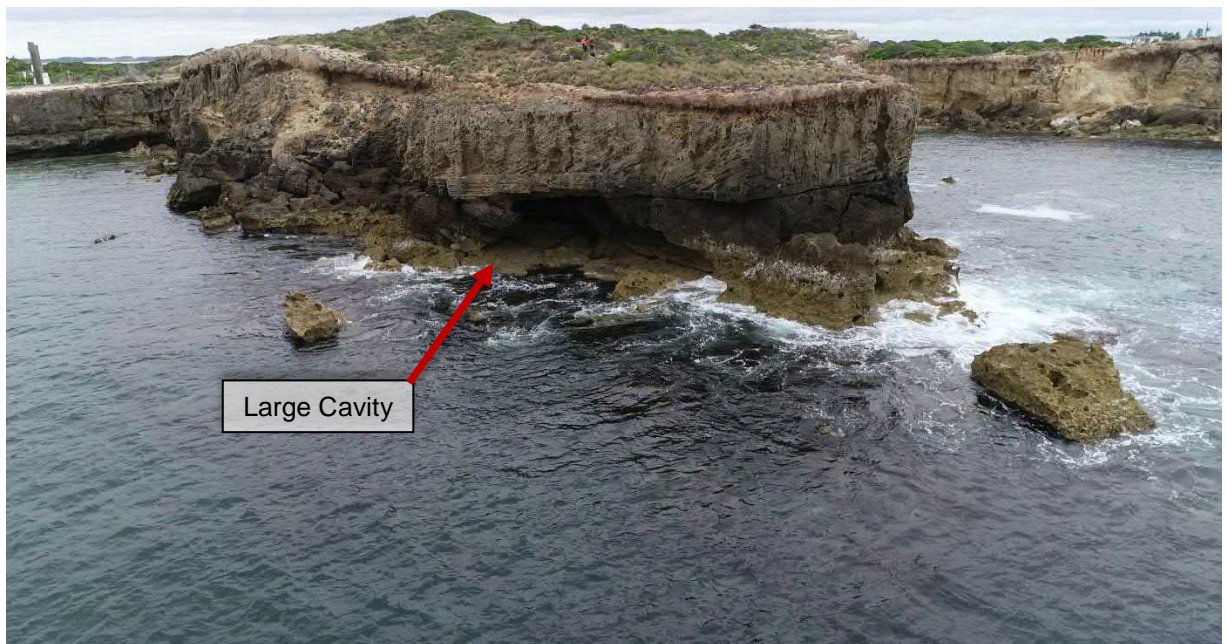
On the Obelisk Nature walk there is a large cliff top overhang with a significant amount of undercutting which has created a large void. At the time of the inspection this was not fully understood and hence the footage captured is limited in this area. There is an informal walking path that has been abandoned as part of the recent trail upgrade.

As far as we can tell the undercutting could be underneath the informal walking path documented in Figure 11. It is believed that the risk of collapse will increase as erosion persists at the foundation of the cliff face.

**Figure 10** CH 825 – Large cavity under informal walking path.

We suggest that council introduces additional signage at the entrance to the informal walking path as it is a risk that the public will take this walking trail. It is thought that the risk of current collapse is not high but will occur as erosion persists and undercuts the foundation. It should be monitored as the stability over time is compromised.

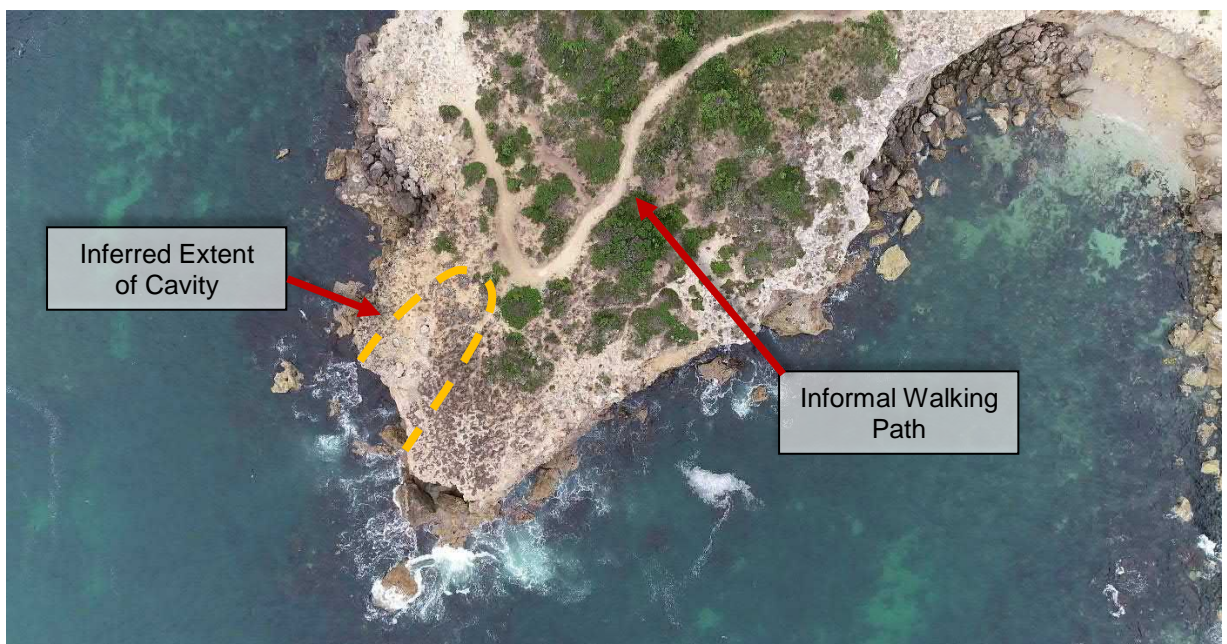
**Figure 11** CH 825 – Informal walking path and assumed extent of cavity

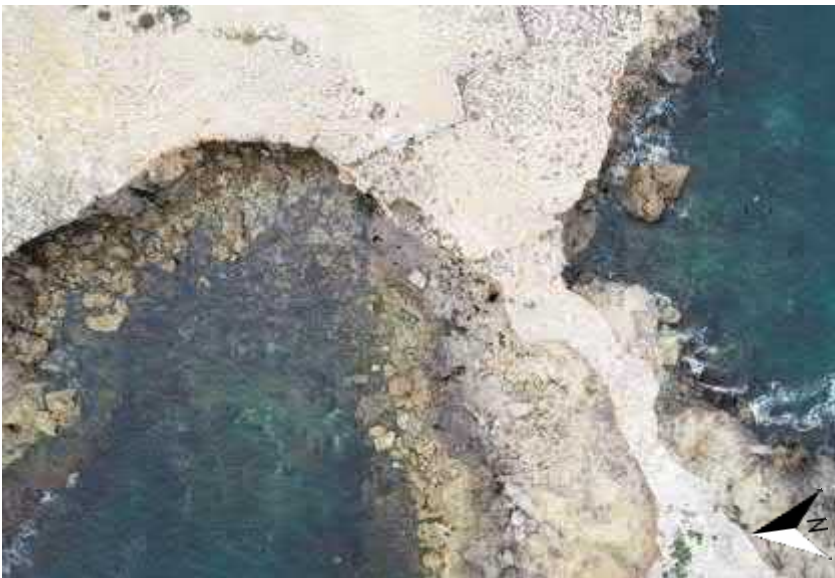
Chainage 300 to 400

Obelisk Carpark viewed in Chainage 300 to 400. Noted as high risk

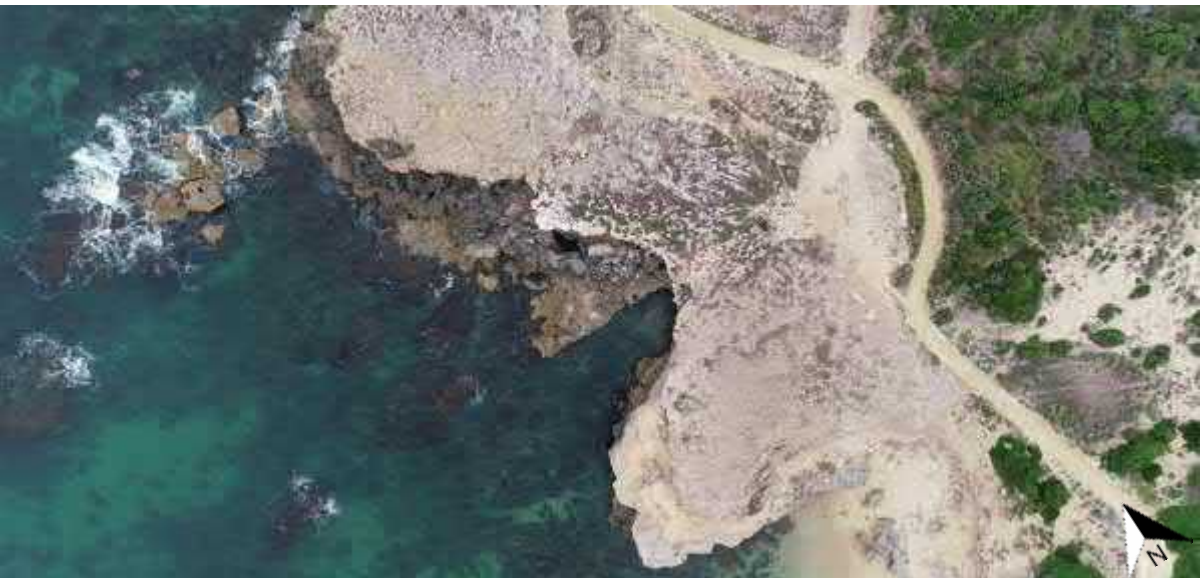
Chainage 1150 to 1230

Obelisk Nature Walk Blow Hole viewed in Chainage 1150 to 1230. Noted as high risk and to be monitored.

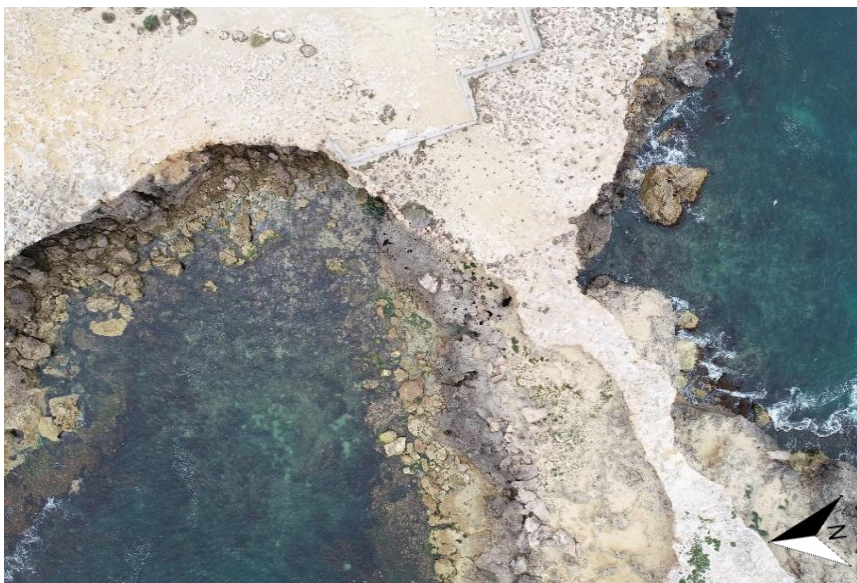
Chainage 300 to 400

Note: Aerial Photos and chainages to be read in conjunction with 20181771M01 Coastal Chainage Overview. (MAP 1)
Obelisk Carpark viewed in Chainage 300 to 400. Noted as high risk
Aerial Imagery Captured on the 29th of November 2018

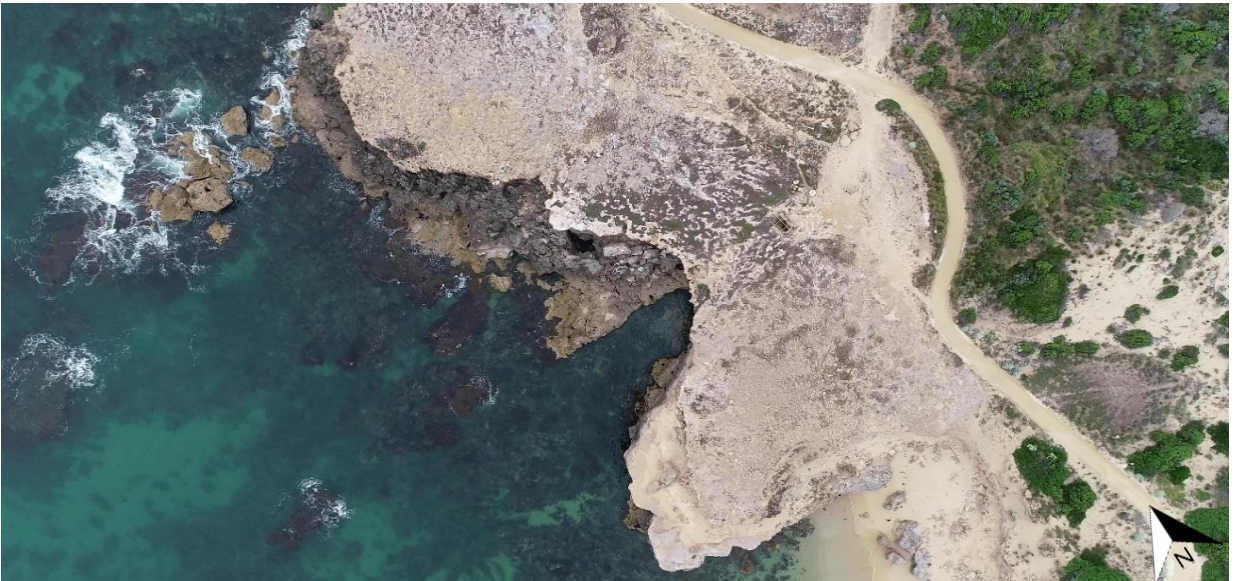
Chainage 1150 to 1230

Obelisk Nature Walk Blow Hole viewed in Chainage1150 to 1230. Noted as high risk and to be monitored.

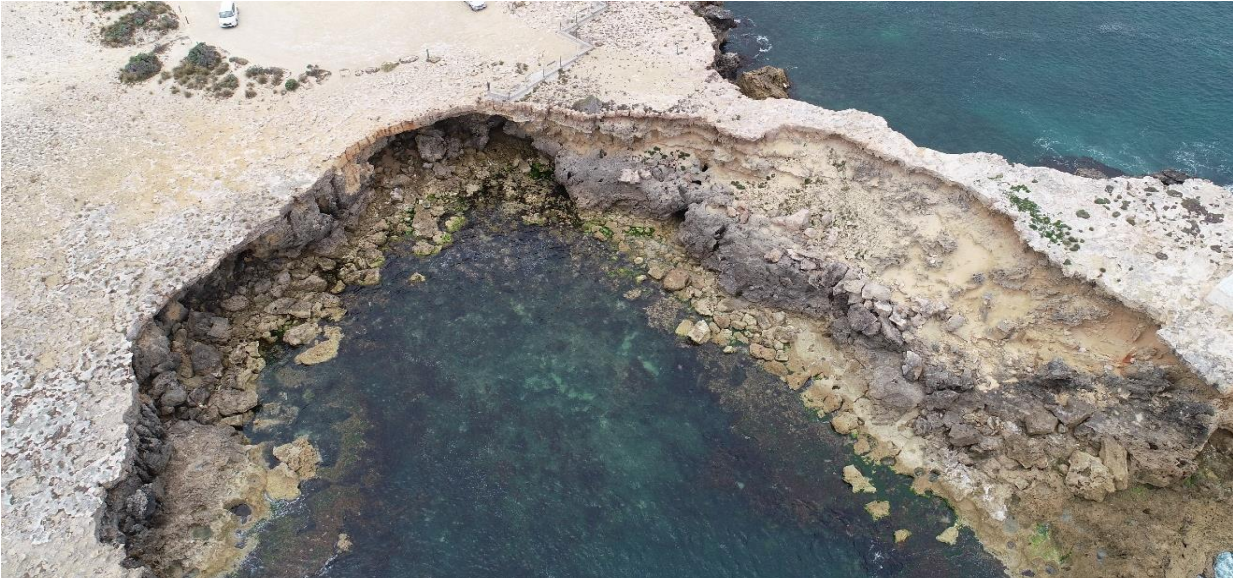
***RZ2\_0 - Obelisk Main Car Park North Side - Chainage 370***

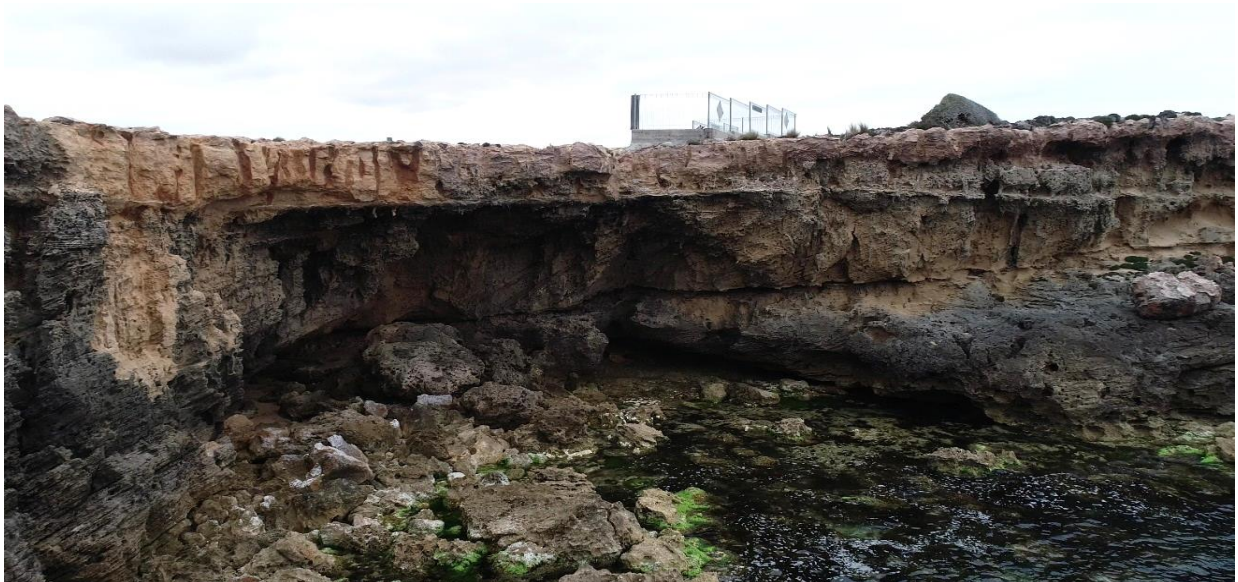
***RZ2\_3 - Obelisk Main Car Park North Side - Chainage 370***

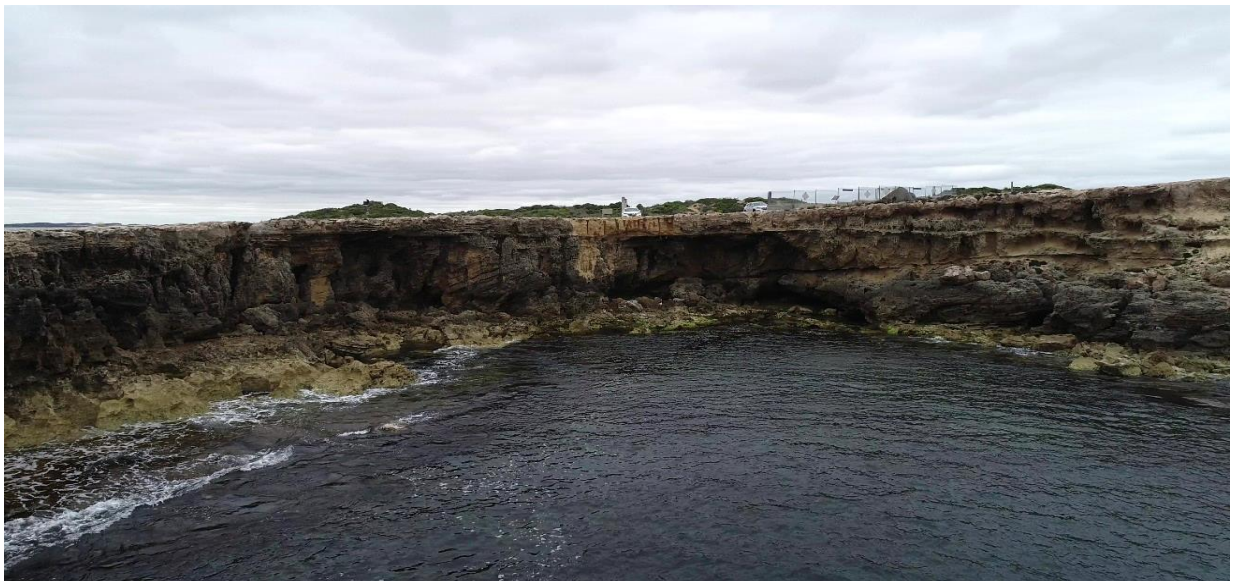
***RZ2\_4 - Obelisk Main Car Park North Side - Chainage 370***

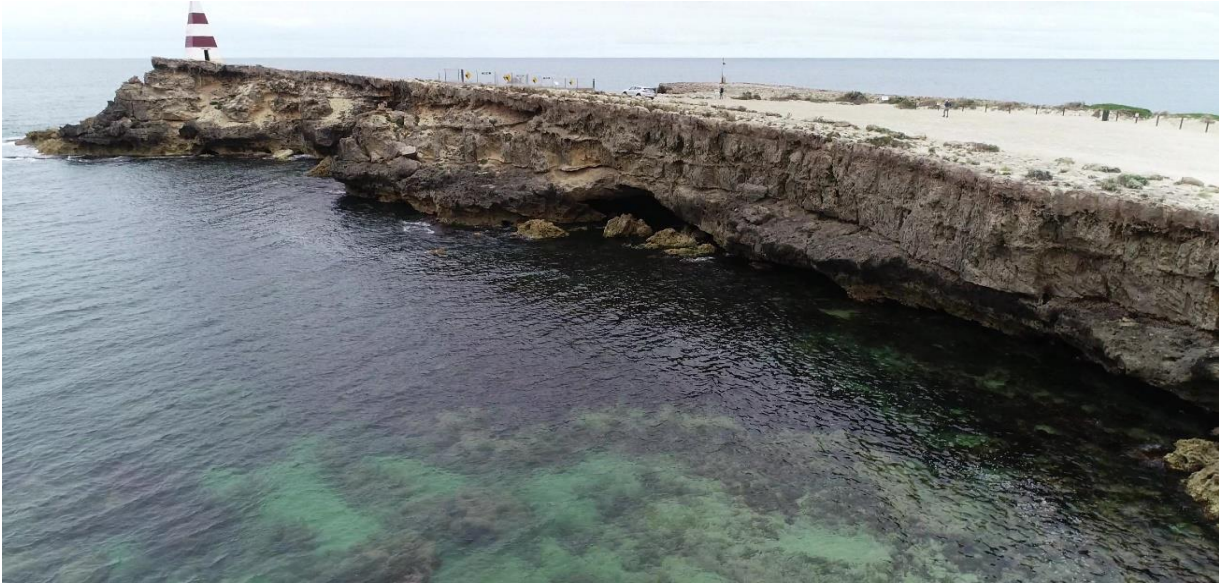
***RZ3\_0 - Obelisk Main Car Park South Side - Chainage 630***

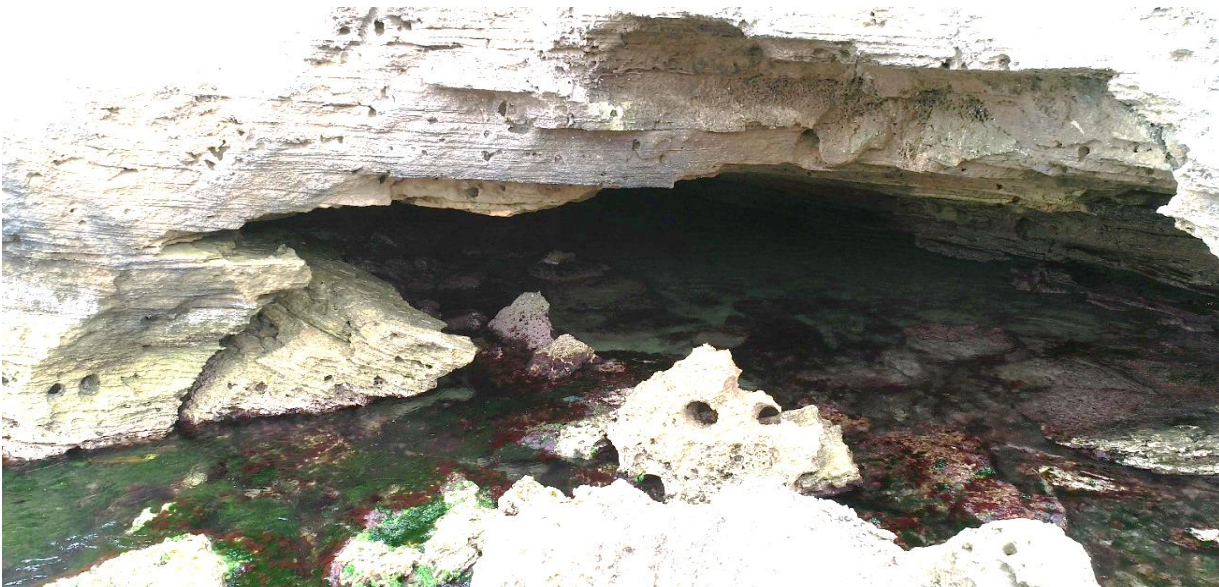
***RZ3\_2 - Obelisk Main Car Park South Side (Adjusted Brightness) - Chainage 630***

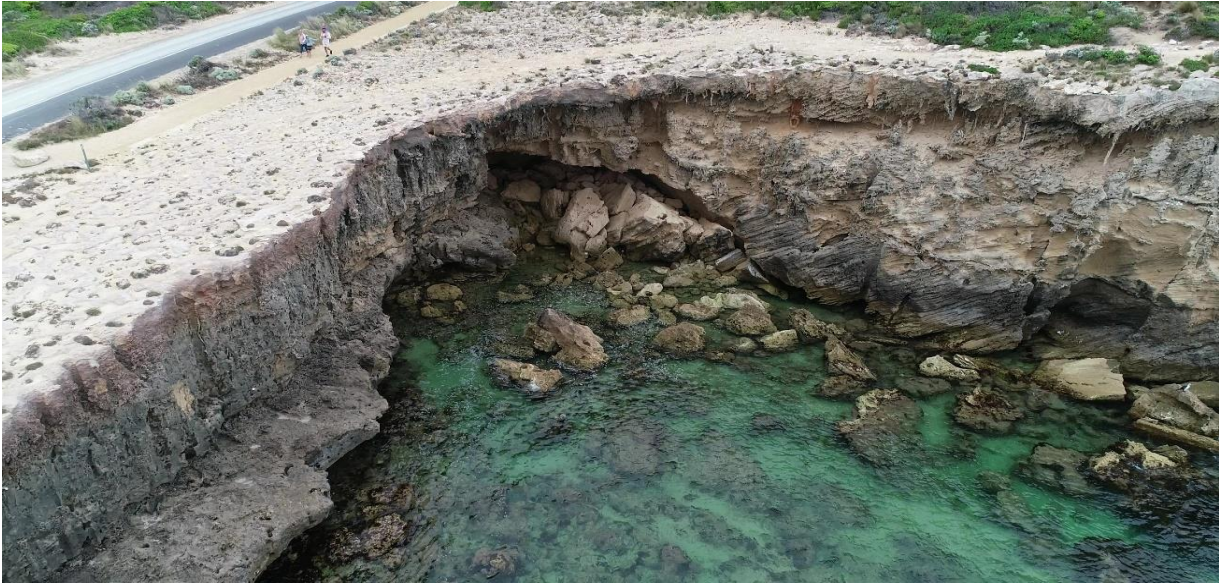
***RZ4\_0 - Obelisk Main Car Park Entrance - Chainage 670***
