**Robe Obelisk**

## **Landslide Stability Assessment**

**District Council of Robe**

Ref No. 20181771

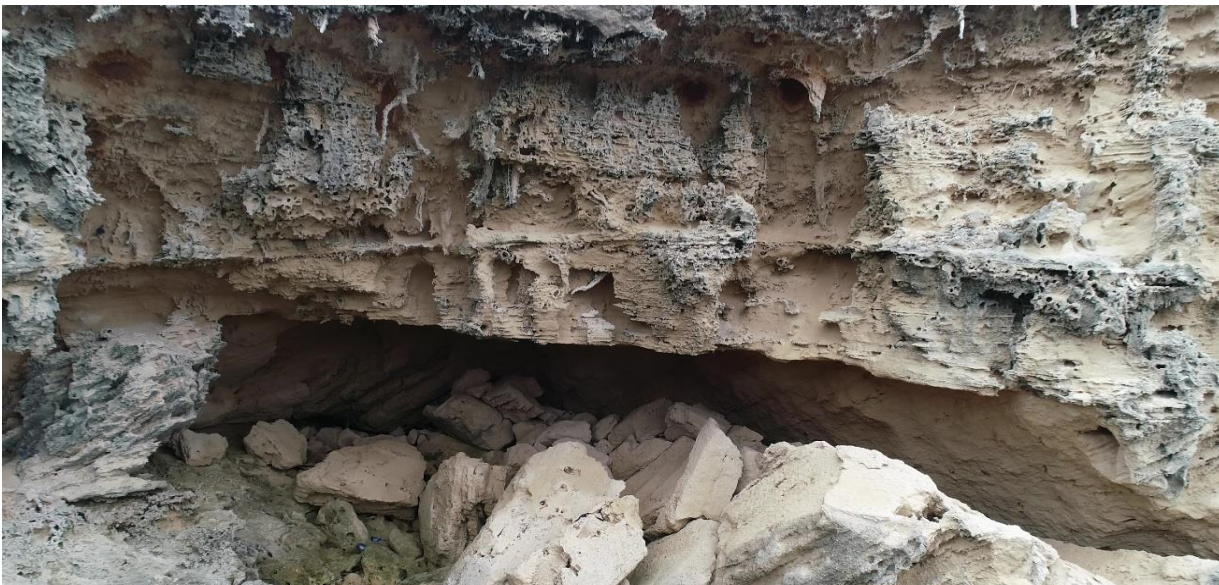
***RZ4\_2 - Obelisk Main Car Park Entrance - Chainage 670***

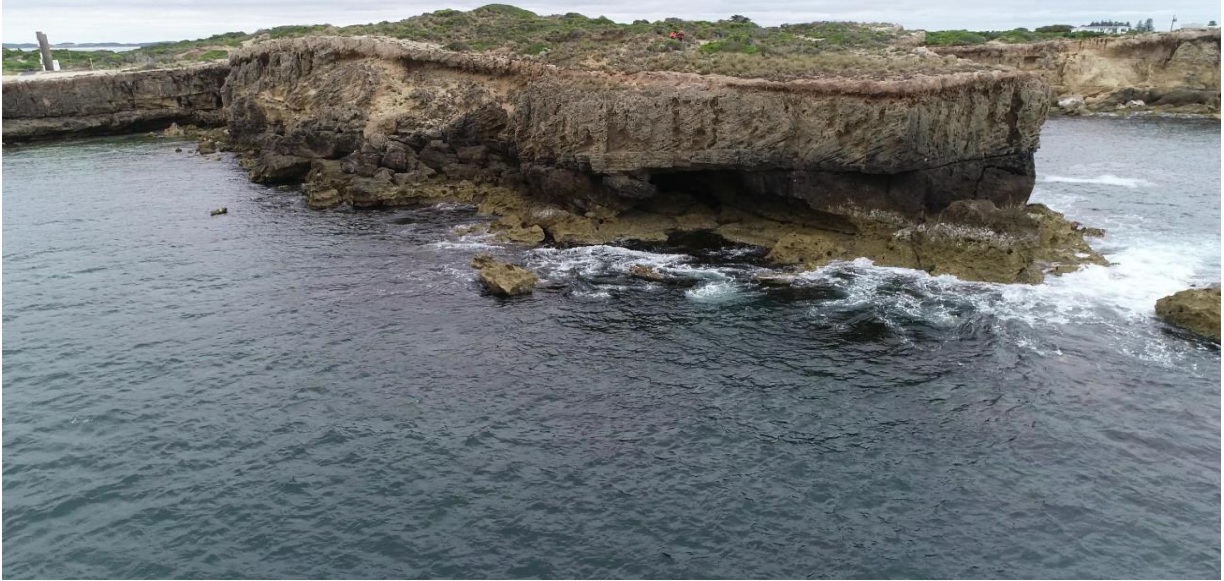
***RZ5\_0 - Cliff Undercutting - Chainage 825***

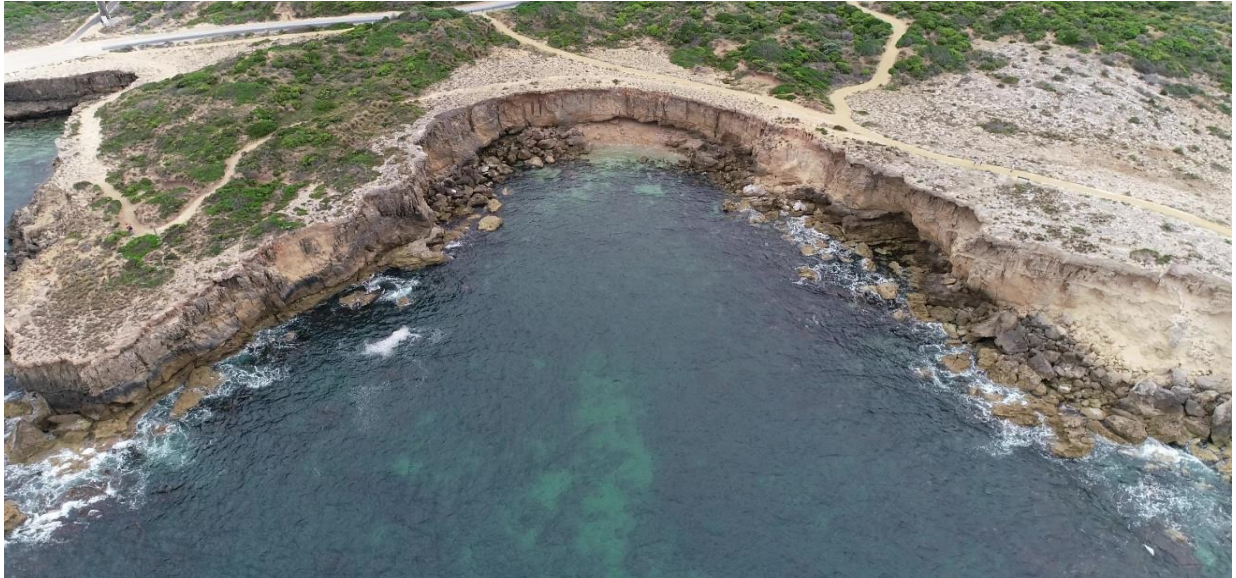
***RZ6\_0 - Cliff Undercutting (Right Side) - Chainage 1000***

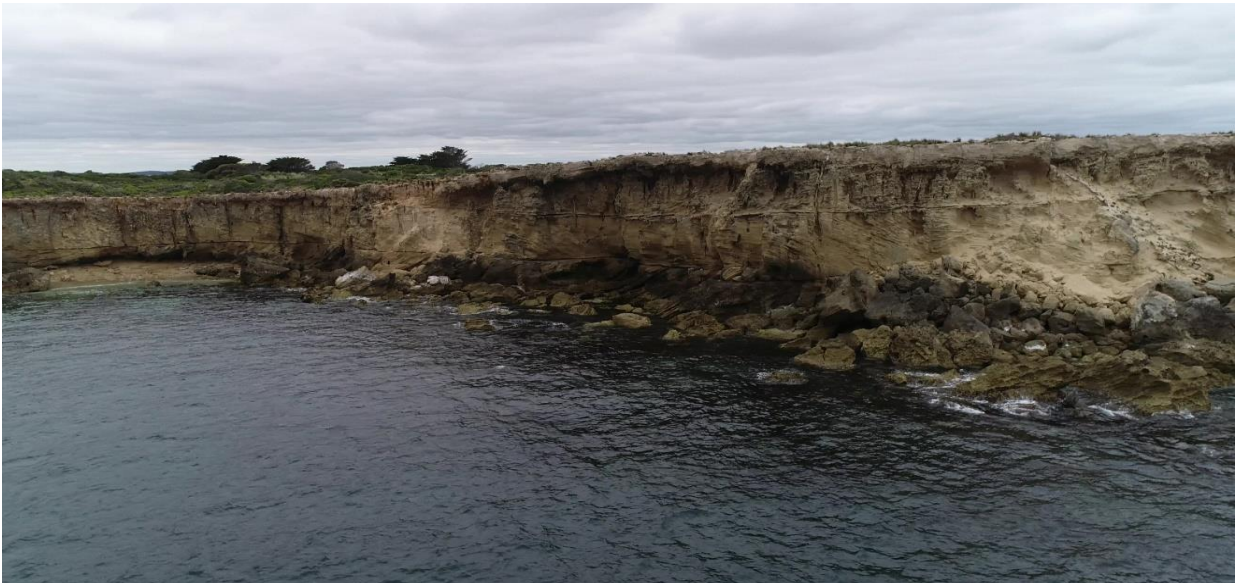
***RZ6\_1 - Cliff Undercutting - Chainage 1000***

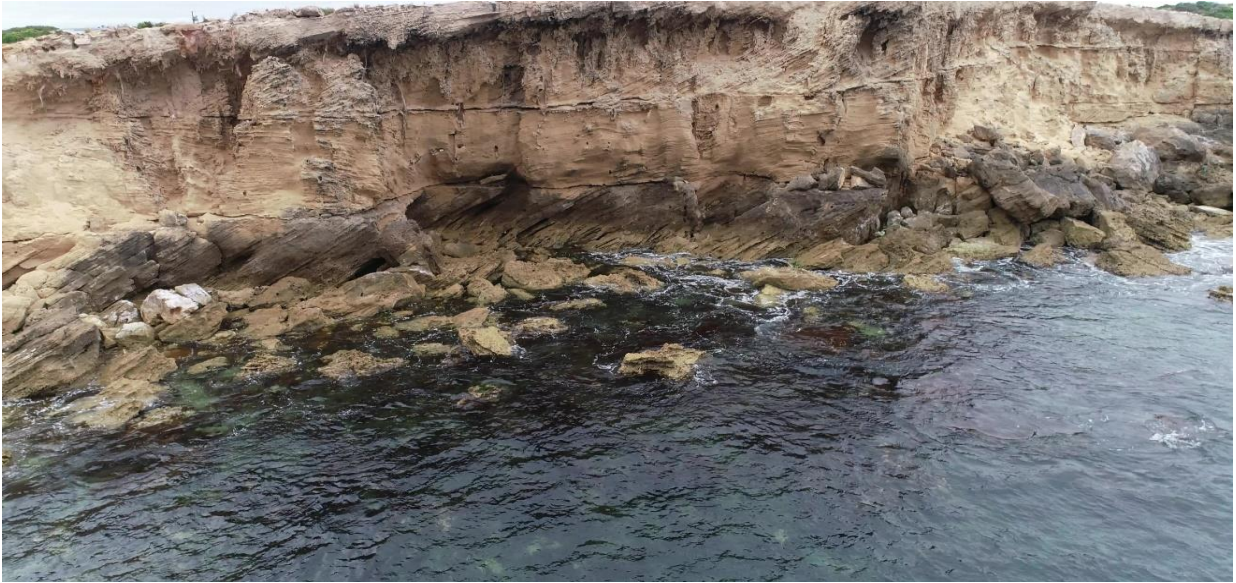
***RZ6\_2 - Cliff Undercutting - Chainage 1000***

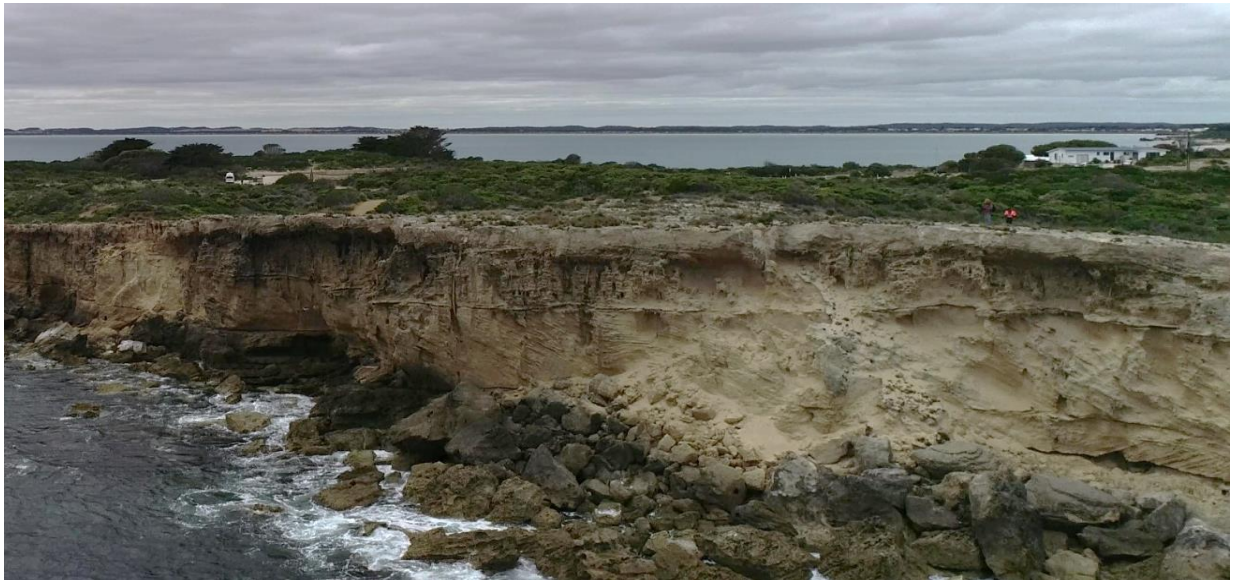
***RZ6\_3 - Cliff Undercutting - Chainage 1000***

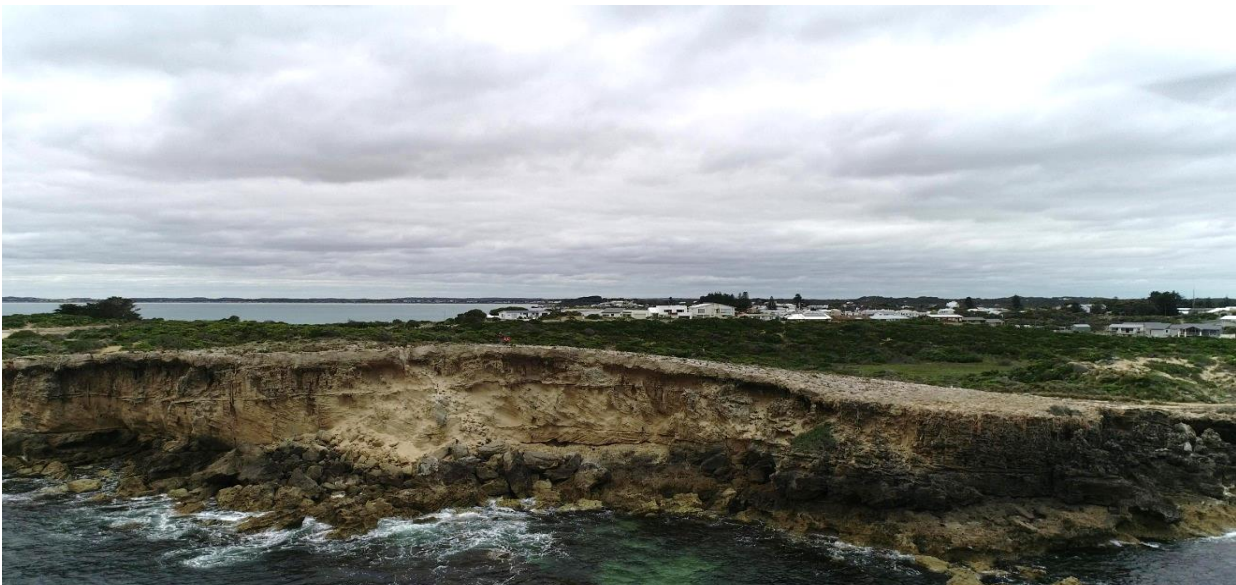
***RZ7\_0 - Cliff Overhang - Chainage 1100***

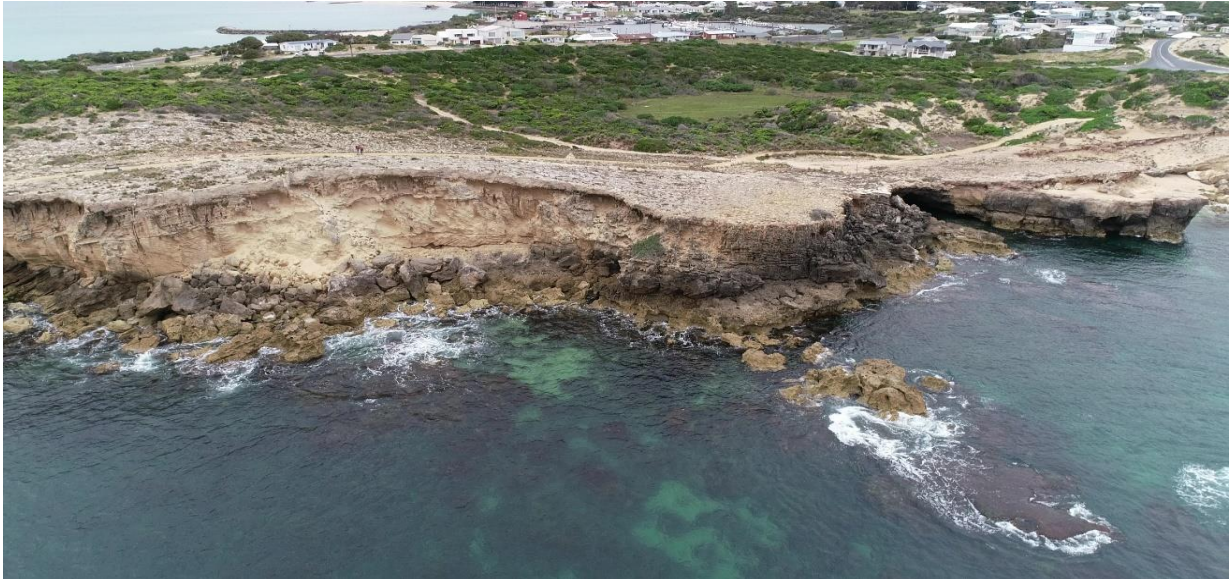
***RZ7\_1 - Cliff Overhang - Chainage 1100***

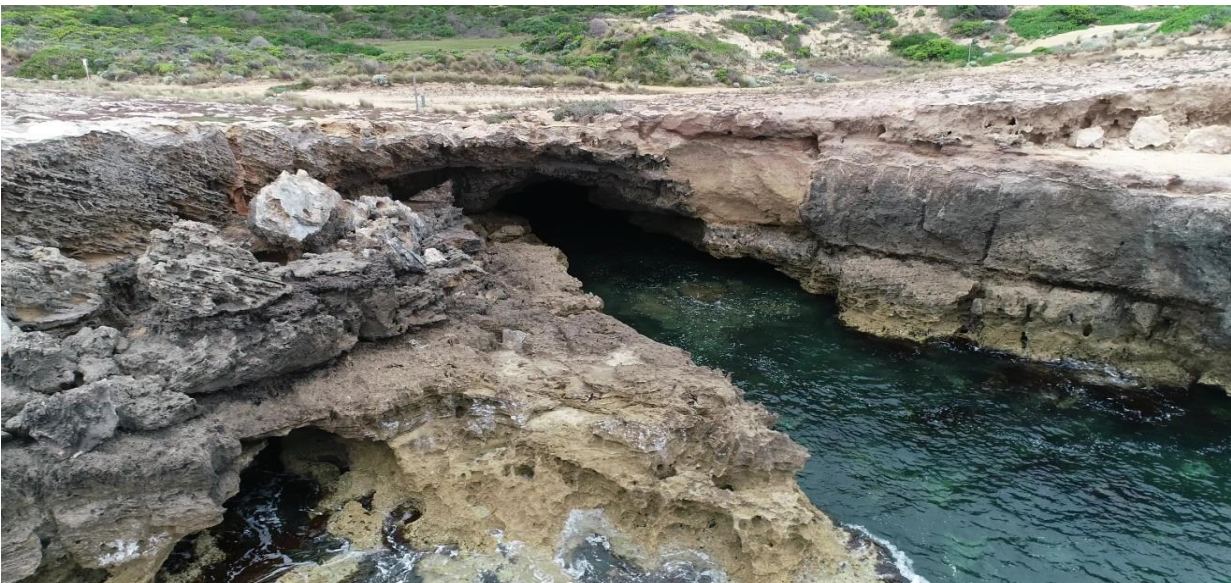
***RZ8\_1 - Blow Hole Undercutting of Cliff Face- Chainage 1200***

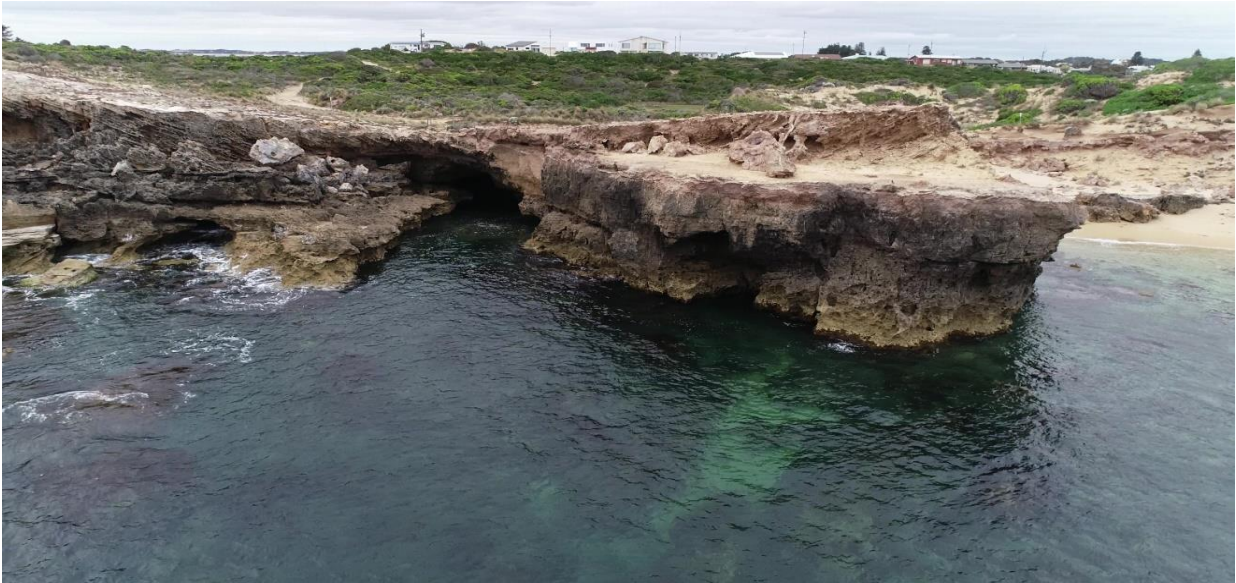
***RZ8\_2 - Blow Hole Undercutting of Cliff Face- Chainage 1200***

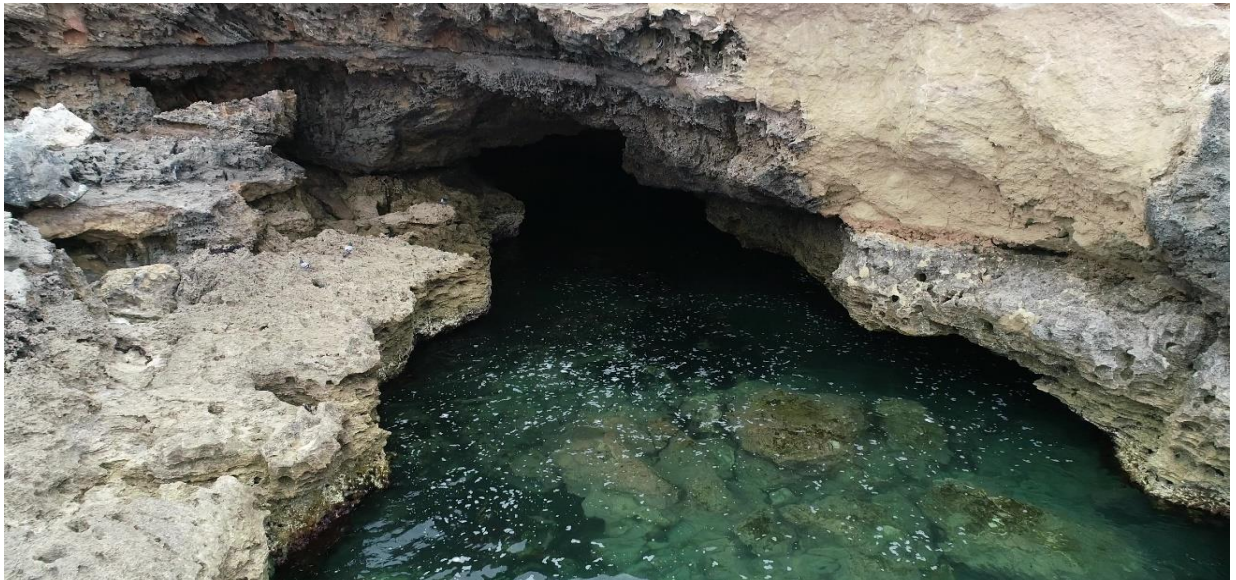
***RZ8\_3 - Blow Hole Undercutting of Cliff Face- Chainage 1200***

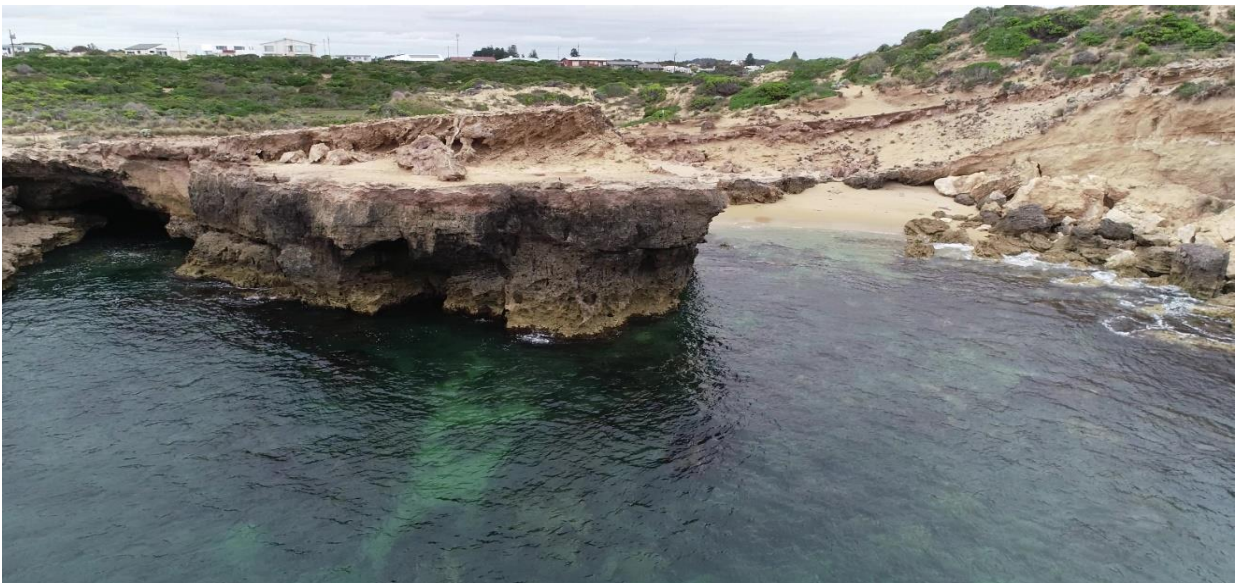
***RZ9 - Undercutting of Cliff - Chainage 1220***

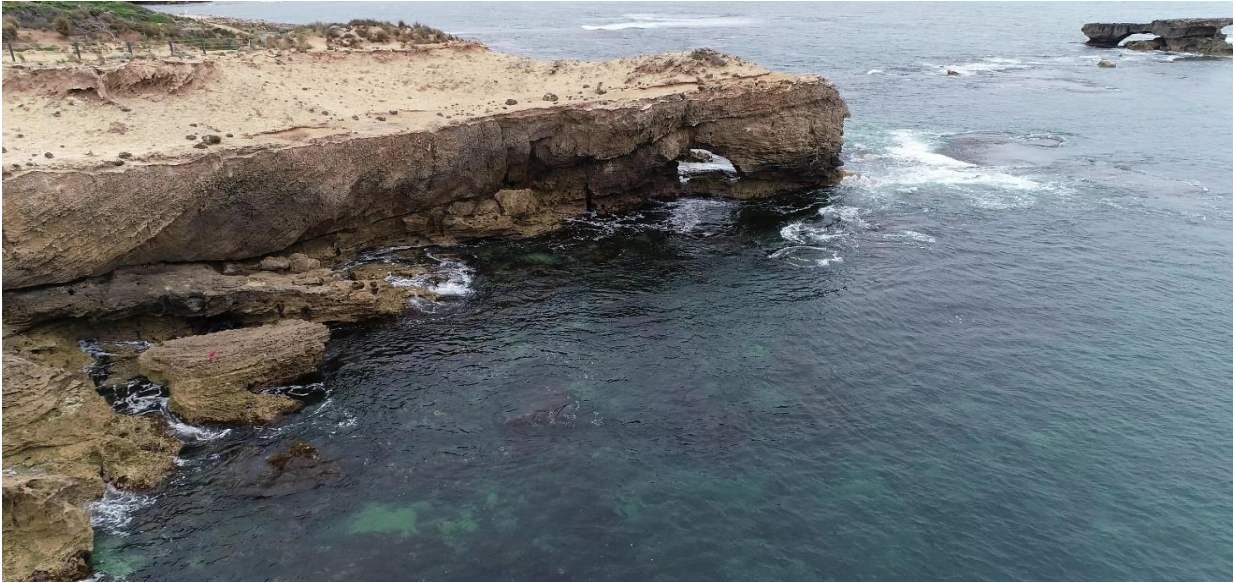
***RZ10\_0 - Doorway Rock - Chainage 1330***

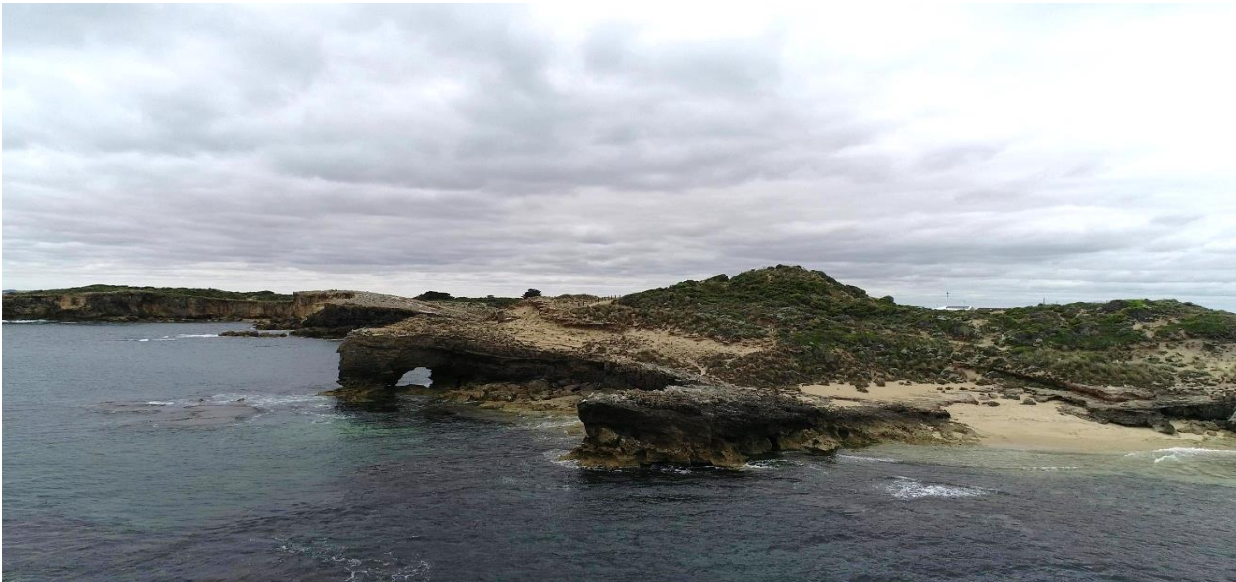
***RZ10\_1 - Doorway Rock - Chainage 1330***

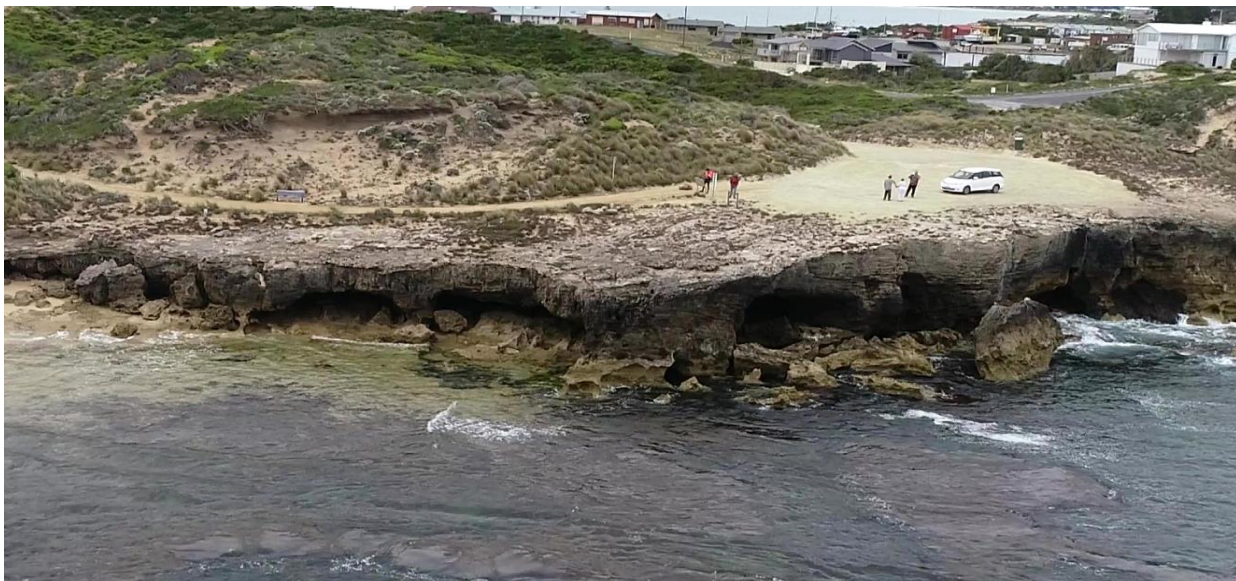
***RZ11 - Undercutting of Cliff (North Side of Carpark) - Car Park 2 - Chainage 1580***

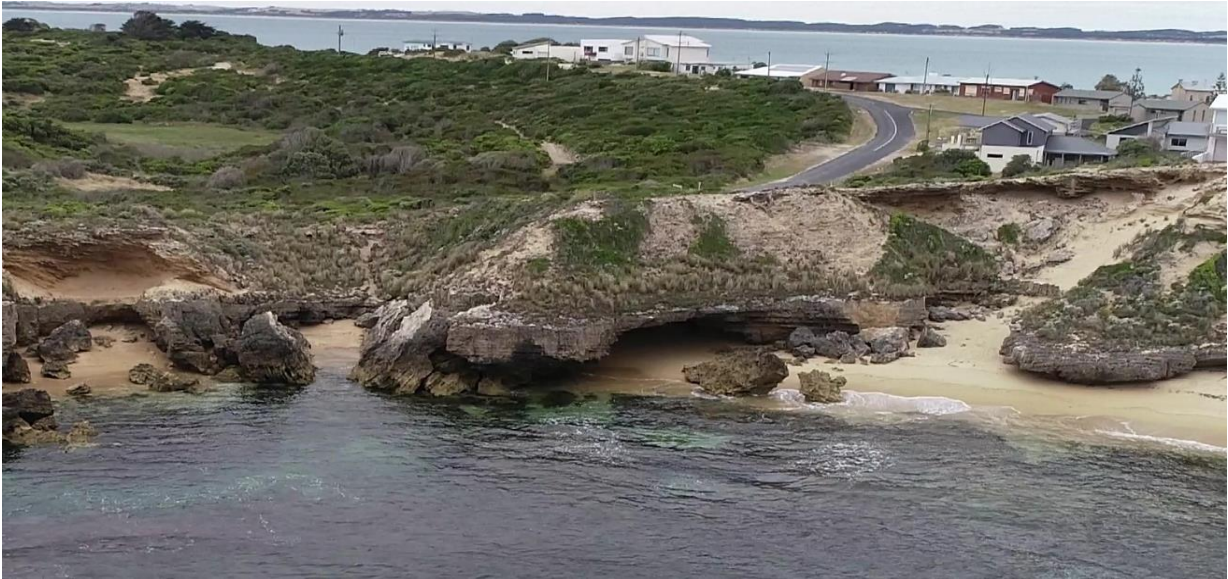
***RZ12\_0 - Undercut of Cliff Face with large soil mass above - Chainage 1750***

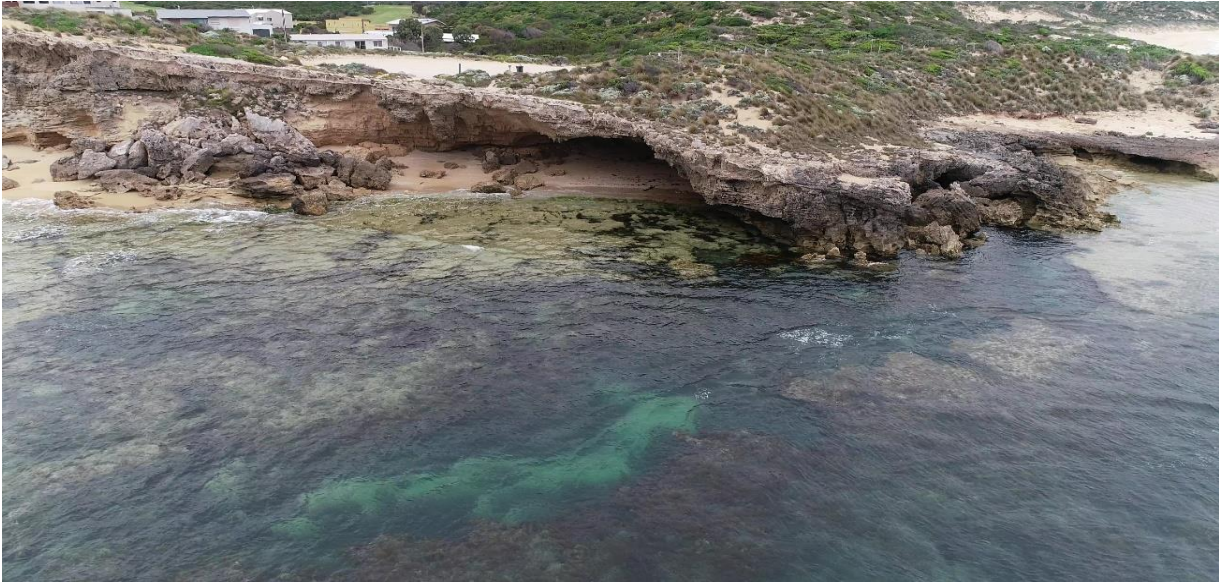
***RZ15\_0 - Obelisk Nature Walk - Southern Carpark - Undercutting of Cliff - Chainage 2250***

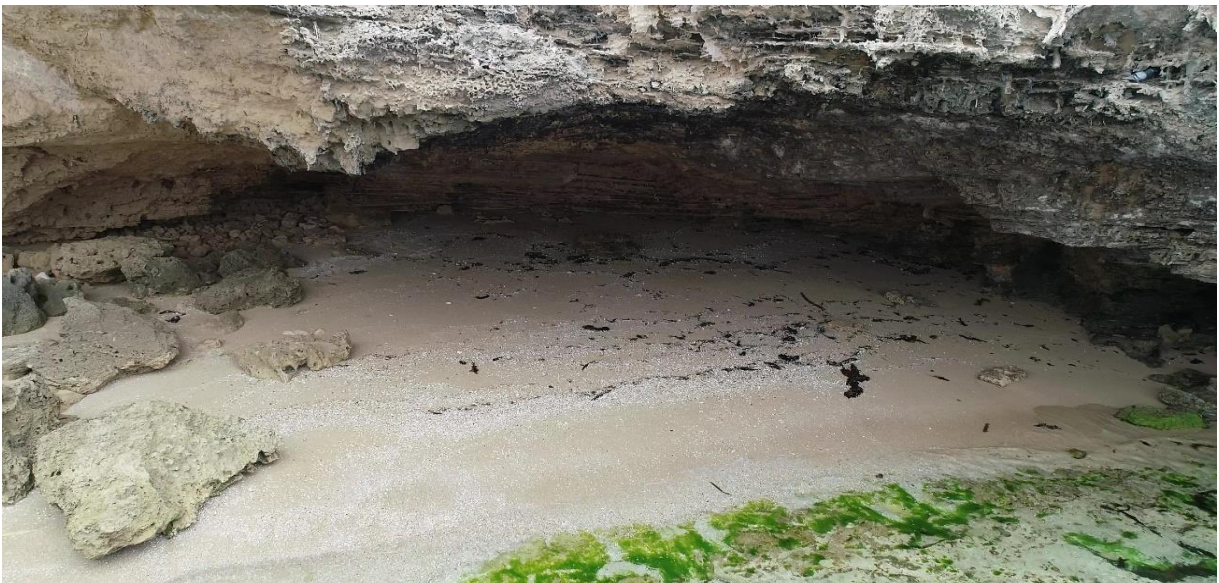
***RZ15\_2 - Obelisk Nature Walk - Southern Carpark - Undercutting of Cliff - Chainage 2250***
