# **Report on the Condition of the Building Fabric with Recommendations**

**February 2023**

**The Robe Institute,  
Smillie Street, Robe**

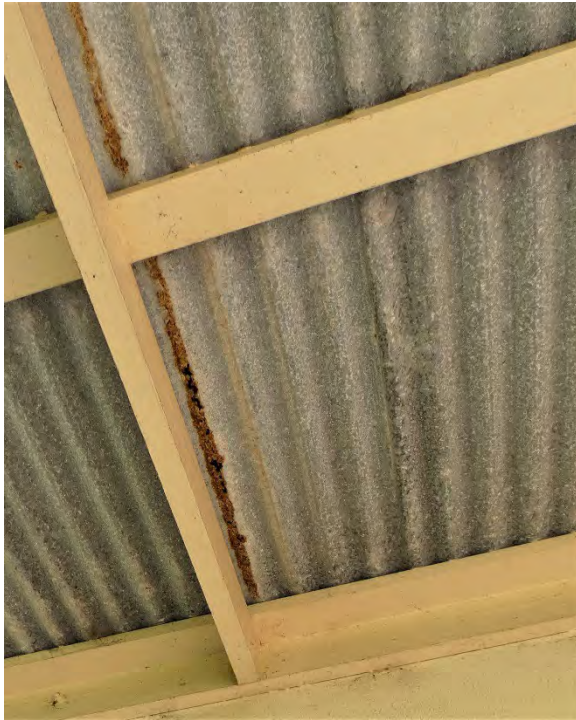
A view of the underside of the corrugated sheets over the east verandah of the library, though, show rust lines at the overlapping joints between sheets suggesting that it would be worth inspecting the underside of the main roof sheets from within the Institute roof space.

**Above:** Rust at junctions between galv roof sheets seen only be seen on underside of the east verandah.

If sheeting to the upper roofs is the same age as that to the east verandah roof it is likely that the main roof sheets will require to be replaced now. This should be determined by inspection both from above, and from underneath the sheets within the main roof spaces. This is because galv sheeting often rusts at the vertical laps between sheets, as has happened on the east verandah roof.

Should roof sheeting require to be replaced, this should be done using new Z600 Heritage Galv sheeting. Prior to fixing new sheets all laps should be painted with a 2-pack paint system to protect from future rusting.

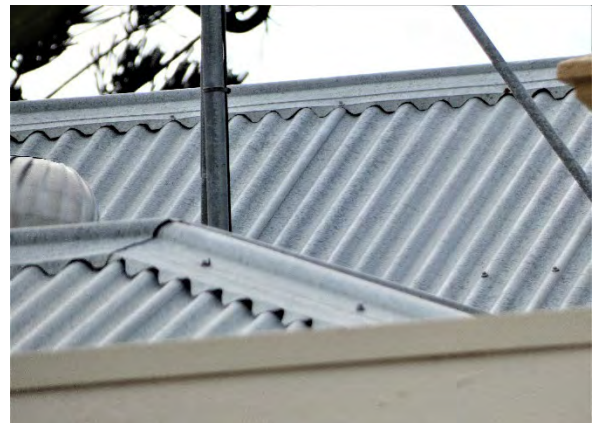
The roofs are all finished with full length corrugated galvanized steel roof sheets that, from distant inspection, appear to be in good condition, albeit some of the roof screws are badly rusted.

**Above:** In the foreground is the galv roof above the main entrance and side rooms. Beyond is the roof to the hall. Apart from some rusted roof screws the roof sheeting appears to be in good condition.

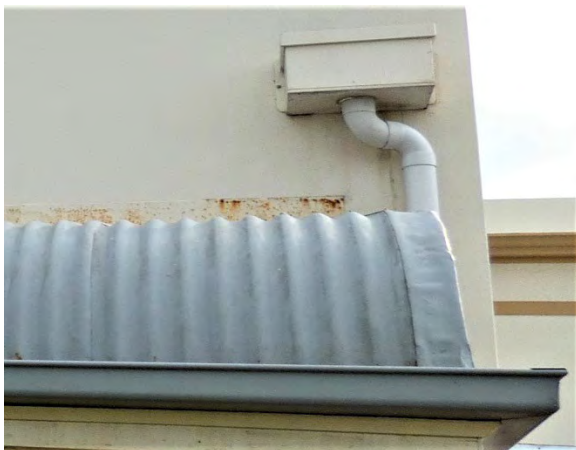
The painted metal flashings at the top of both the east and west extension roofs are rusting.

**Above:** Rusting abutment flashing to the roof of the east verandah. Note the galv rainwater head and uPVC downpipe. The gutter appears to be Colorbond. The gable flashing is painted lead.

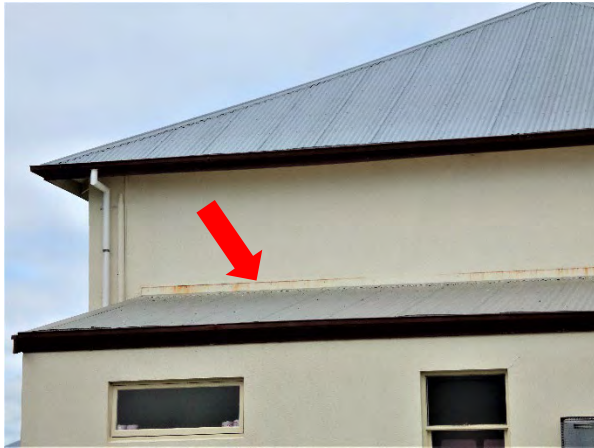
Above: View of north west corner showing D-profile painted galv eaves gutters. Note the rusting abutment flashings to the lower roof.

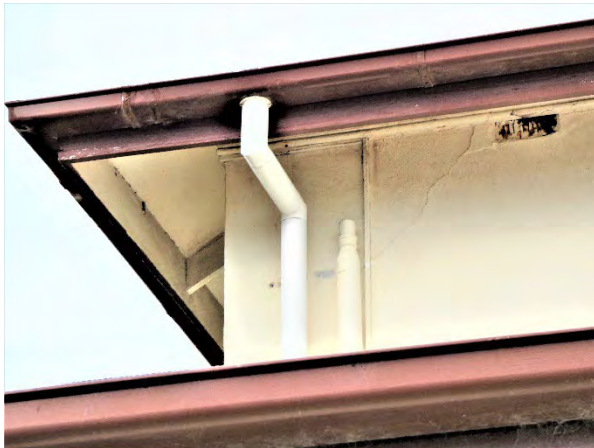
Above: A closer view of north west corner showing that the galv gutter and brackets to the top hall roof are badly rusted.

The eaves gutters to the main roofs appear to be painted galv in a D-profile, not an appropriate pattern for gutters on a State Heritage Place (SHP). During the survey it was not possible to ascertain the condition of these gutters, although the paint is peeling off in places and the gutter to the upper hall roof appears to be badly rusted.

It appears likely that the painted galv eaves gutters will require to be replaced now, and the opportunity should be taken to install more appropriate ogee-profile gutters in their place.

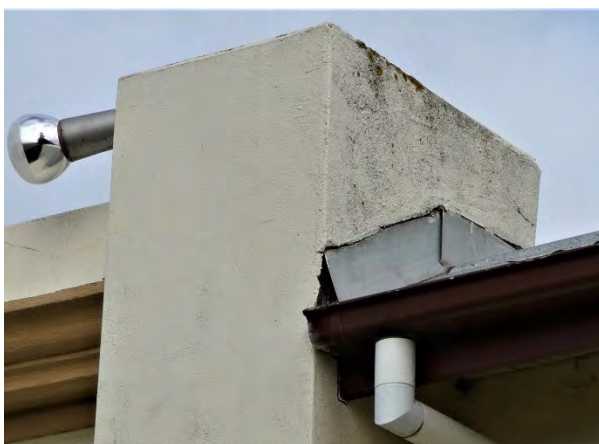
Above: Poor abutment flashing detail at the east end of the hall roof where it meets the library roof along the north elevation. The flashing is not properly sealed against the wall.

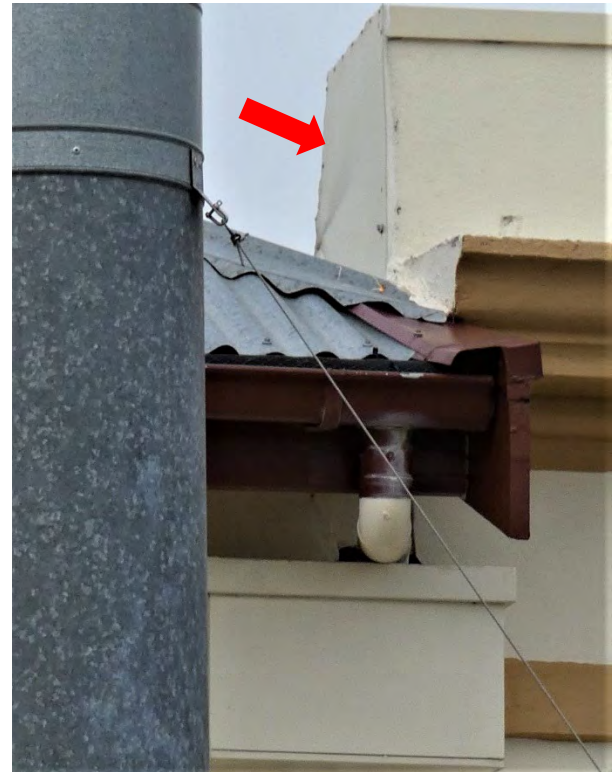
Above: Poor abutment flashing detail where a Colorbond flashing has been rivetted and screw-fixed to the end of the upper parapet wall.

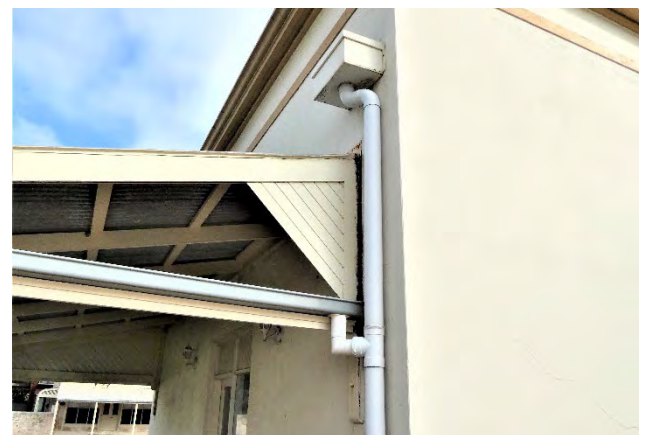
The eaves woodwork appears to have been generally well maintained and seems to be in good condition, although there is a section of missing diagonal boarding to the north gable of the library east verandah roof.

Above: Missing area of diagonal boarding on the gable of the east verandah roof.

Also, most of the steel fixings to the same verandah roof structure are badly rusted.

The missing diagonal boarding to the north gable of the east verandah roof should be replaced immediately.

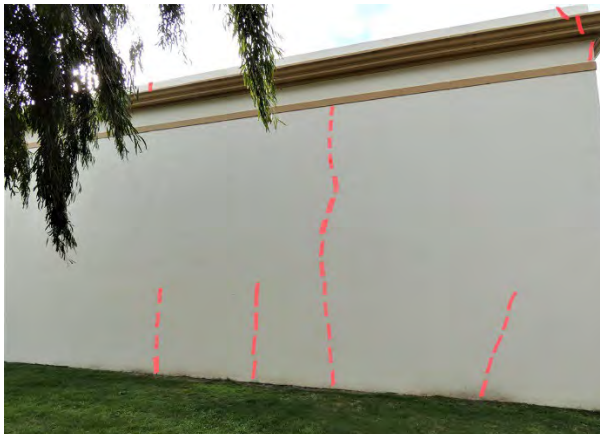
All external walls have been finished with a cement render that appears to have been painted with an acrylic masonry paint. Probably because there are very few movement joints in the render, there are fine cracks throughout the external walls over the whole building as a result of minor movements. These cracks will be drawing in moisture because of the severe exposure of the building along the sea front, and the cement render and masonry paint will prevent the walls from breathing and drying out. Moisture readings taken inside the hall indicate relatively high levels of moisture along the exposed north elevation, confirming that the walls are damp.

**Above: East end of south elevation indicating the most obvious cracks the in render.**

Much of the damp present within the external walls is likely to be due to the fine cracks throughout the external cement render. That render, and the acrylic paint finish, are also preventing that moisture from drying out through the external surfaces.

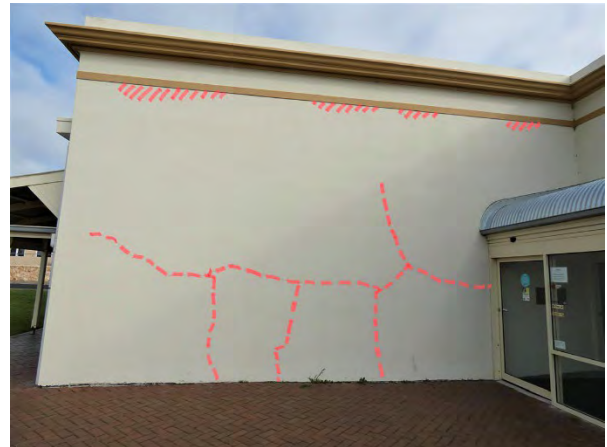
**Above: North elevation adjacent to library/ visitor centre entrance. Dashed lines show the cracks. Hatching higher up shows where trapped water and/ or salts is pushing off the paint.**

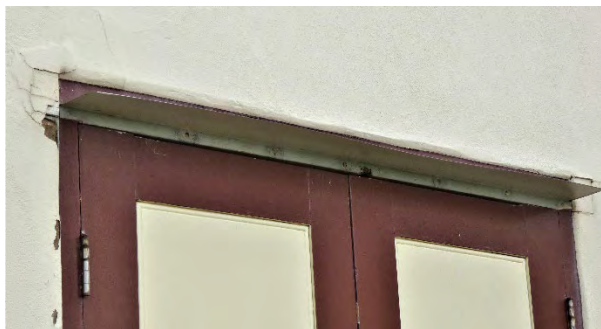
The doorway formed in the north elevation to the hall is likely to have been a later alteration. Its lintel has moved resulting in failure of the cement render at both ends.

**Above: The render is failing at both ends of the lintel to the northern door into the hall.**

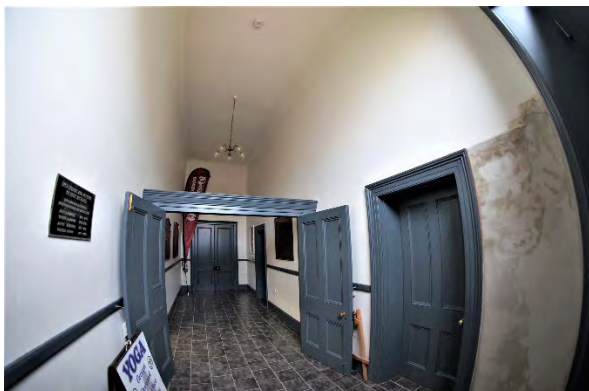
The entrance lobby has been well maintained. There has been some damp on the outside wall to the east side of the entrance door where the plaster has been repaired recently.

Above: Entrance lobby looking from the front door. The recent plaster repair can be seen on the right side of the image.

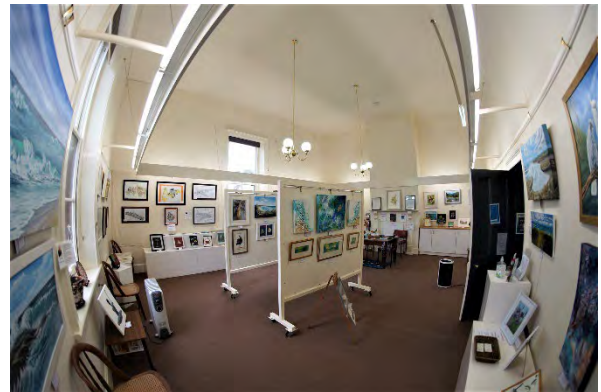
In the west room/ gallery the ceiling cornice, is separating from the walls, especially along the west and north sides. This may be as a result of water ingress from the box gutter above, which should be checked.

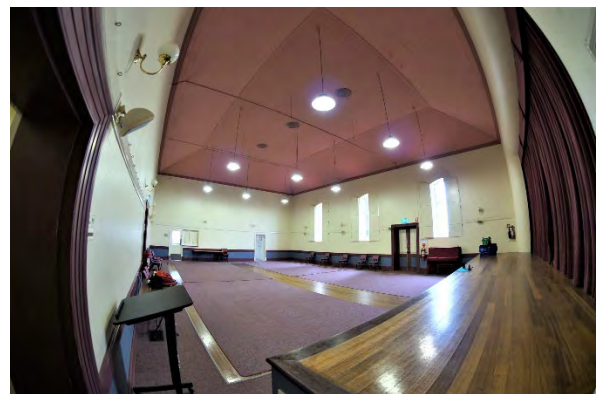
There is minor damage to the boarded ceiling in the hall, possibly because of past roof leaks.

There are minor movement cracks in the plaster to the left/ south side of the stage above and to the side of the curtain.

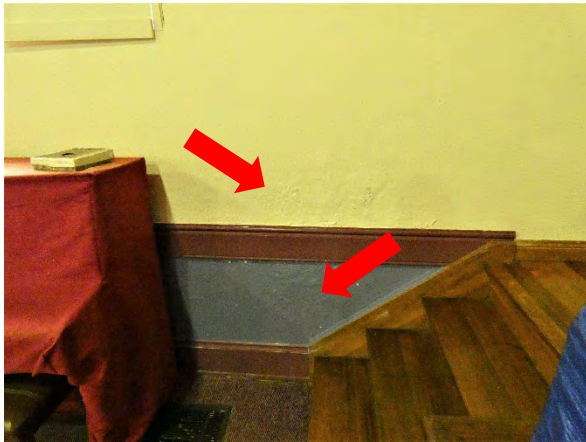
**Above:** Blistering paint at the base of the wall into the north east corner adjacent to the steps onto the stage.

Using a moisture meter, high damp levels were registered to over 2 metres above floor level along the full length of the outside wall, extending around the west wall also.

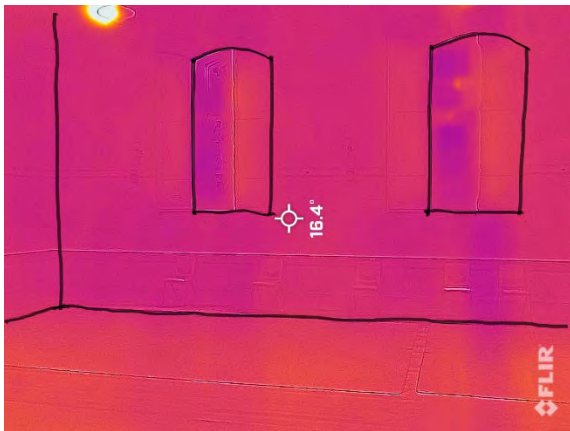
**Above:** Thermal image looking into the north west corner of the hall. The purple, as opposed to red/ orange colour, indicates a lower temperature where moisture evaporating from the wall surface cools the wall slightly. The window glazing can be seen as purple also.

Thermal images confirm the presence of moisture, concentrated in particular into the north west and north east corners and beneath the windows.

The high moisture levels along the north elevation may be a combination of rising and falling damp. The eaves gutter may be leaking and/ or overflowing on occasions onto the gravel pathway beneath. If the external wall has no damp proof course (dpc) it may be that the moisture is being drawn up from the ground and into the walls. Multiple thin cracks in the cement render may also be drawing moisture into the masonry. Because the cement render and acrylic masonry paint prevent moisture from drying out through the outside surface of the elevation, moisture trapped in the walls will migrate inwards to dry out inside the hall, leading to blistering paint.

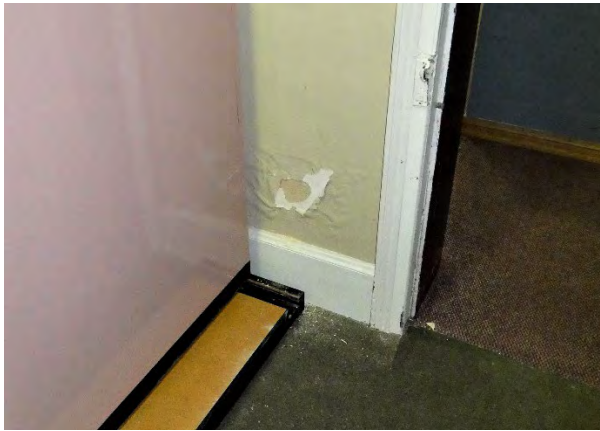
Damp can also be seen in the base of wall behind the compactus in the storage area to the north of the Kathleen Brown Room. This may again be combination of rising and falling damp – perhaps rising up from the ground because of a lack of dpc, and falling due to a failing valley gutter above.

Above: Blistering paint at the base of the wall behind the compactus.

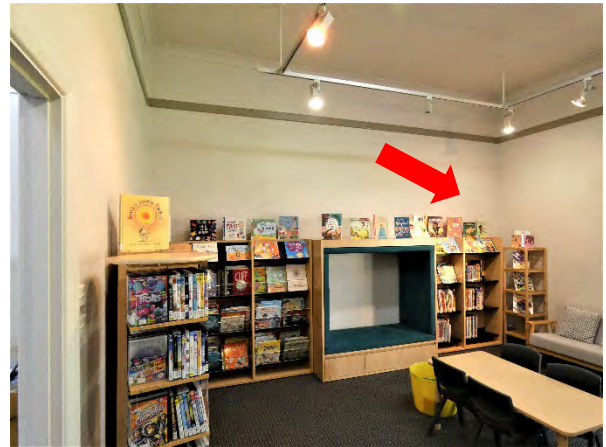
On the other side of the north elevation wall leading to the main entrance into the library/ visitor centre, where the render is cracked, the paint is blistering internally. The parapet box gutter may be failing above and/ or moisture is being drawn through the wall cracks.

Above: Red arrow indicates where the paint is blistering from moisture drying out through the wall surface.

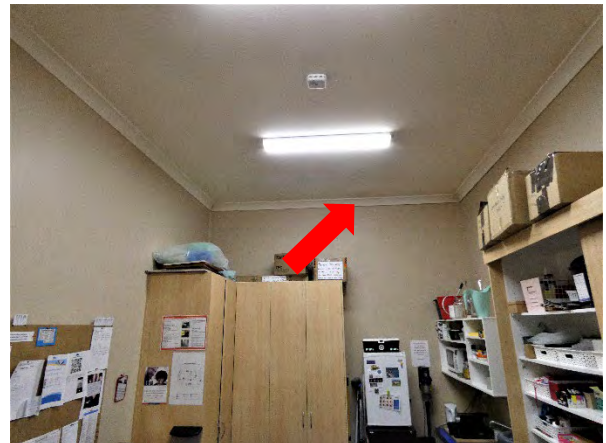
In the south store room there is water staining at ceiling level along the external wall suggesting a possible failure of the abutment flashing at roof level above.

Above: Red arrow indicates water staining on the ceiling of the south store room.

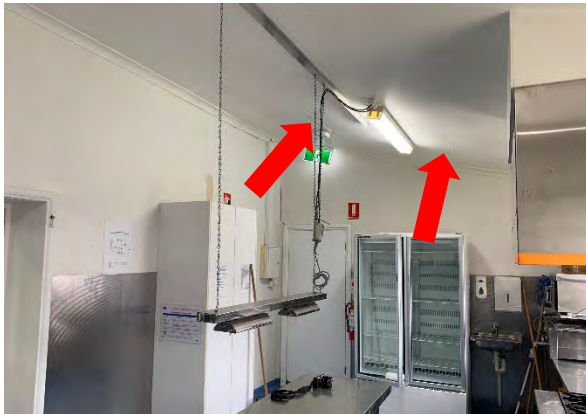
The south end of the kitchen ceiling has water damage. This is likely to result from the concentration of storm water from the upper roofs draining onto a small area of roof above. The drainage pipe installed in place of a spreader may be exacerbating the problem.

**Above:** Water damage to the ceiling at the south end of the kitchen.

As regards the water ingress through the south end of west extension kitchen roof, the area of roof sheeting concerned should be inspected and repaired/replaced as necessary as a matter of urgency. A proper double-spreader at least 1,200mm in overall length should be fixed onto the downpipe above, and ideally the large extract flue should be relocated from the roof to the outside wall where it can more easily be weatherproofed.

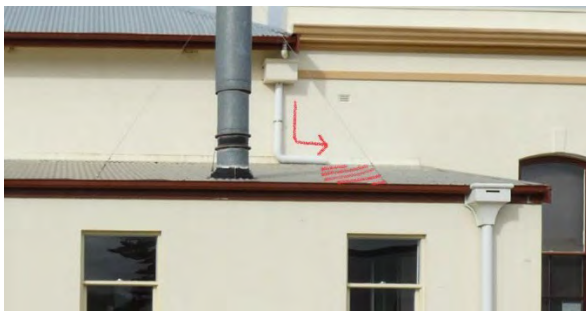
**Above:** Water draining from the upper roofs is concentrated onto the south end of the kitchen roof. The uPVC drainage pipe does not appear to be a spreader.

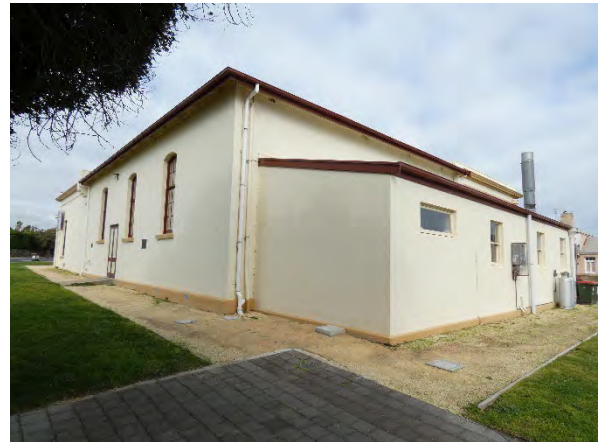
The gravel area along the north elevation, and partially along the east and west elevations, retains a lot of moisture and may be leading to issues of rising damp inside the building.

**Above:** Damp gravel strip along north, west and east elevations.

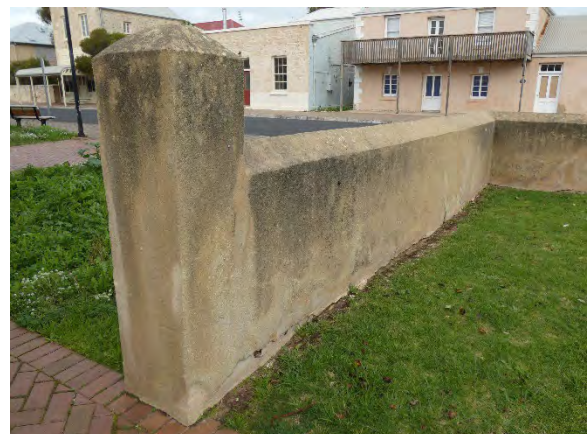
The cement-rendered walls to the grounds around the south entrance are in poor condition in places and look unsightly.

**Above:** The cement render to southern walls requires repairs.

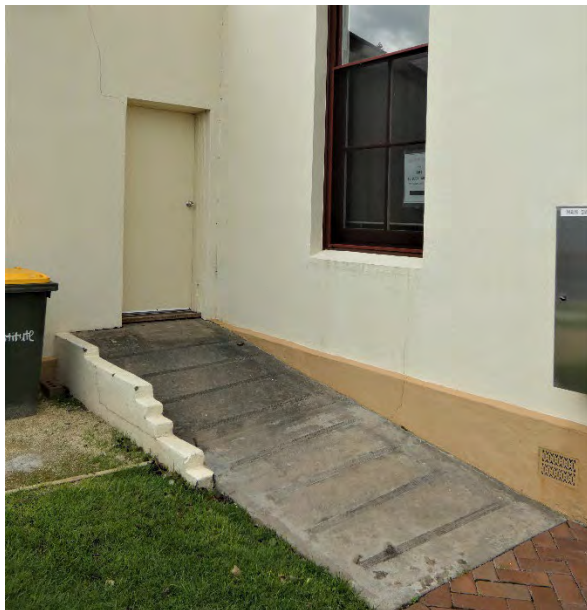
**Above:** If the ramp to the south kitchen door is redundant it would be best to remove it.

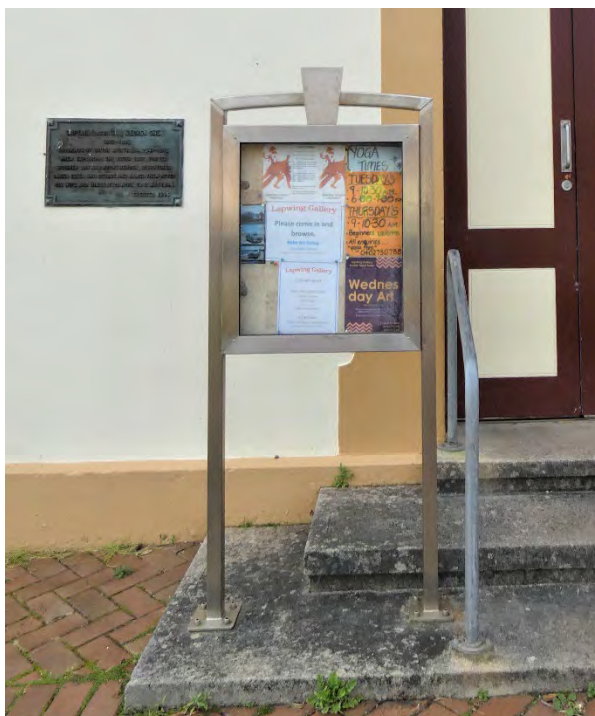
There is a stainless steel-framed notice board fixed directly adjacent to the main entrance to the Institute. This detracts from the view of the significant elevation and should be relocated.

**Above:** The notice board at the main entrance to the Institute should be relocated.

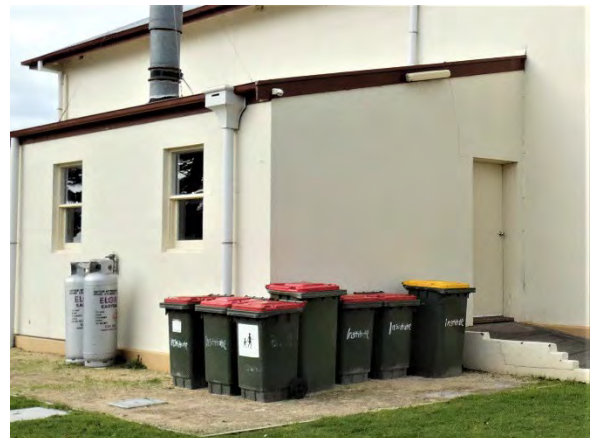
A way should be found to conceal the gas bottles and wheelie bins along the west and south elevations as they can be seen from the main Institute entrance and are unsightly.

**Above:** Gas bottles and wheelie bins on the west elevation can be seen from the Institute entrance.

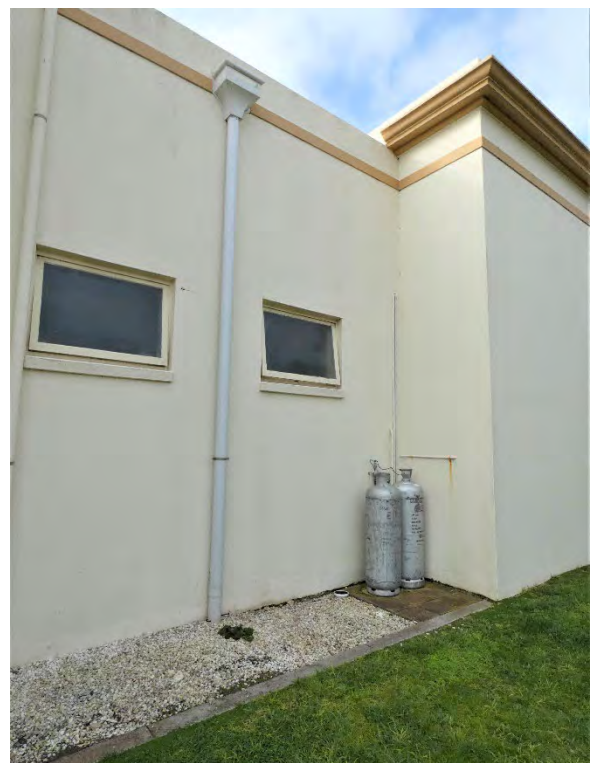
**Above:** Gas bottles on the south elevation.
