**District Council of Robe**

**The Obelisk, Robe – Geotechnical Assessment**

GEOTMEND07773AA-AC

19 October 2015

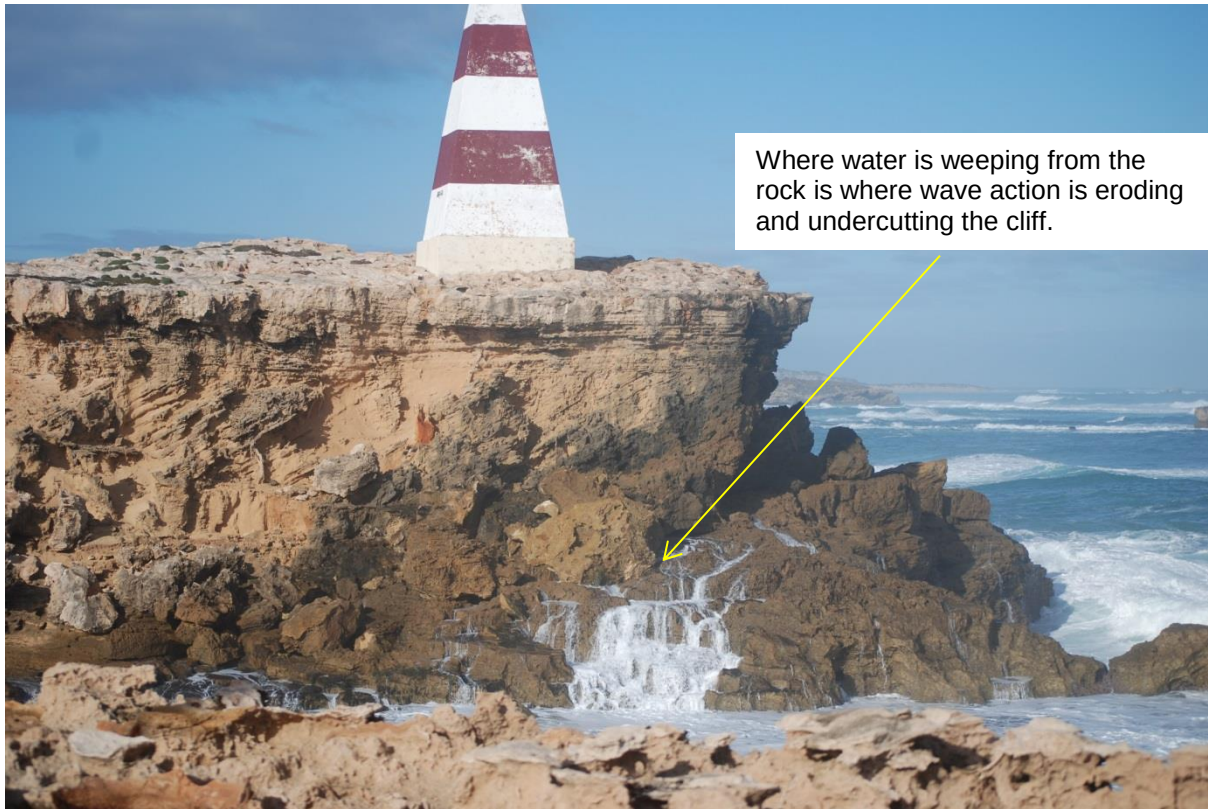
- The Obelisk is located upon a narrow pointed extension of the coast bound by cliffs of 5m to 8m height (Photographs 1, 2 and 3). The ocean surrounding the cliffs has deep currents with wave action impacting on the base of the cliffs. Refer to Figure 1 for a plan of the site;

- Wave action at the base of the cliff is eroding the base of the cliff to a greater extent than the crest of the cliffs (Photograph 1). The long-term stability of the Obelisk will be most influenced by wave action, undercutting of the cliff and then the rock mass cracking from the bottom of the cliff to the upper surface and individual blocks tilting/toppling to the base of the slope;

- To the East – a narrow access to the Obelisk;
  - To the South – the shortest distance the cliff crest is 1.8m adjacent to the Obelisk;
  - To the West – the landform is significantly undercut (almost to the edge of the Obelisk, see Photograph 1);

Photo 1: View looking South. Note width of western footing is 6m.

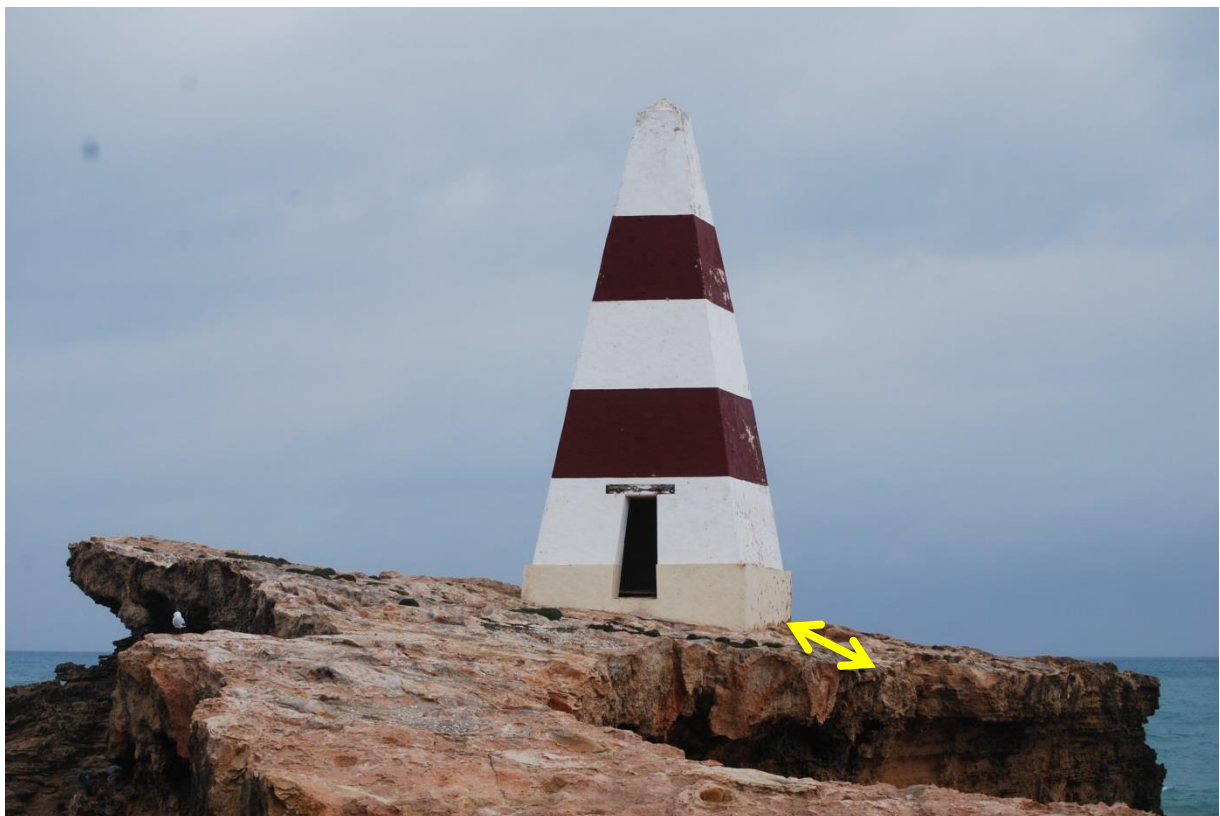
Photo 2: View looking West. Note width of north eastern footing of the Obelisk is approximately 3.8m. (yellow arrow denotes distance). Also the ledge is undercut by atleast 0.5m.

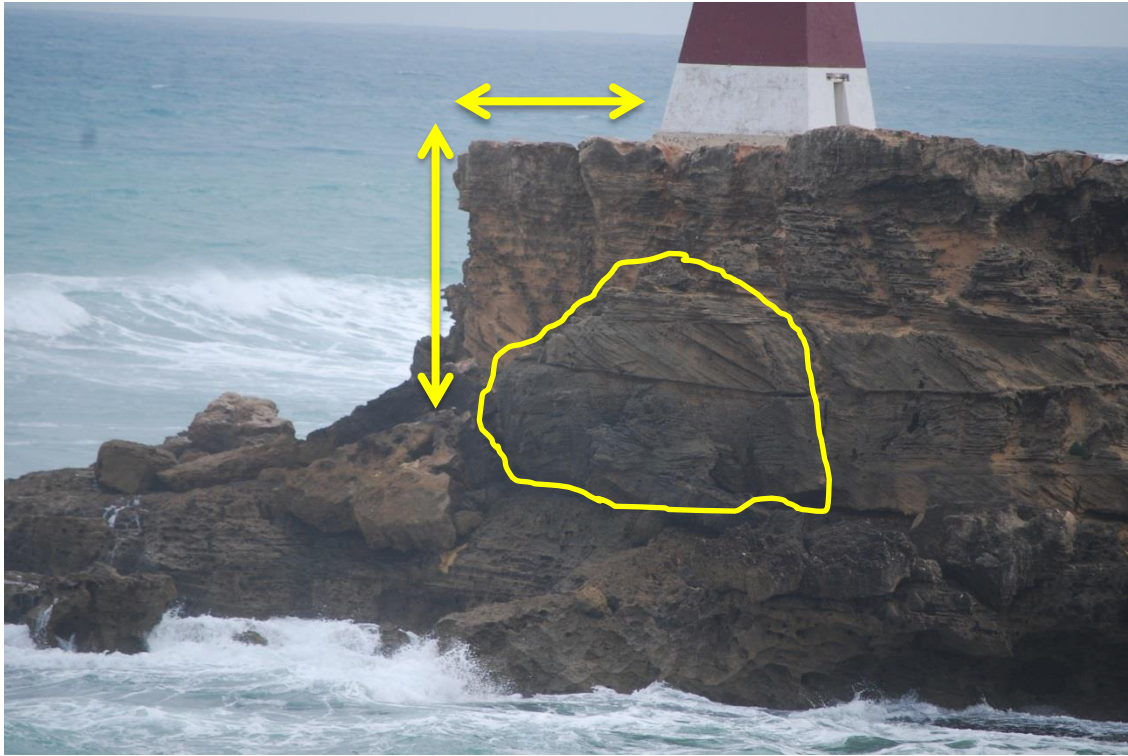
Photo 3: View looking West. Arrows highlight horizontal length is less than vertical height. Irregular yellow shape outlines a loose large block that will detach from the rock substrate in the near future.

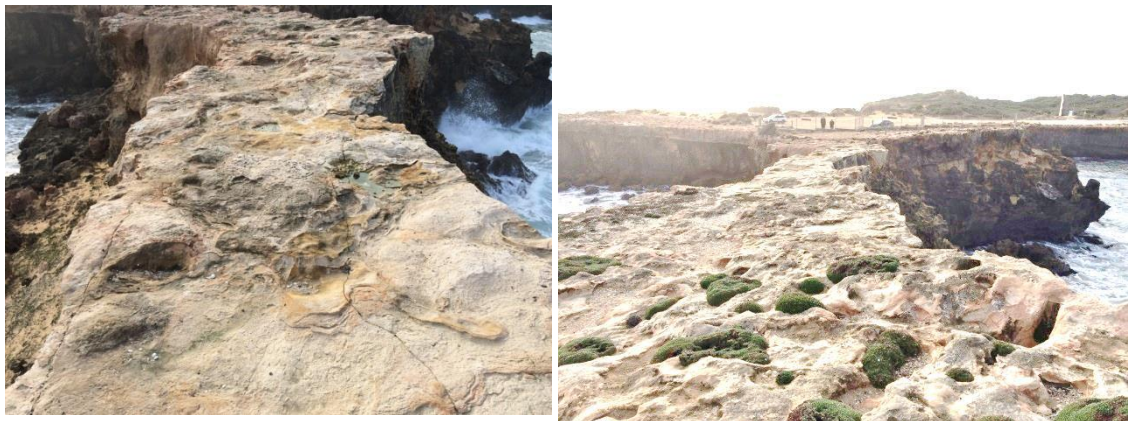
- Access to the structure is via a narrow 2m wide segment of land bound by cliffs that extend into deep water (Photograph 4);
- The Obelisk is a simple unreinforced hollow structure, assumed to be built from local rocks (less than 200mm in diameter) bound by a cement matrix (Photograph 5). The pyramidal shape is strong but has not been built to take any additional surface loading.

Photo 4: Access to the Obelisk is via a narrow uneven landmass. Note the cracks in the surface rock.

Due to the undercutting of the landform crest, trafficking the landform is recommended to be undertaken at a minimum of 1m from the edge of the landform. Where cracks are present the cracks should be marked with paint and monitored for the duration of the project by the person responsible for staff entering the work area.

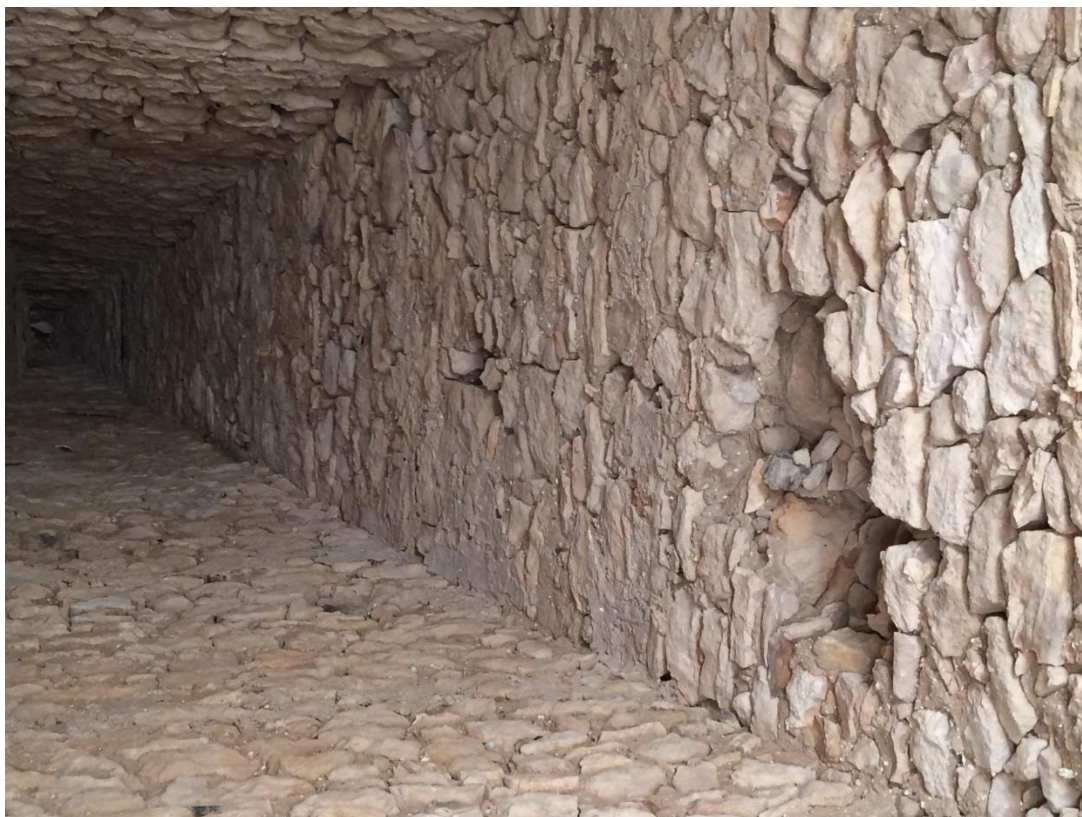
Photo 5: photograph of internal northern wall where a segment (approx.  $1\text{m}^2$ ) has a significant weakening. Location is approximately at the location of the 1st Red line on the outside of the Obelisk.

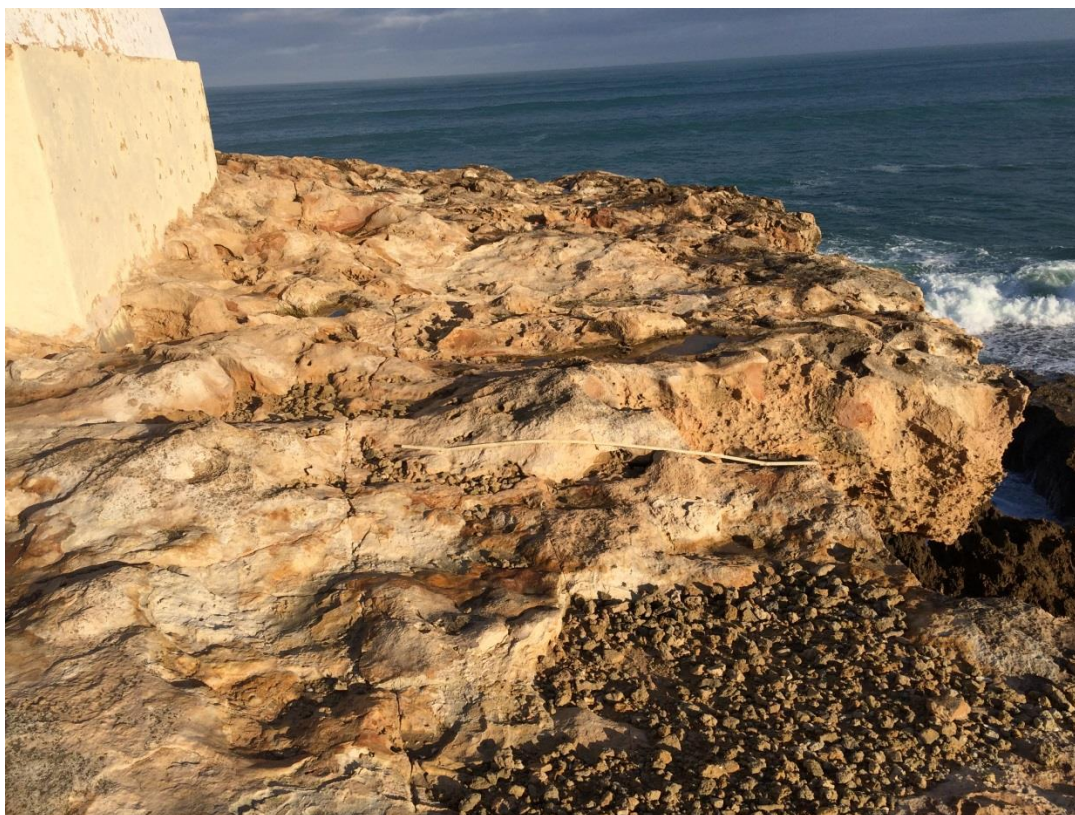
Photo 6: View looking west at the northern boundary to the Obelisk, noting uneven ground and a long crack between the Obelisk and the white 2m length tape.
