Robe Coastline Monitoring Roadmap

Prepared for the
Robe District Council
July 2020

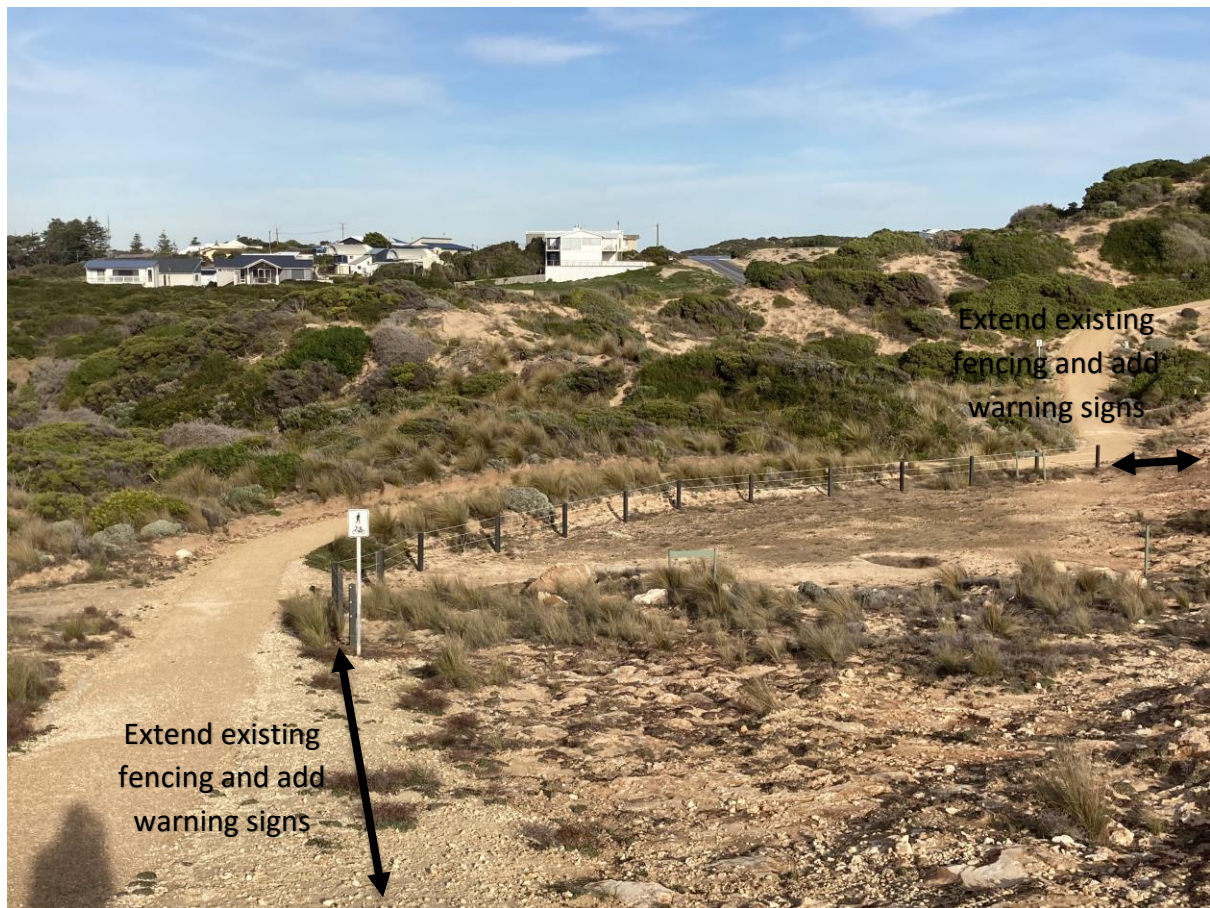
Figure 2: Locations for additional exclusion fencing and warning signs

<i>Vertical aerial survey</i>	<p>A high-resolution georeferenced aerial survey of the coastline to allow quantitative comparison of the cliff edge and rates of change.</p> <p>Extent: full extent of coastal unit.</p> <p>Frequency: every 5 years, commencing in year 3 of this program.</p> <p>Resources: Commercial contract.</p>
<i>Visual inspection</i>	<p>A qualitative assessment of changes to the area above the blow hole noting changes in the size of the existing surface features. An inspection template should be developed.</p> <p>Extent: full extent of coastal unit</p> <p>Frequency: Annual</p> <p>Resources: Commercial contract.</p>
<i>Photo monitoring (drone oblique imagery)</i>	<p>A qualitative method to assess cliff change and failure frequency.</p> <p>Extent: the full length of the unit.</p> <p>Frequency: Annually</p> <p>Resources: Council staff / Flinders University / Contractor</p>
Immediate Actions	<p>Installation of additional fencing to exclude people from accessing the blowhole area (Figure 2) until the 3D survey has been completed and the full risk extent determined.</p> <p>Warning signs on existing and new fencing.</p>

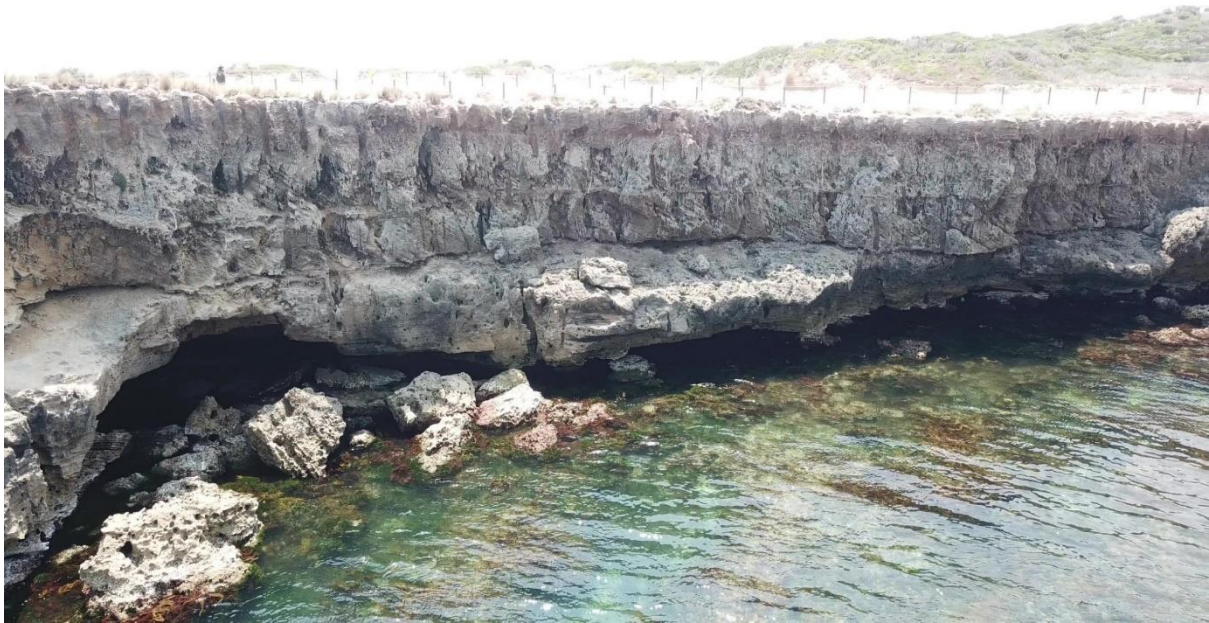
Figure 3: Cape Dombey undercut features possibly extending beneath adjacent carpark

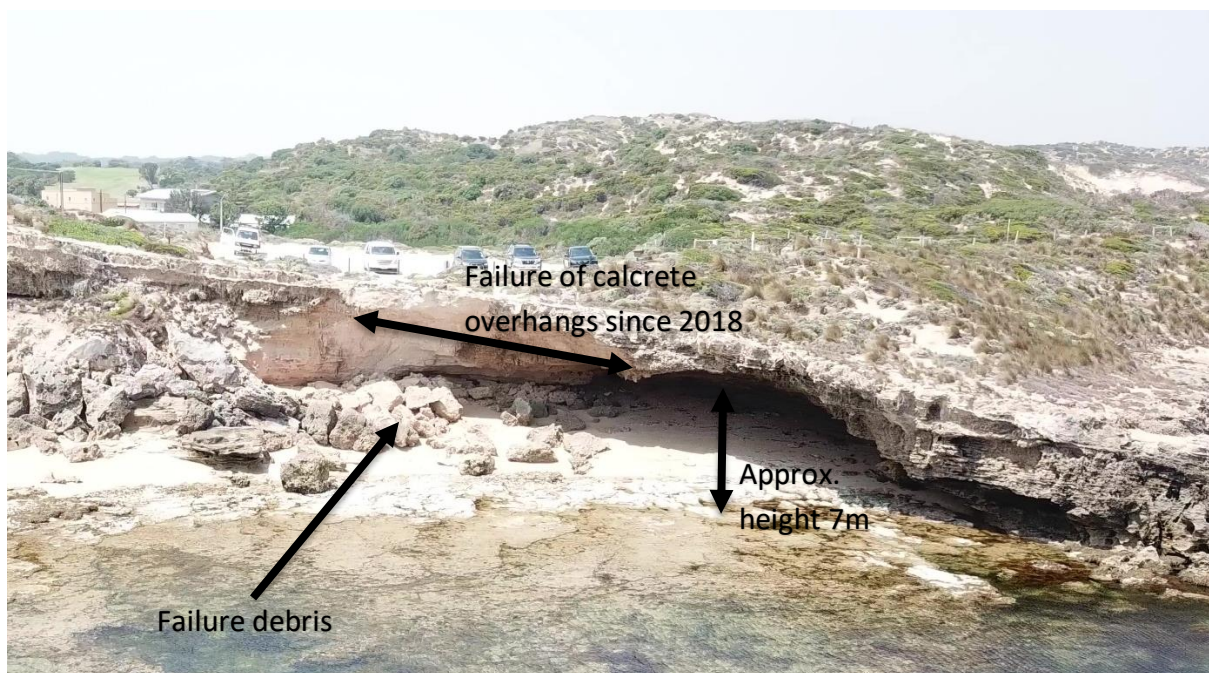
The undercut extends some distance beneath the cliff edge and Tonkin (2018) estimated it could extend towards as far as the carpark although the exact extent is unknown. The recent failure confirms the weakness of thin remaining calcrete layer and the significant erosion hazard at this location.

Figure 11: Large undercut cliff at the southern carpark

Immediate Actions	<p>Installation of signage to warn against cliff collapse risk due to undercut failures. Warning signs at the carpark and on the beach (if accessible)</p> <p>Additional fencing and signage may be required once the full extent of the undercut risk area is determined from the 3D survey.</p>

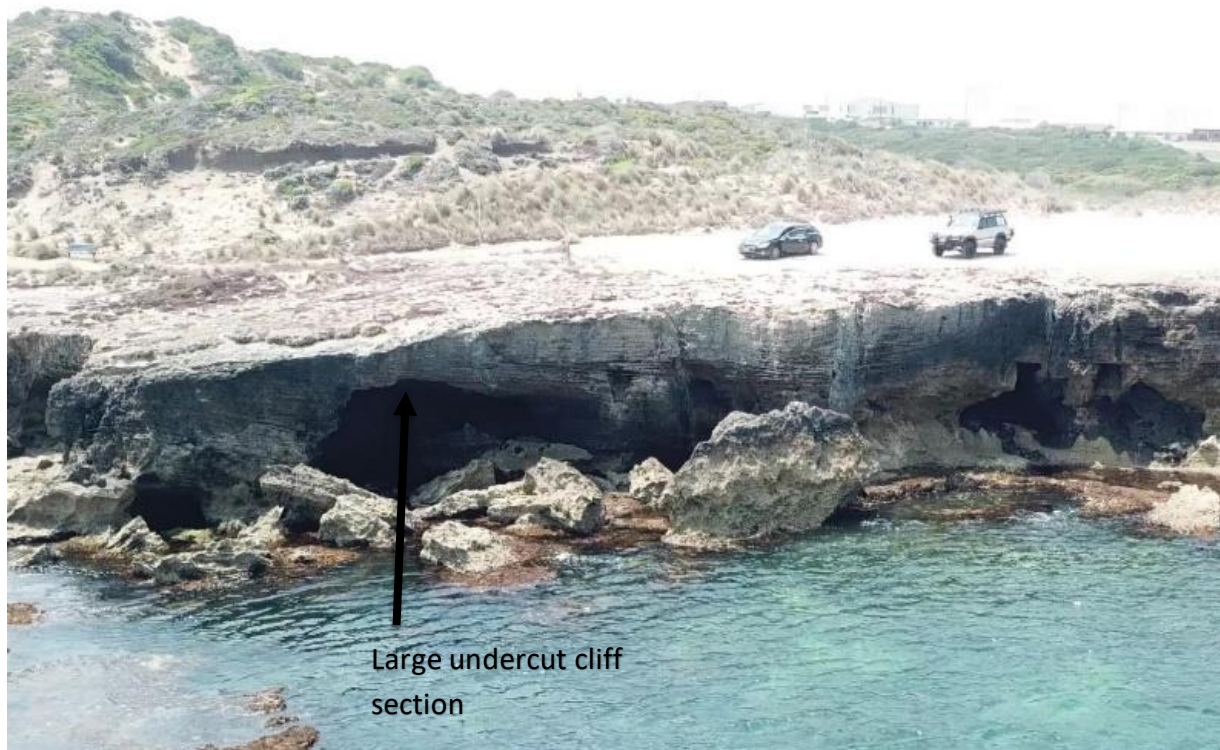
An undercut cliff section at the carpark at the end of Joy Terrace was observed, Figure 12. There is currently no signage or fencing to exclude people from this area. The cliff height is around 4-5m.

Figure 12: Carpark at the end of Joy Terrace with cliff undercut sections visible

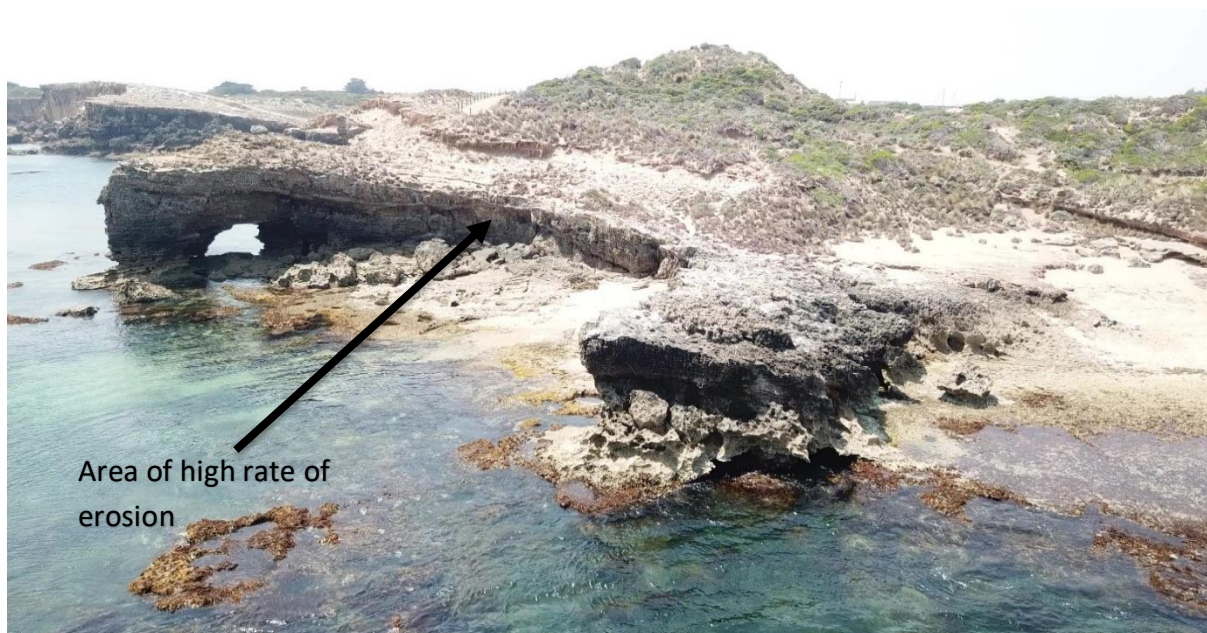
Within the embayment adjacent to Doorway Rock, Figure 13 is location 20 from Figure 5 where Fotheringham (2009) recorded significant cliff line recession of 22.53m over the 100-year period.

Figure 13: Doorway Rock

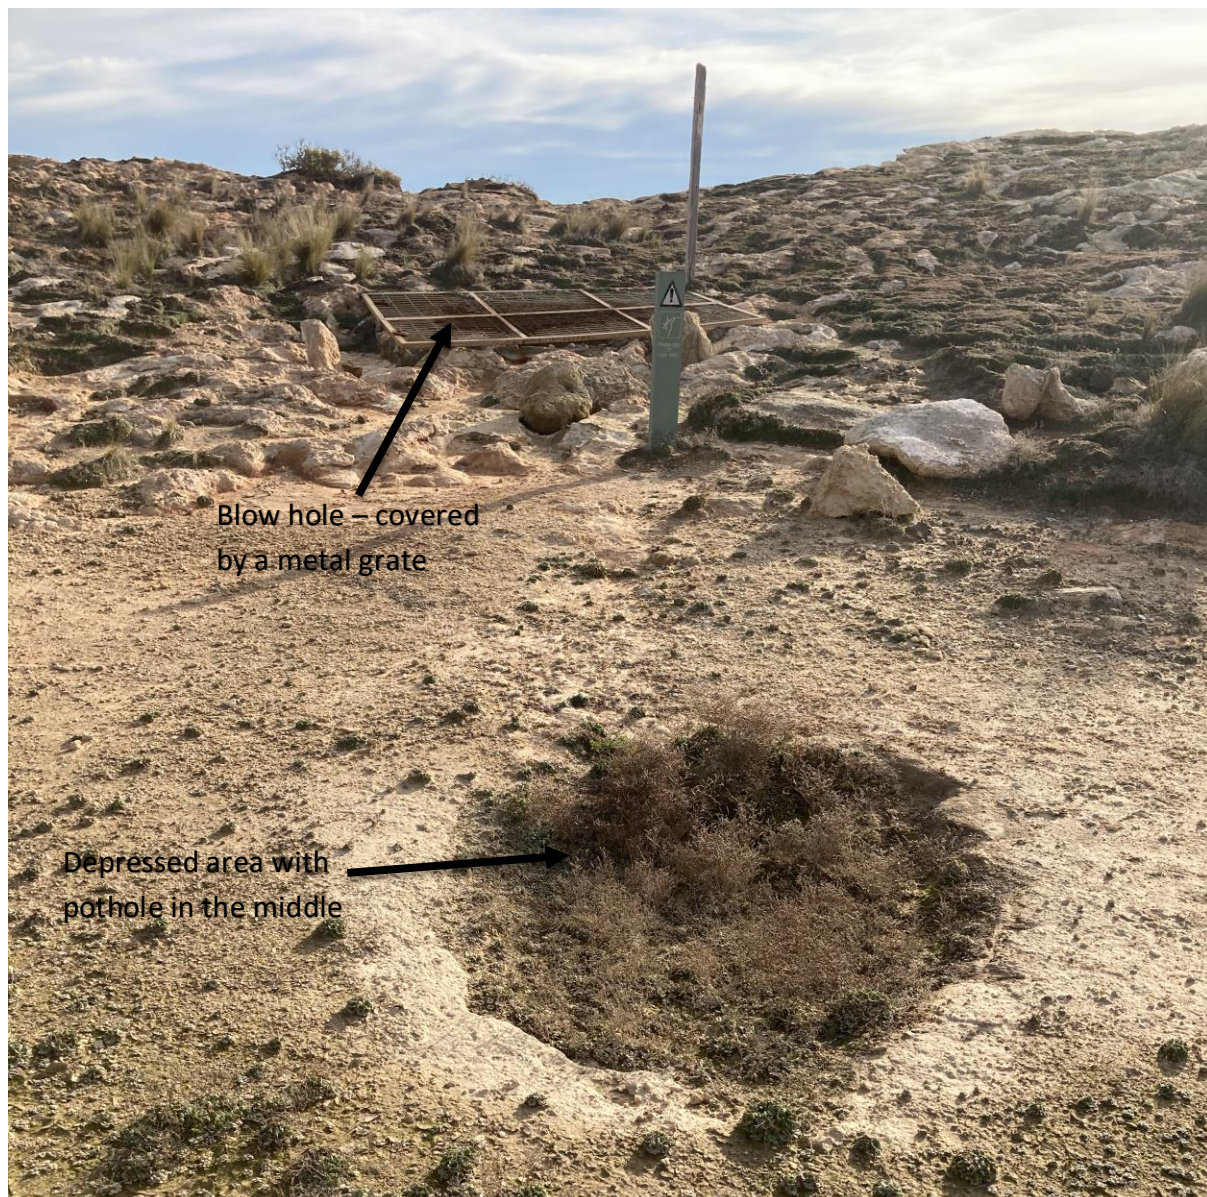
No obvious visual changes have occurred between the 2018 and 2020 imagery of the cliff cavity feature. However, as noted by Tonkin (2018) if there is a large connected cavity between the cliff and the blow hole area a sinkhole could develop. Sinkholes tend to develop rapidly (seconds to minutes) and it is not possible to predict when a sinkhole will appear.

Figure 14: Blow Hole and adjacent depressed area

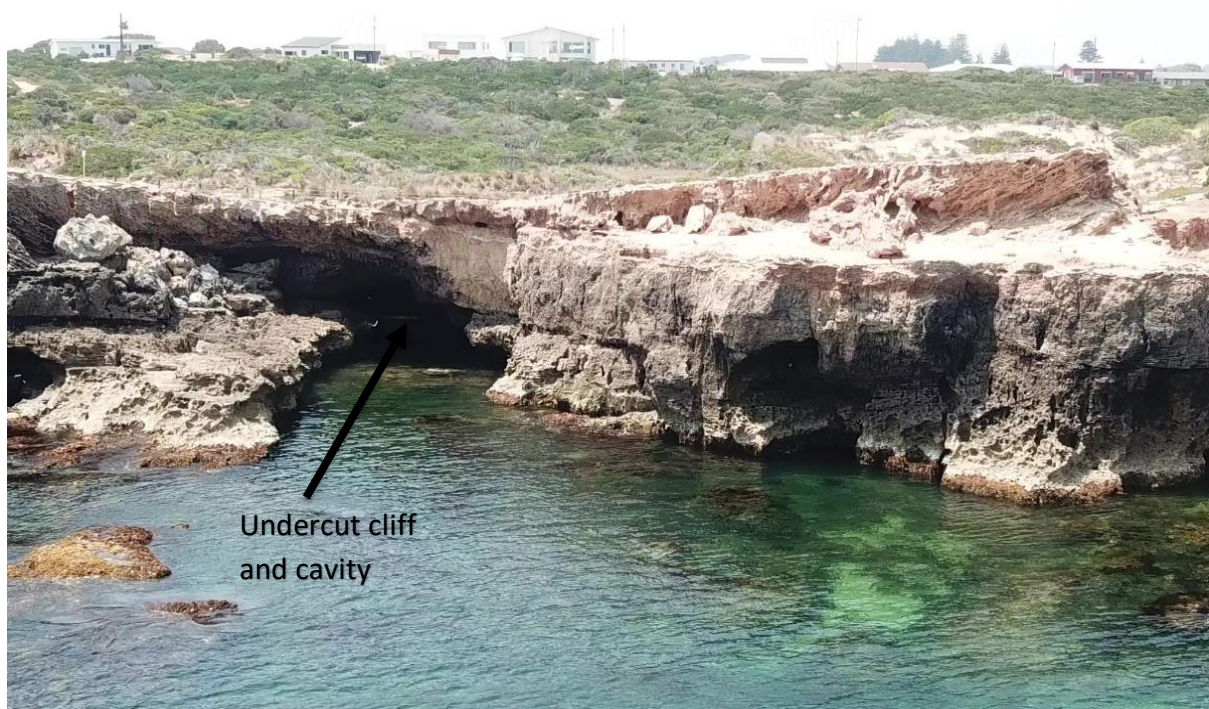
Figure 15: View of the cavity feature which likely links to the Blow Hole

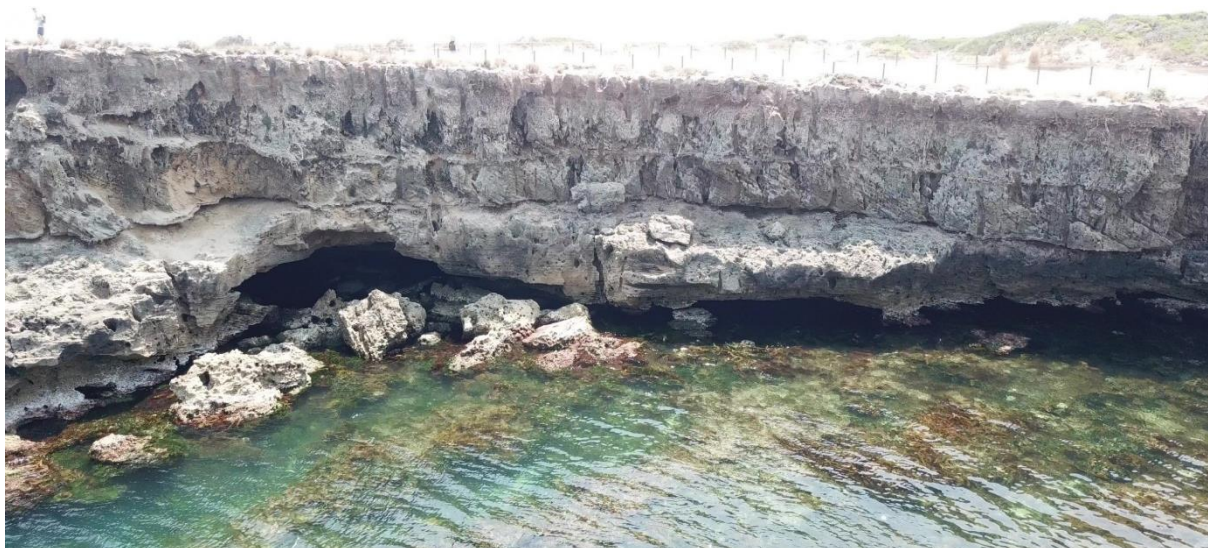
No changes in the condition of the cliffs was observed between the 2018 and 2020 imagery. It was not possible to determine any additional information on the size and depth of the undercut features in the 3 locations.

Figure 17: View of undercut at Risk Zone 3 adjacent to the carpark

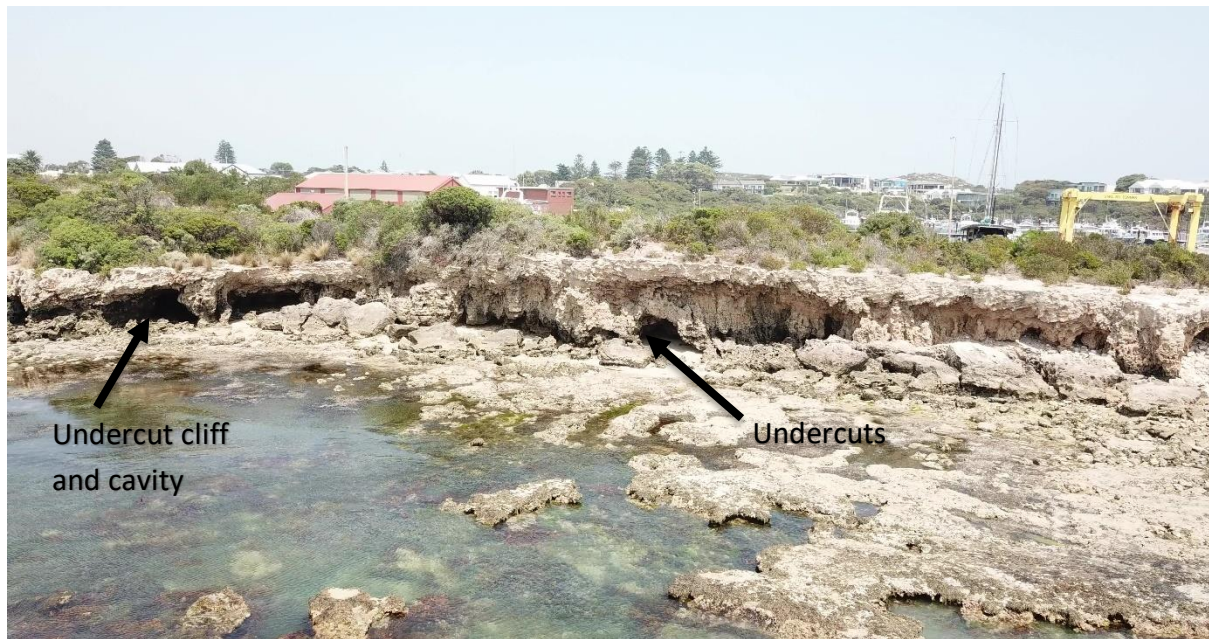
There are no formal pathways along this cliff section and the area around the cliff appears to be heavily vegetated which would limit access.

Figure 21: View along Marina coastal unit showing cliff undercuts and cavities

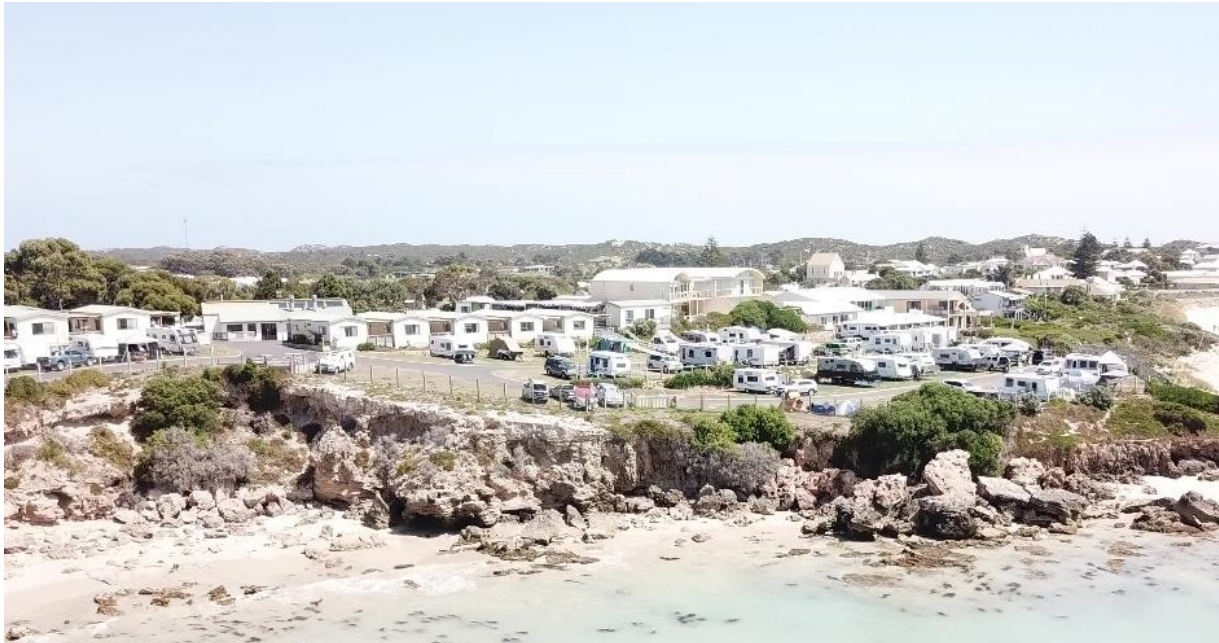
The stability of the cliffs around the SeaVu Caravan Park were visually assessed in the GHD (2016) report. The assessment indicated undercutting of the cliffs in some areas by up to 1.5m. A view of these cliff areas from the 2020 drone imagery is presented in Figure 24.

Figure 24: View of the cliffs at SeaVu Caravan Park

Although remedial works were recommended in the report, visual observations indicate these areas are fenced off and well outside the current fence line. The previous risk rating is likely therefore to be overly conservative.

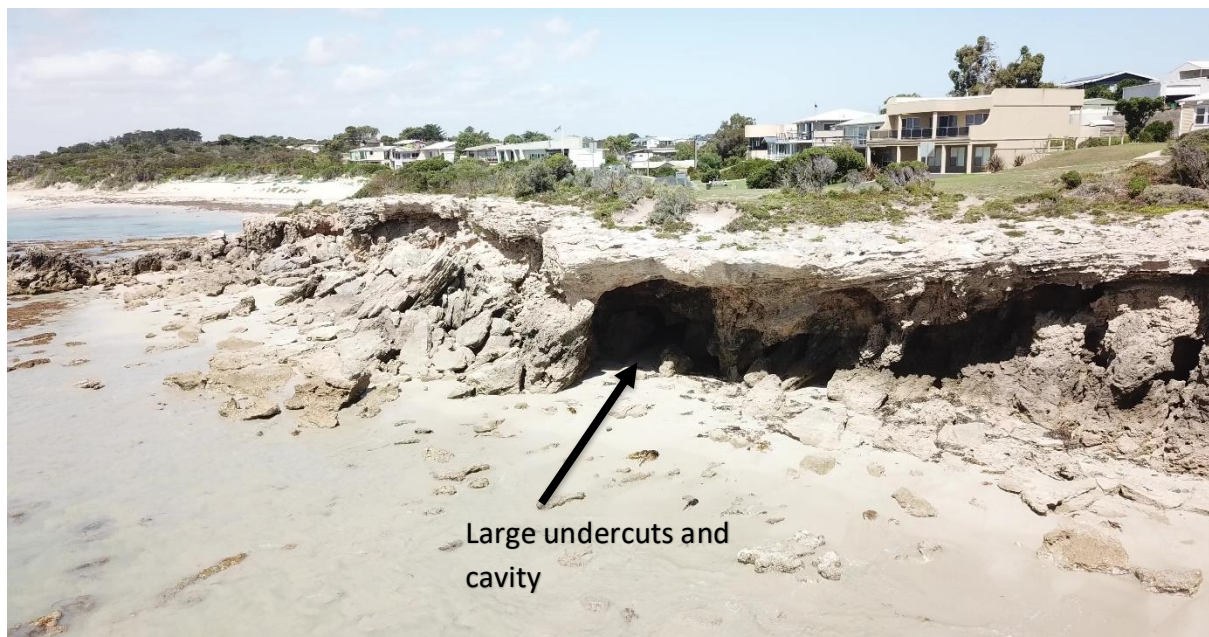
Of more immediate interest is the cliff section to the east of the Caravan Park along Seafarers Crescent. Figure 25 shows the current undercut cliff sections. These areas are accessible by pedestrians and by vehicles in some areas. The cliff failures here appear to be the result of tensile failures of the calcrete overhangs (failure types 6-8, Figure 4), with failed sections still present along the face in some locations. It is unknown how far the current overhangs extend beneath the point.

Figure 25: Undercut cliff at Seafarers Crescent, east of Squires Drive

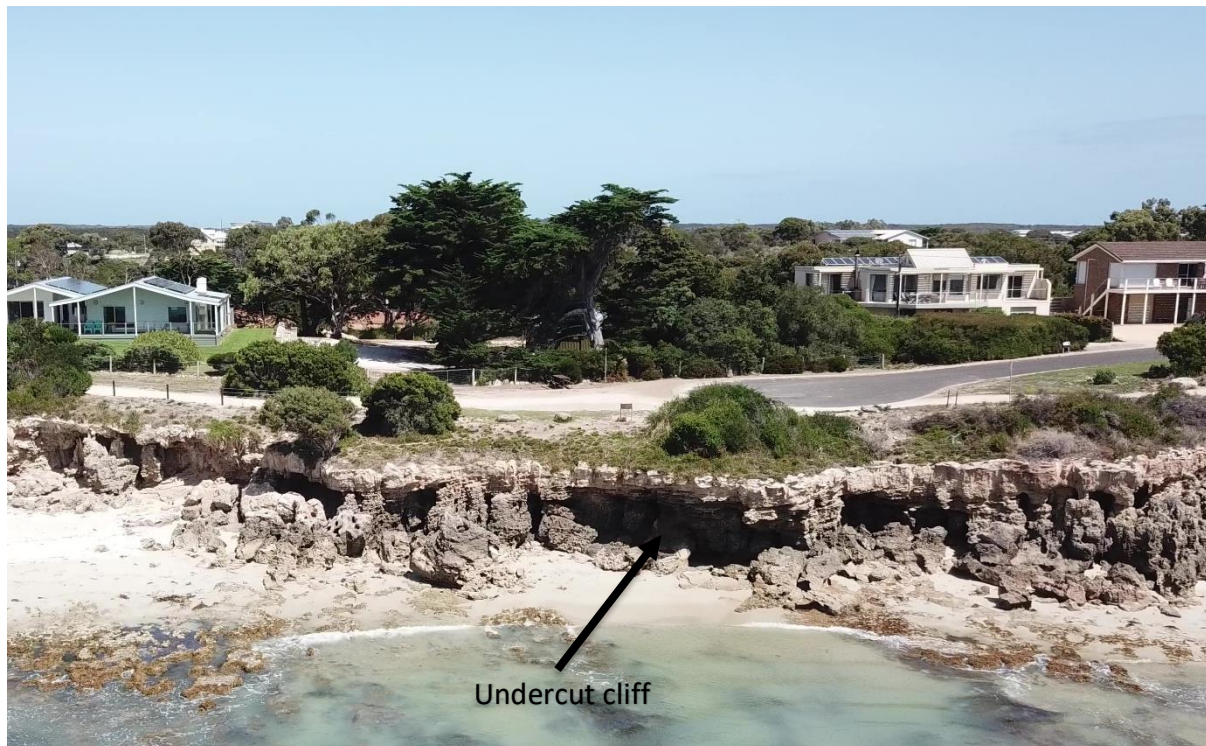
Figure 28: Cliff undercut at the turning bay on McIntyre Street

Additional warning signage would be warranted along the coastal walk to encourage walkers to remain on the path and avoid walking near the cliff edge. Additional signage at McIntyre Street is also recommended.

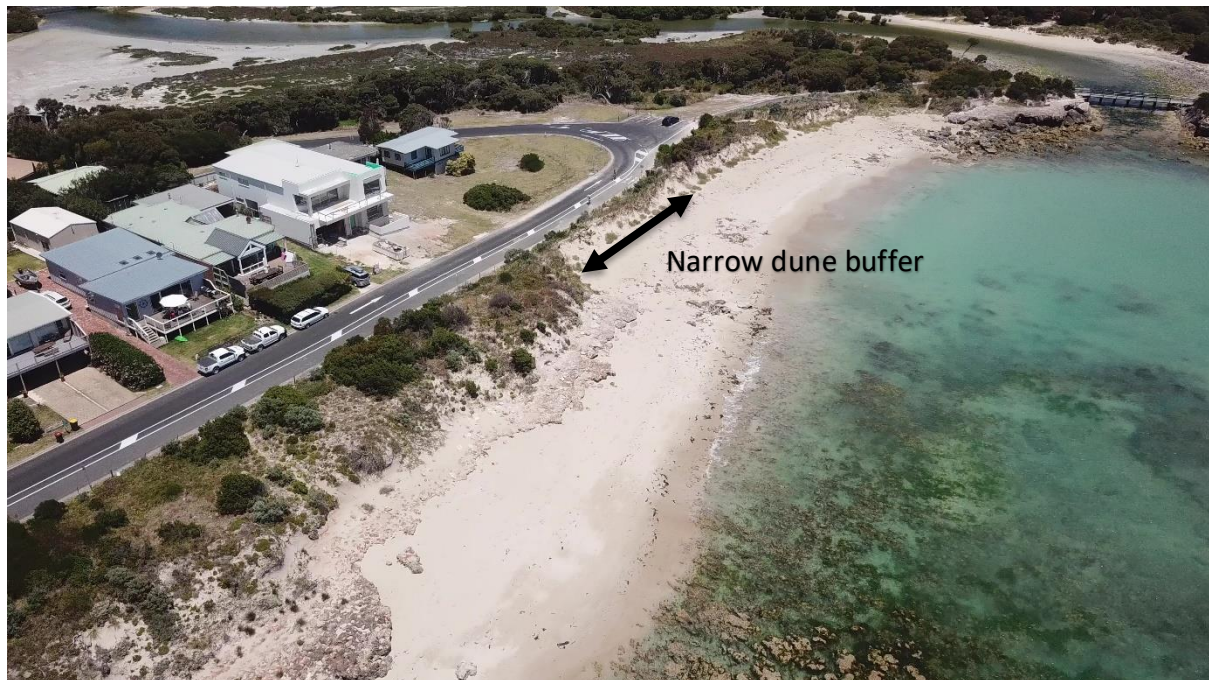
Like Hoopers Beach, Fox Beach exhibits a long-term erosional trend, which has been accelerated by a series of storm events since 2016. There is only a limited buffer between the dunes and adjacent roadway, Figure 30. Beach nourishment was completed in June 2020, Figure 31.

Figure 30: Aerial view of Fox Beach in February 2020 showing a limited dune buffer between the beach and adjacent roadway

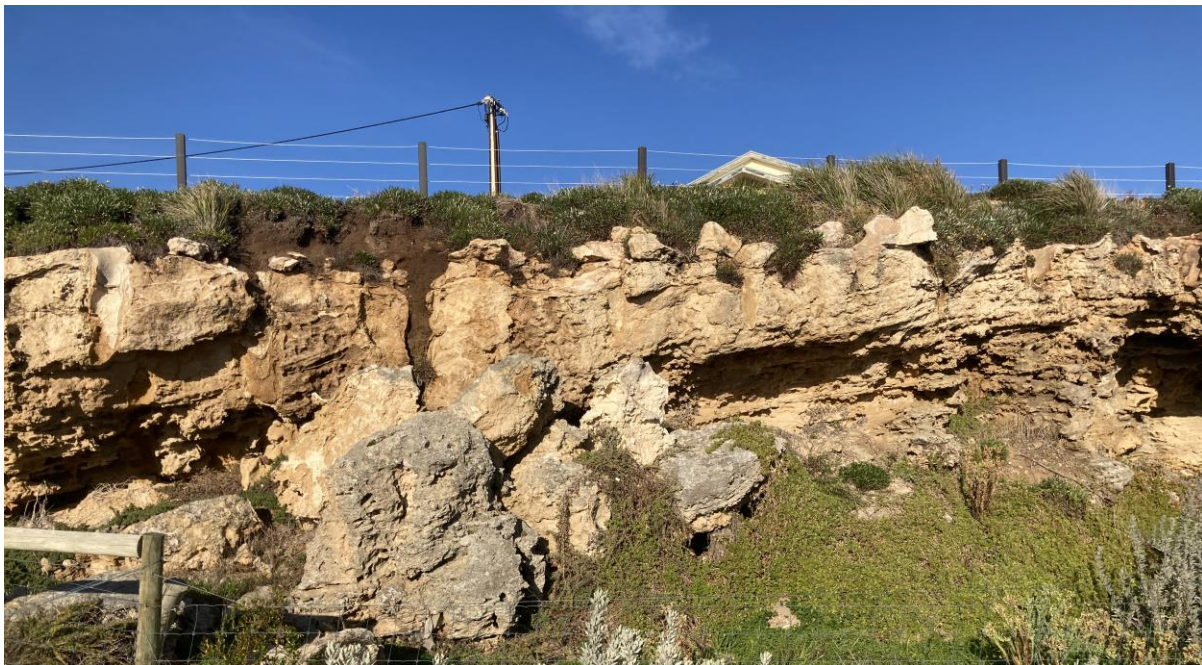
The cliff failures here appear to be the result of tensile failures of the calcrete overhangs (failure types 6-8, Figure 4).

Figure 32: View of the undercut cliff opposite no. 26 The Esplanade (similar location to Figure 8 in Tonkin, 2017)

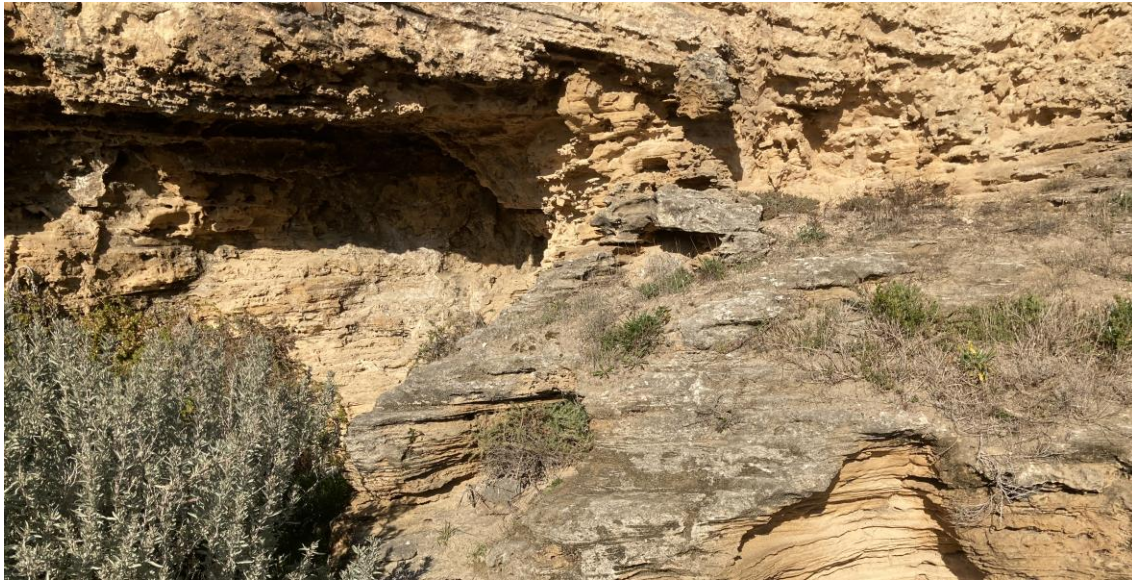
Figure 33: View of the failure surface of the undercut cliff at The Esplanade

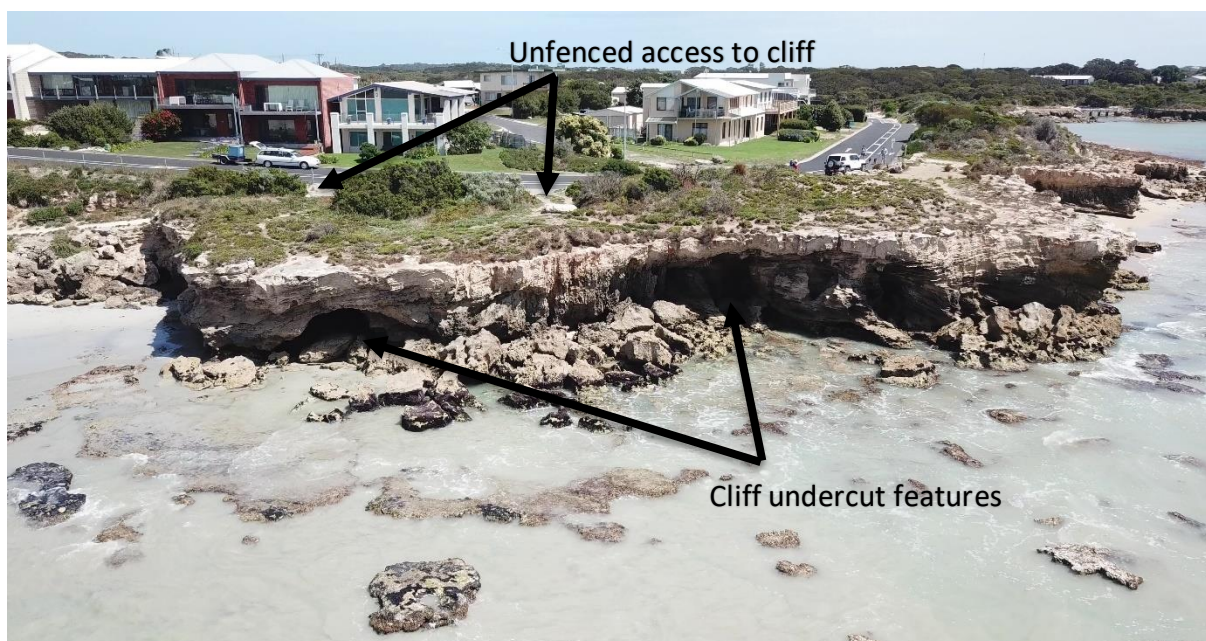
Figure 34: Coastal cliffs showing undercut sections on The Esplanade, opposite Gruschen Street
