# **Fox Beach Robe Dune Erosion Assessment Report**

Document     Draft Report

Ref             2018-06

Date            16-11-18

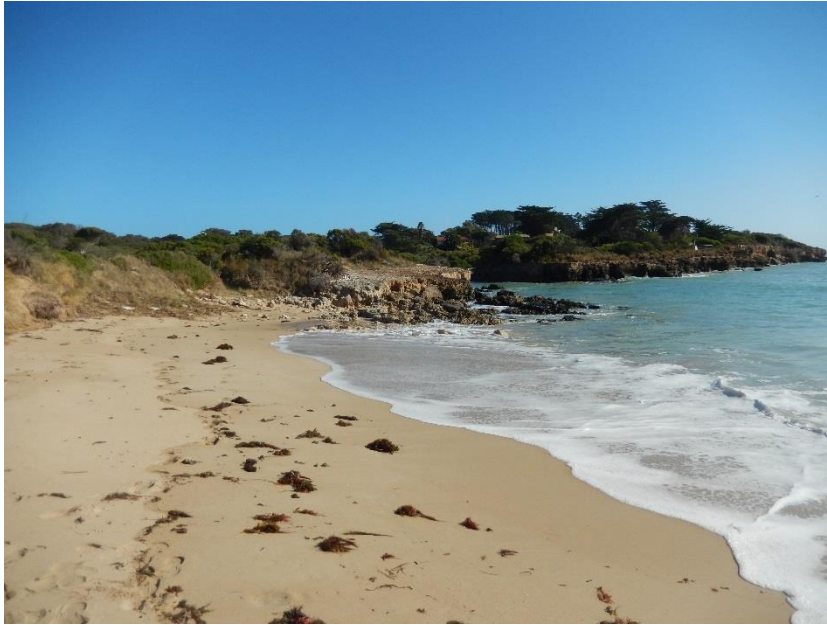
- The existing back of beach position is approximately 2.5-3m landward of where it was in 2015 and the erosion scar ranges from 1.5-2m in height which regular slippage cracking evident at the top of dune interface;
- The top of dune is vegetated with spinifex and other established coastal vegetation with evidence of recent revegetation;
- Waves appear to break approximately 130m offshore adjacent to the submerged reef;

**View of western end of Fox Beach**

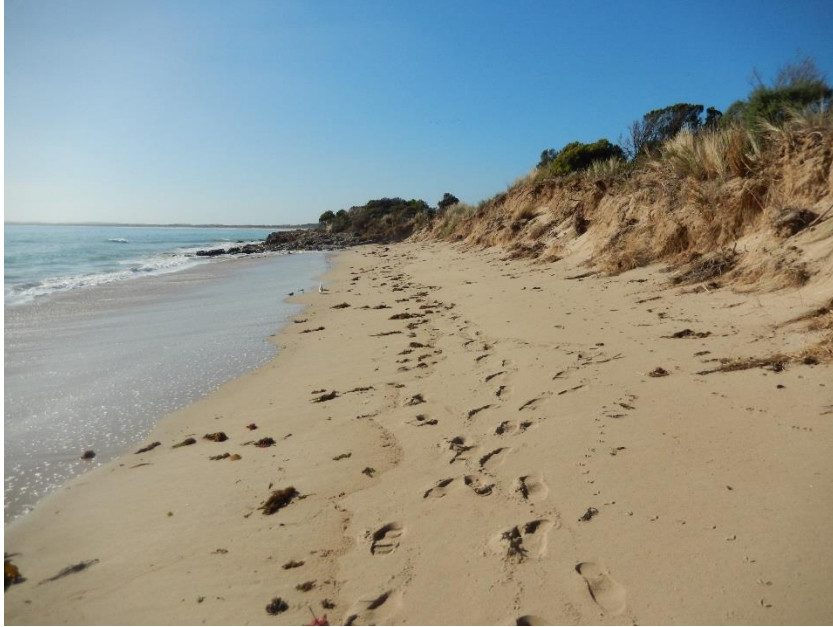
**View of eroded dune looking towards eastern end**

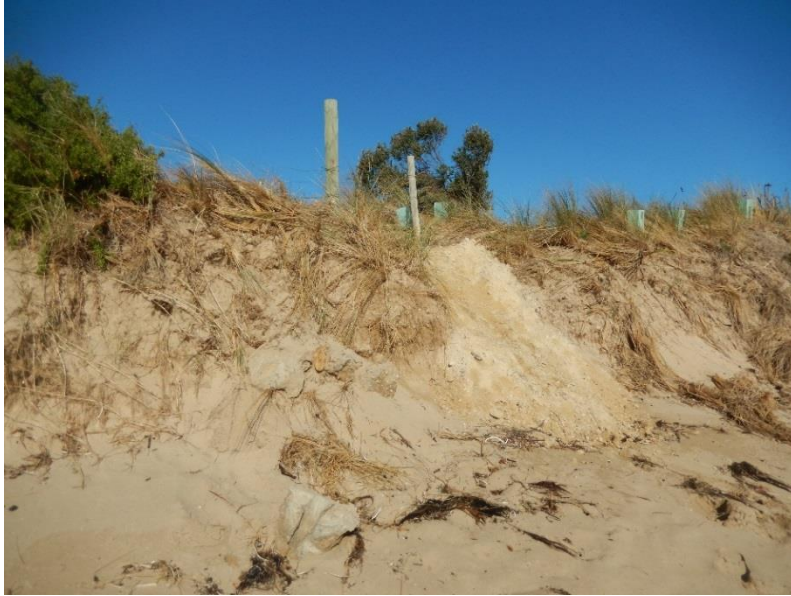
**View of dune at former access stair location**

- The erosion began to accelerate approximately 3 years ago and the toe of the dune has receded inland by 2.5-3m since;
- The existing beach access steps were damaged in 2016 following storm surge events and subsequently repaired however they were subsequently removed due to further undermining of foundations
- Some people are beginning to access the beach further north over the existing dune fence which is also impacting on dune vegetation.

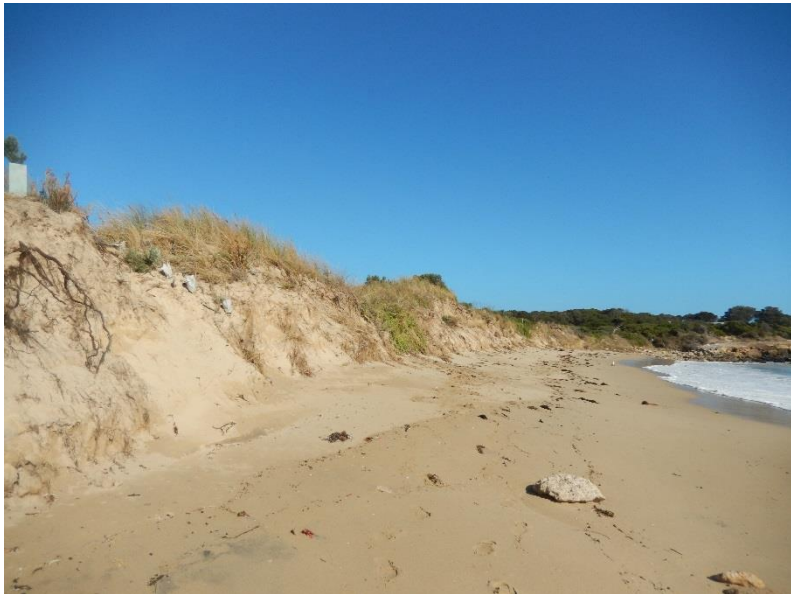
**View of eroded dune at beach midpoint**

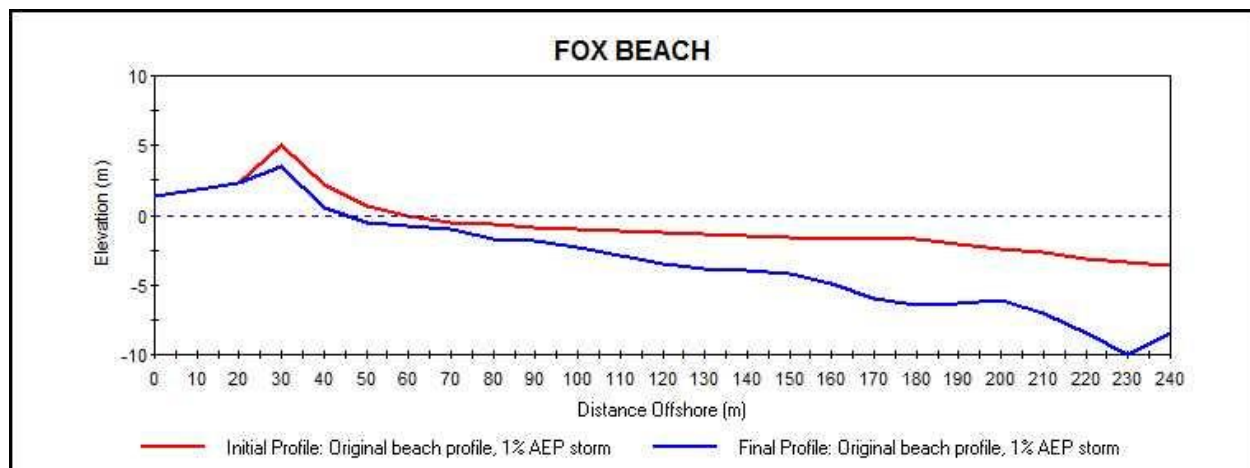
It is noted that the back of beach above RL 1.2m AHD has a 12% slope which would contribute to higher wave run up whereas in the normal intertidal zone range, the beach has a 7.4% profile flattening to 2.1% in the near shore zone.

The estimated erosion in a 1% AEP storm surge at the top of the dune is 8m as shown in Figure 7.

**Figure 7-Estimated erosion in a 1% AEP storm surge event**

The estimated volume of sand eroded from the front and back of the beach in such a storm over the 120m beach length is 11,300m<sup>3</sup> as well as considerable sand loss in the nearshore zone.

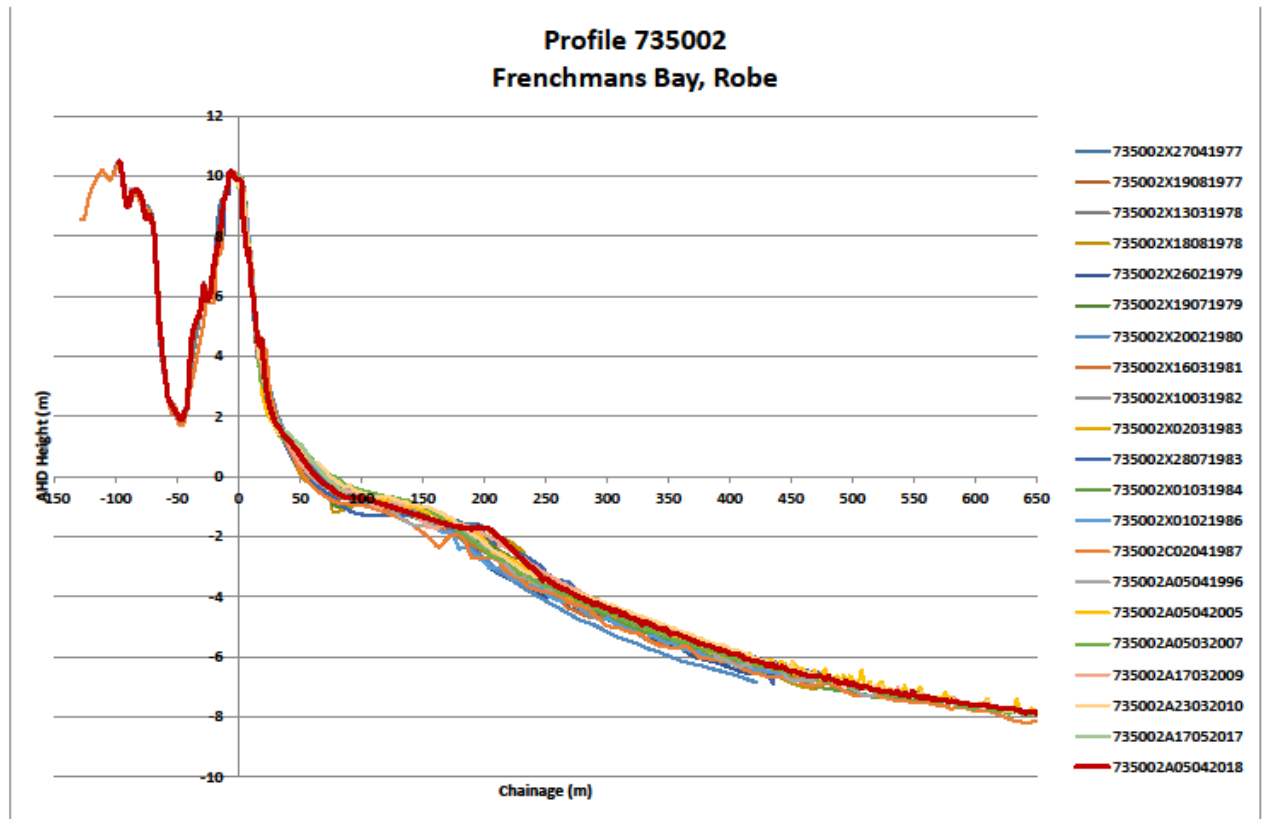
Figure 8-DEW Profile 735002

Location	Recession (m)
Profile 735002 Back of beach (2.0m AHD) 2010-2018	+1
Profile 735002 Back of beach (1.0m AHD) 2010-2018	-1
Profile 735002 Front of beach (0.0m AHD) 2010-2018	-15
Profile 735002 Nearshore Zone (-1.0m AHD) 2010-2018	-25
Profile 735002 Nearshore Zone (-2m AHD) 2010-2018	+10
Profile 735004 Back of Beach (2m AHD) 2013-2018	0
Profile 735004 Back of Beach (1.0m AHD) 2013-2018	+1
Profile 735004 front of beach (0mAHD) 2013-2018	-2
Profile 735004 Nearshore Zone (-1m AHD) 2013-2018	-3*
Profile 735004 Nearshore Zone (-2m AHD) 2013-2018	-5*

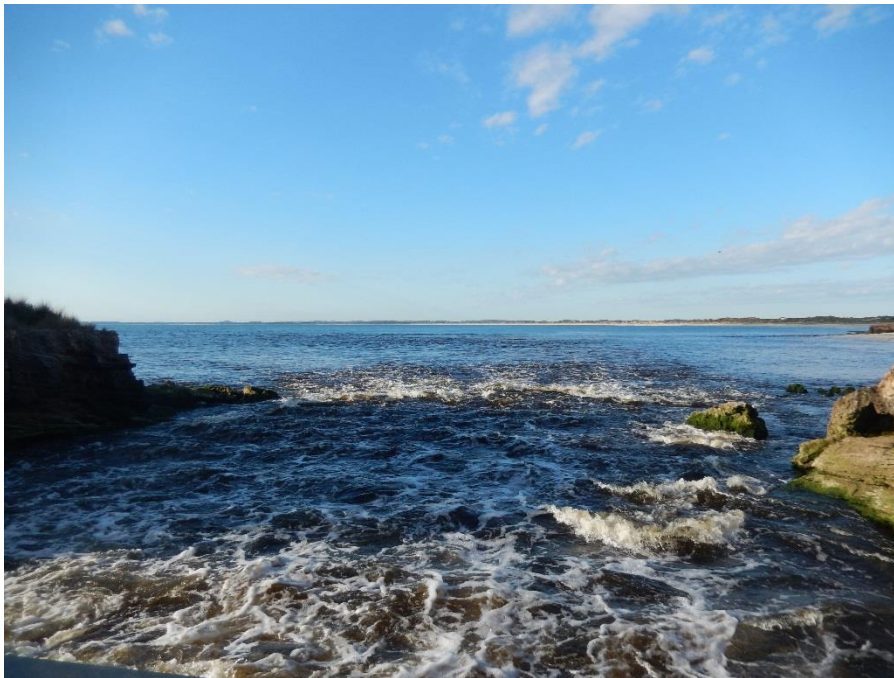
Long term variability in beach levels indicates that this current erosion trend may be cyclic, with a current trend towards loss. The close proximity of the Fox lake Drain L outfall channel and strong tidal currents during tide recession periods is also likely to contribute to sand loss in the near shore zone potentially impacting on the ability of the system to naturally recover which in turn may impact on the timing of any long term hard engineering options.

#### **View of strong tidal outflows from Drain L outlet**

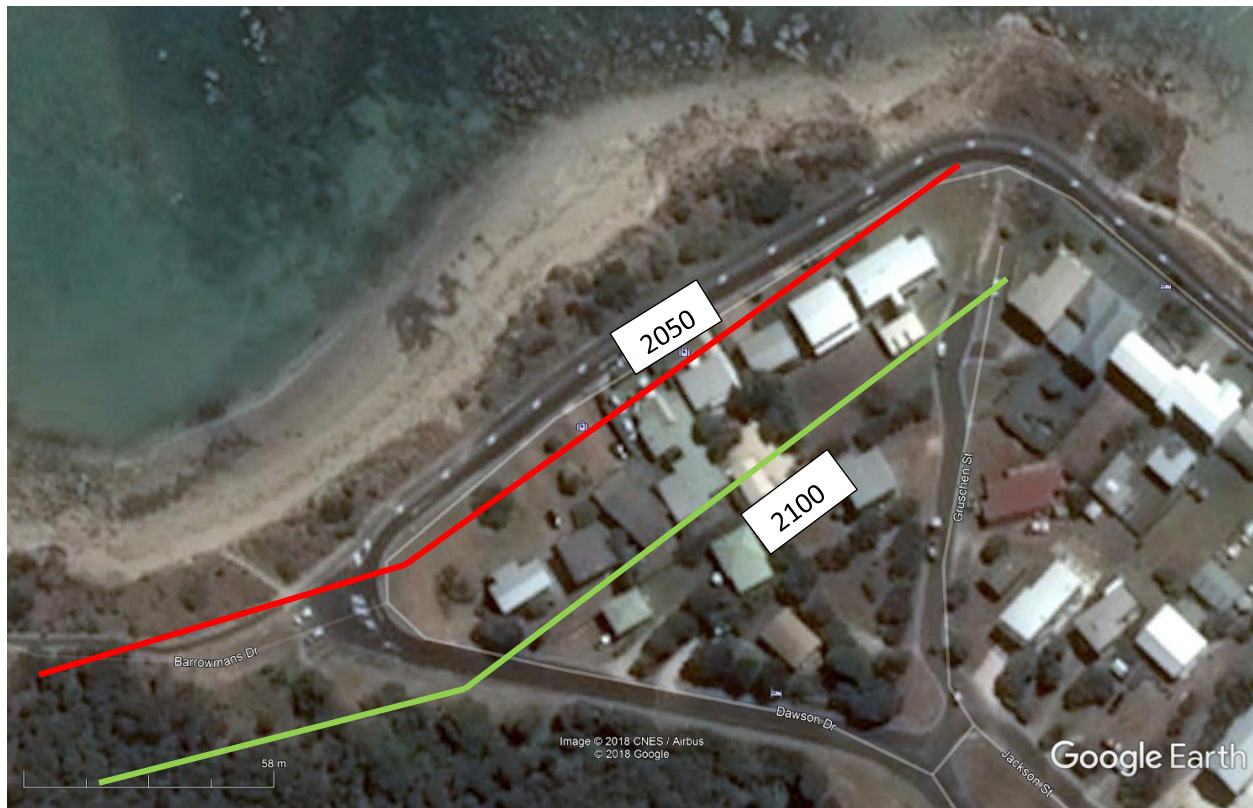
The total estimated coastal recession in 2050 & 2100 allowing for short term erosion, long term recession and erosion from sea level rise is estimated at 23m and 53.1m respectively as shown in Figure 10.

**Figure 10-Projected long term recession line**
