## **CEMETERY MANAGEMENT PLAN**

## CURRENT DESCRIPTION OF THE ROBE CEMETERY

## CURRENT CONDITION ASSESSMENT

## ROBE CEMETERY ACTION PLAN

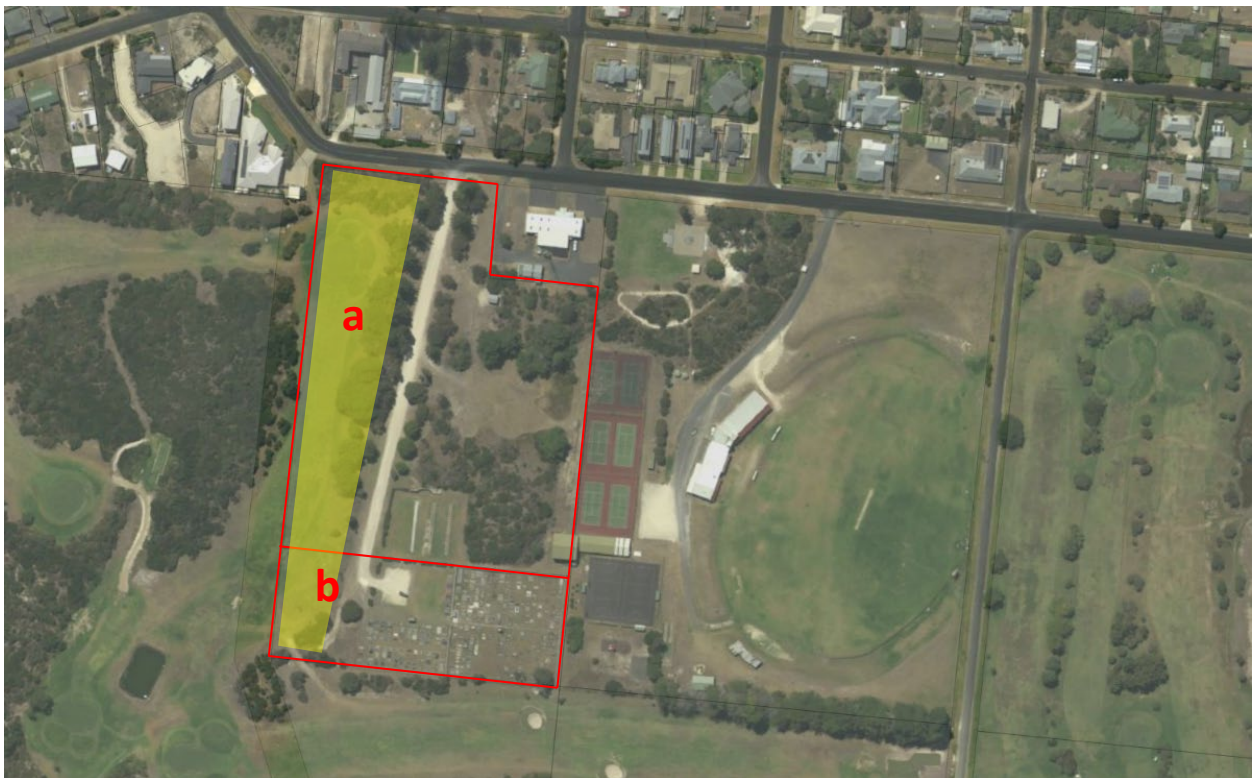
*Aerial map of Robe Cemetery showing cadastral features  
Note – cadastral features are an indicative only*

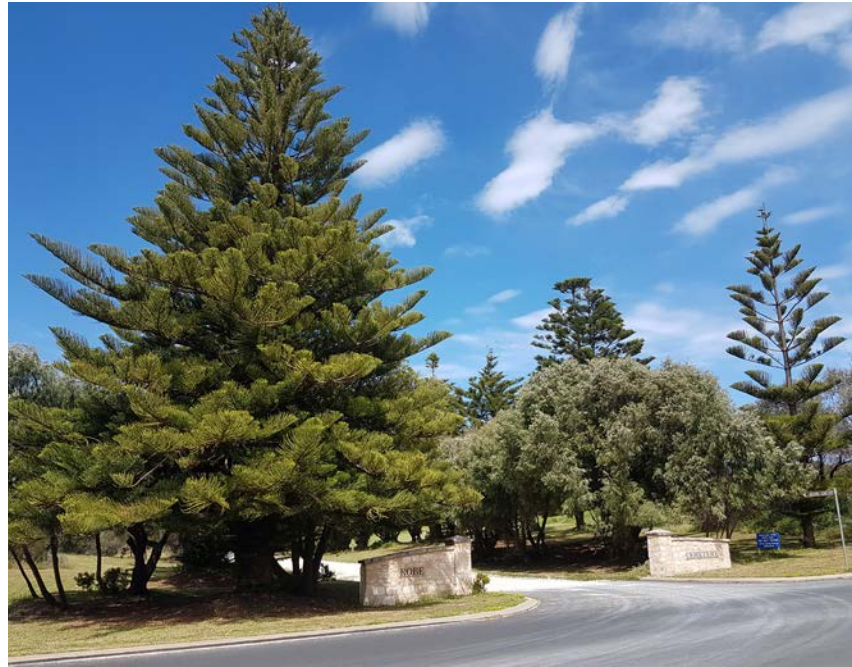
### A ENTRY

Entry road into cemetery framed by symmetrically shaped limestone entry walls that present to O'Halloran Street. Significant stands of Norfolk Island Pine (*Araucaria heterophylla*) and Western Australian Peppermint (*Agonis flexuosa*) frame the entry to the cemetery. These trees are consistent with the coastal character and informal vegetation throughout Robe.

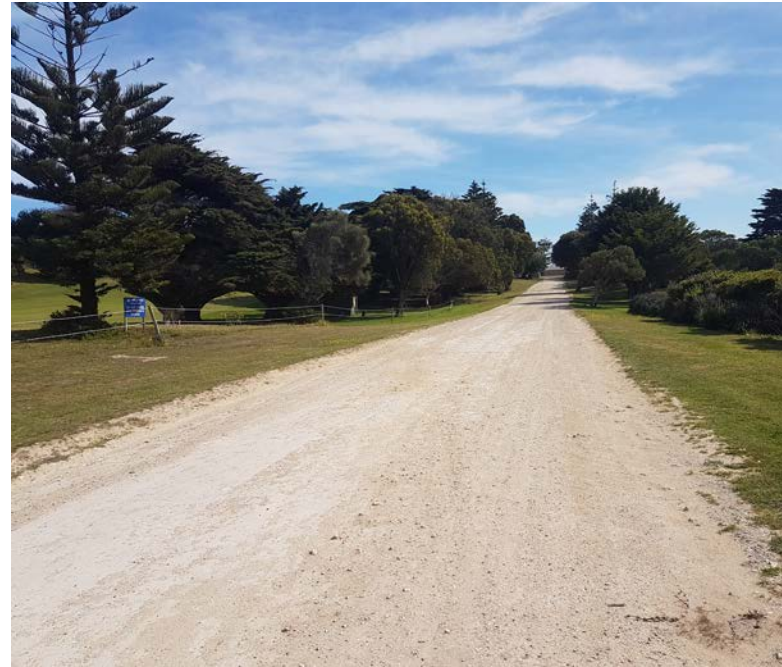
### B ACCESS ROAD

Stabilised limestone entry road creating defined entry way into the cemetery. Road has turfed verges and a defined informal avenue of trees of mixed species. Turfed verges are used for informal parking during funerals. The colour and material of the road surface is a key element of the cemetery connecting to stone wall treatments and natural finishes. Shallow spoon drains formed at edge of road in rubble.

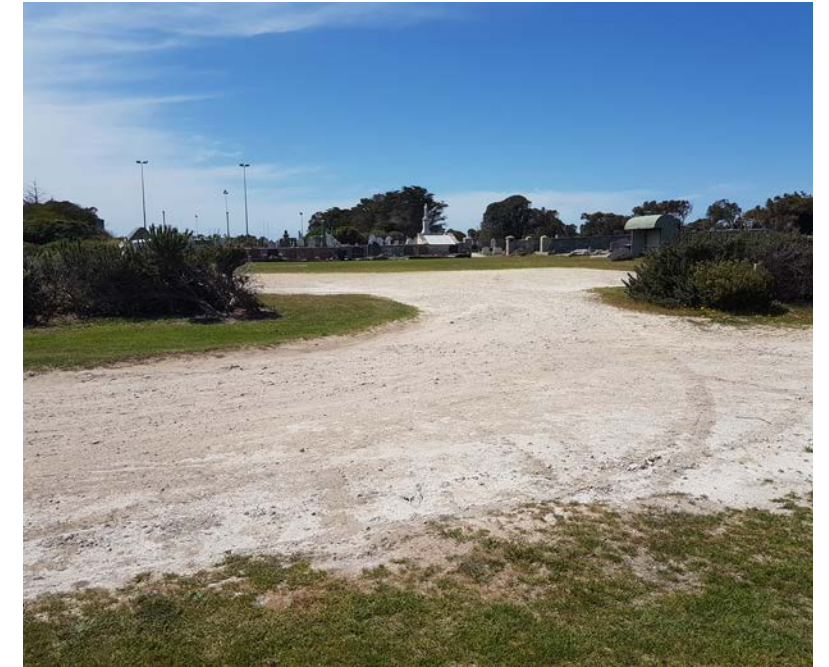
### C CARPARK

Stabilised limestone carpark which services the needs of day to day visitors and small volumes of traffic. No edges, wheelstops or linemarking to carparking bays. Entry through low informal hedges into the Historic Cemetery. Low hedging ensures that parked cars are largely screened from the access road. The carpark is small does not visually or spatially detract from the Historic elements of the cemetery.

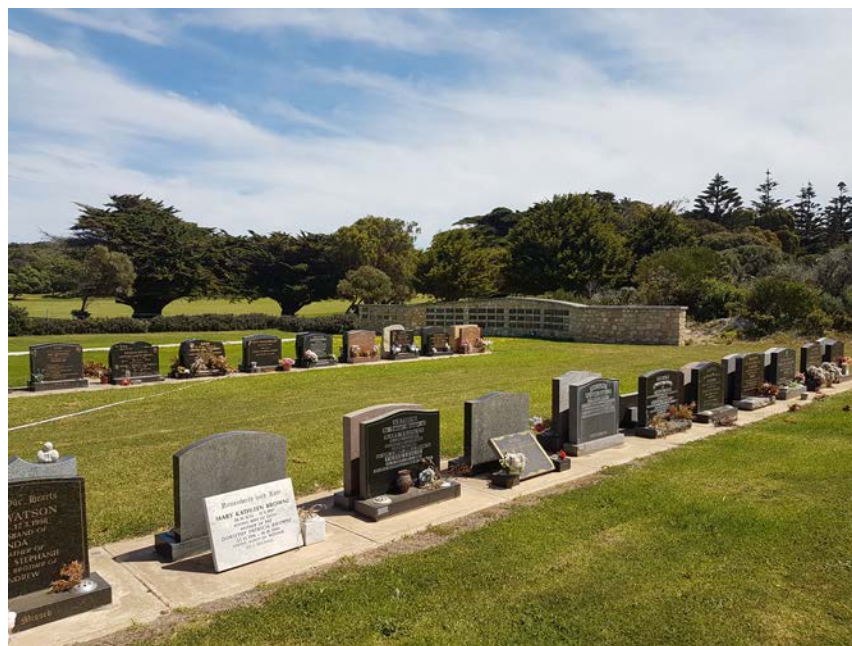
### D LAWN CEMETERY

Currently two double rows of graves with room to expand to the west. Recently a new double row concrete plinth (beam) has been installed. There is room for one more double row beam to the west. Existing niche wall along northern boundary edge. Low hedges along western and southern edges informally define space.

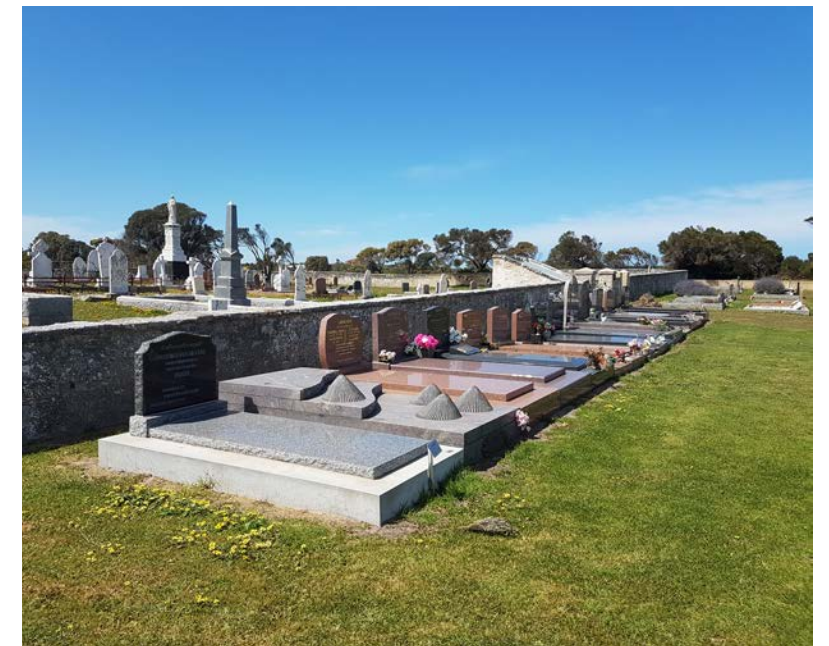
### E CEMETERY - SOUTH SECTION

Glimpsed views of the gravesites and perimeter wall are visible through low hedging as vehicles approach the carpark area. The gravesites fill approximately half of the area inside the rectangular quadrant also containing the carpark and lawn area. The area is bounded on two sides by a low masonry wall with small pillars to the south and western edges.

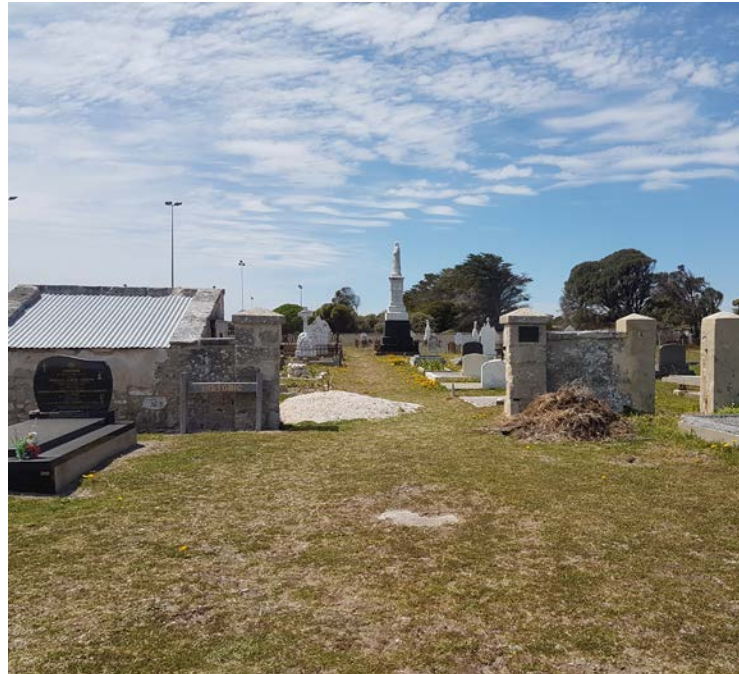
## G HISTORIC CEMETERY

Stone pillars frame the entry as part of a limestone perimeter wall which surrounds this section of the cemetery. A central spine and vista runs east west through the centre of the space. A central monument is significantly higher than other headstones and is visually prominent.

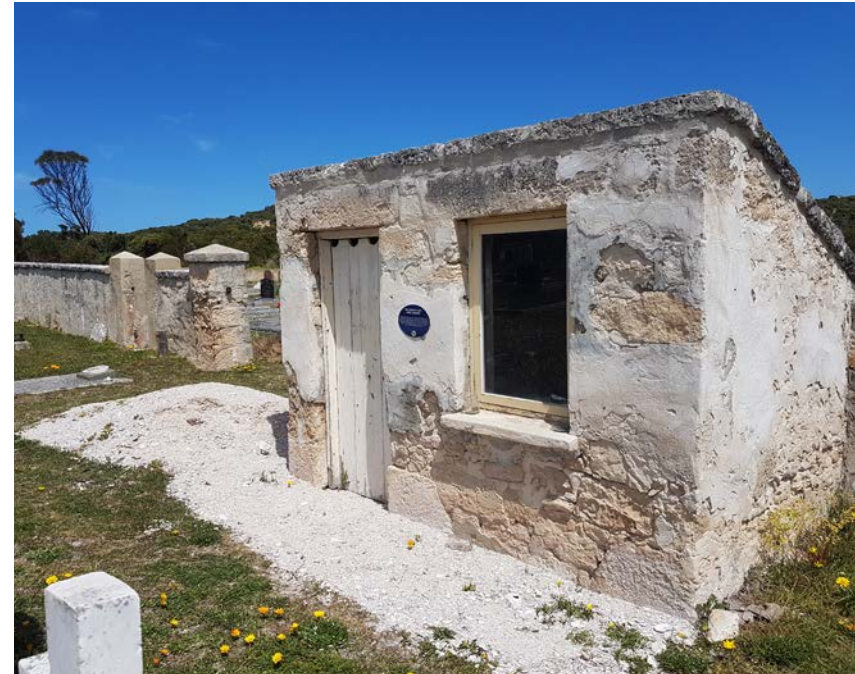
Sexton's Hut is constructed as part of the perimeter wall and faces internally to the grave sites. The condition of the perimeter wall varies with repair works undertaken in several locations.

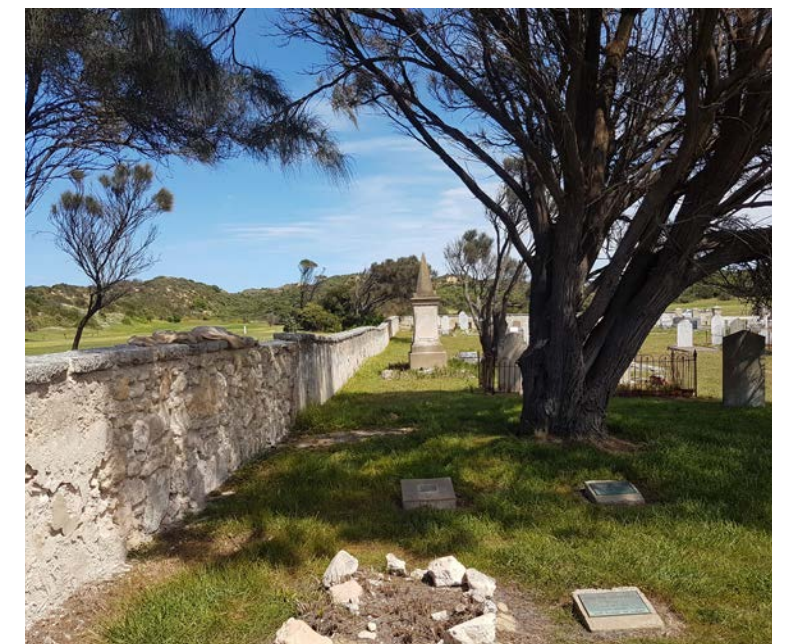
One tree (Casuarina spp.) exists within the perimeter wall in the south eastern corner of the site. This area has a more open character with larger spaces between grave sites. The perimeter wall has been reconstructed in this location.

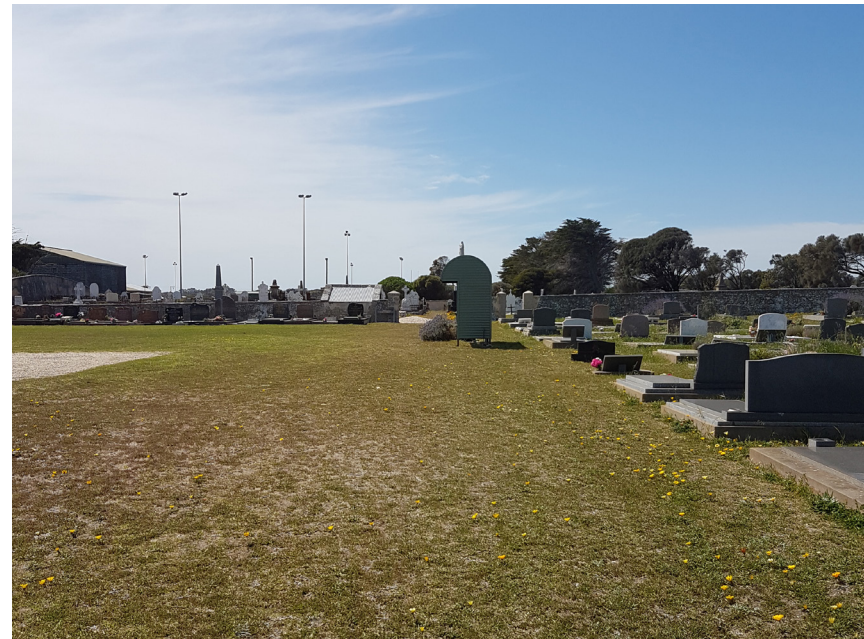
**4** Key vista into historic cemetery blocked by corrugated iron shelter.

- > Define pathway and vista
- > Consider low level flowering coastal plantings to border pathway
- > Remove corrugated iron shelter
- > Consider reinstating heritage gates
- > Consider shade options while not obscuring key views

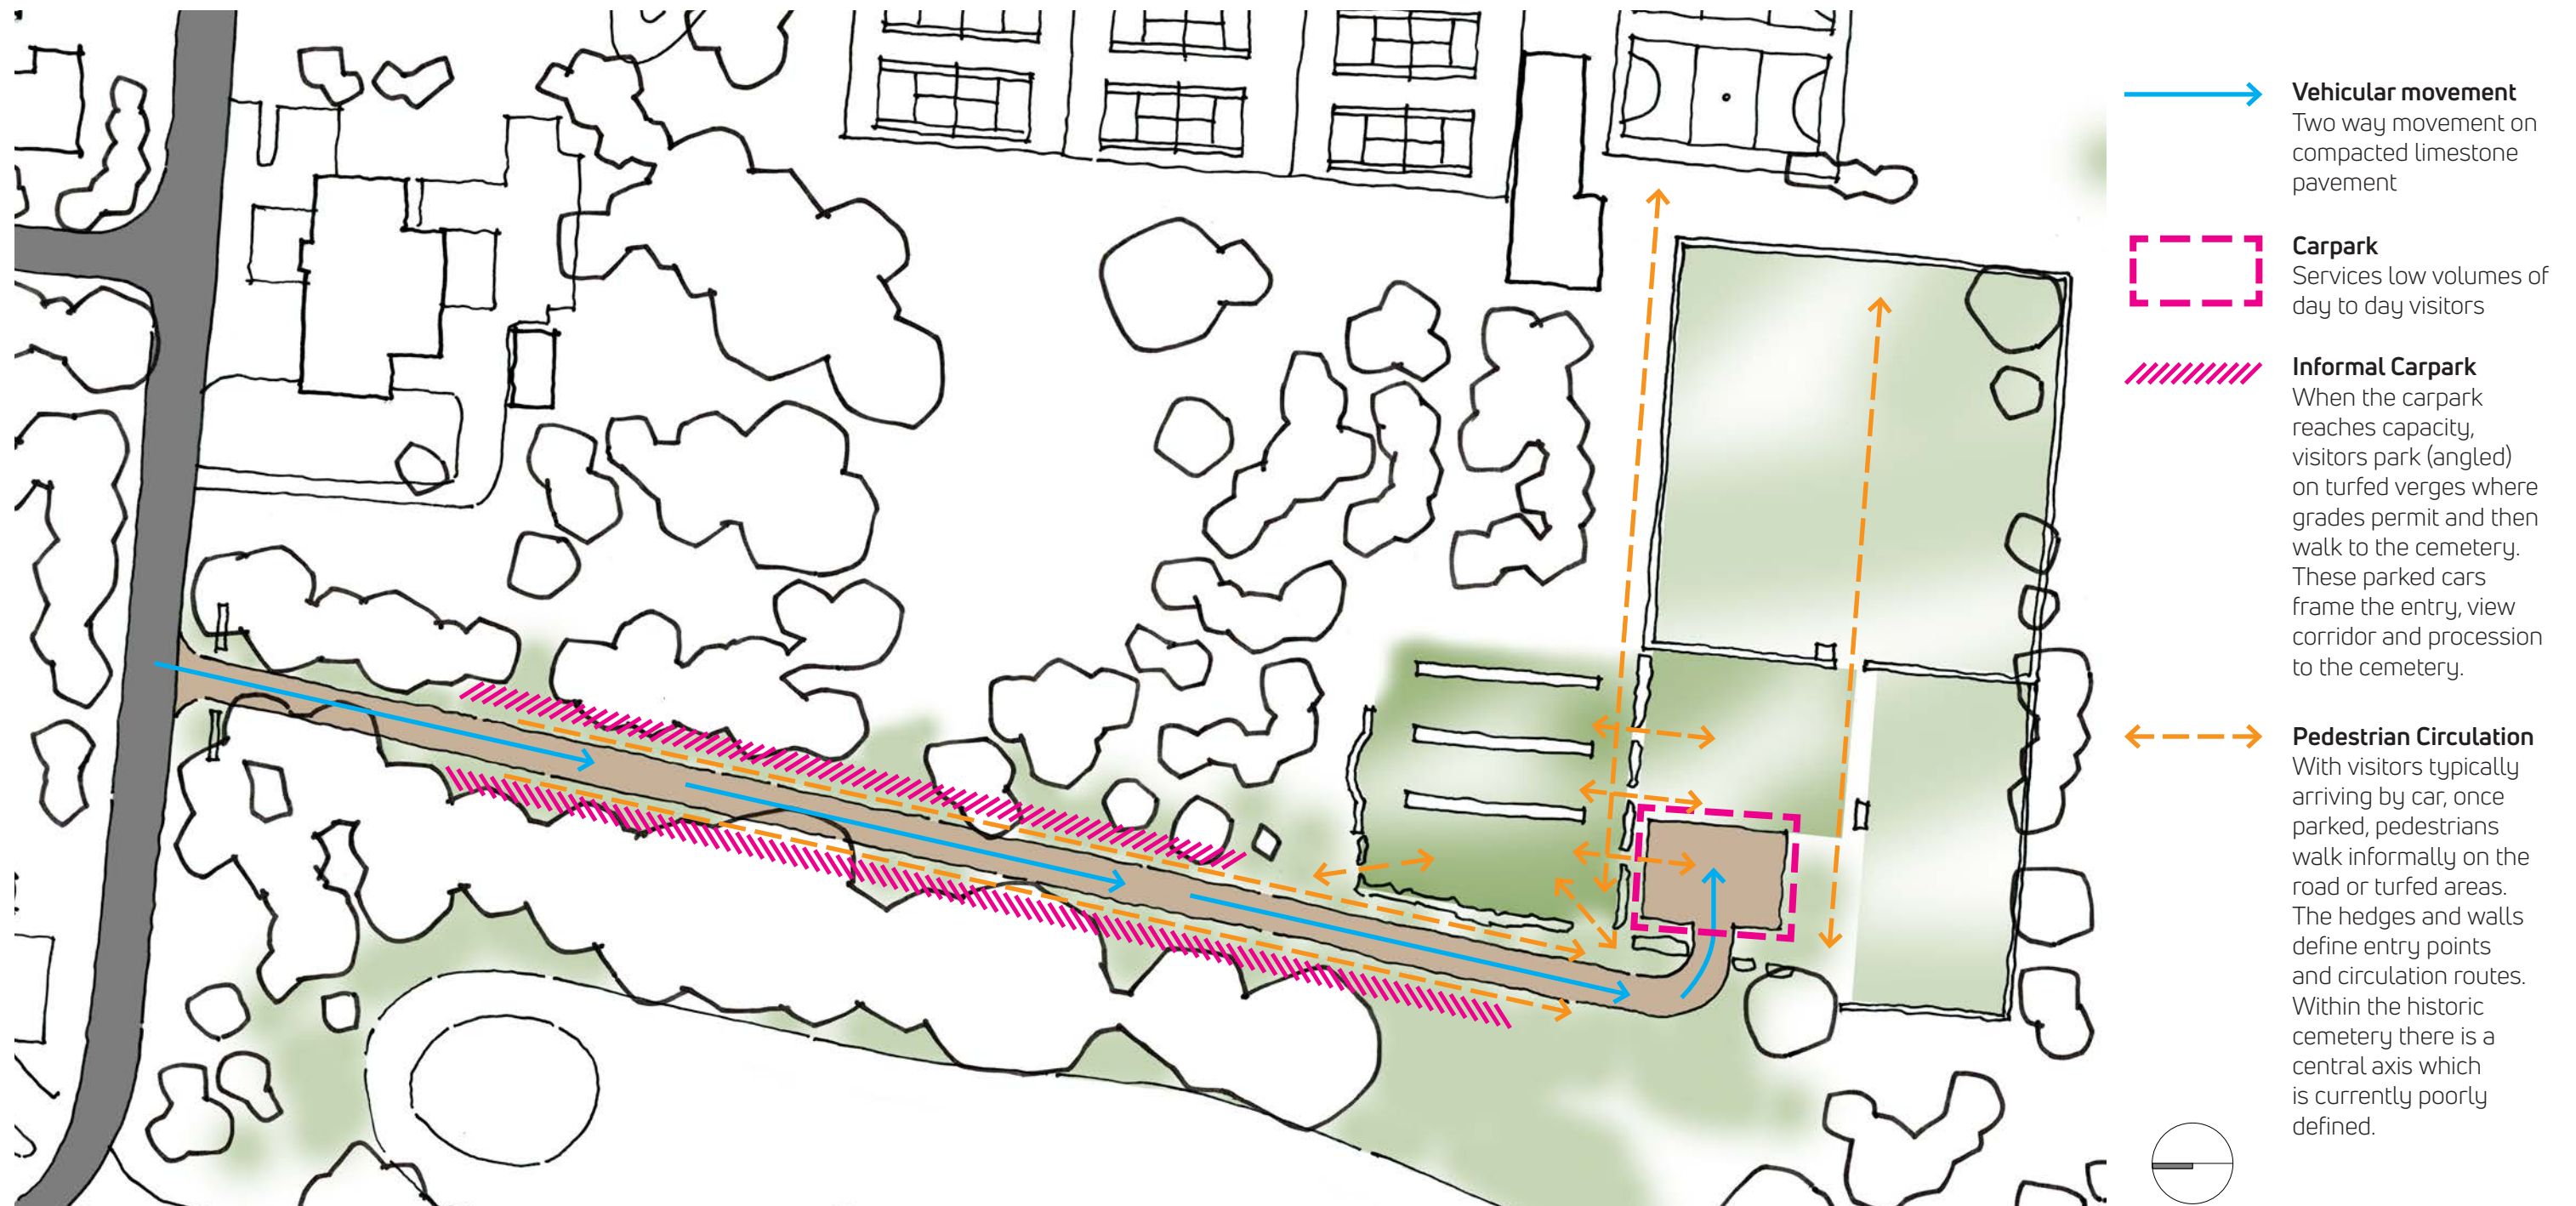
EXISTING CEMETERY / GRAVE SITES

Vehicular movement is facilitated along the entry road and carpark. With visitors typically arriving by car, once parked, pedestrians walk informally on the road or turfed areas. When the carpark reaches capacity, visitors park (angled) on turfed verges where grades permit and then walk to the cemetery.

There are no formal pedestrian paths but there are axial view and circulation lines through the cemetery that could be defined to promote use and experiences.

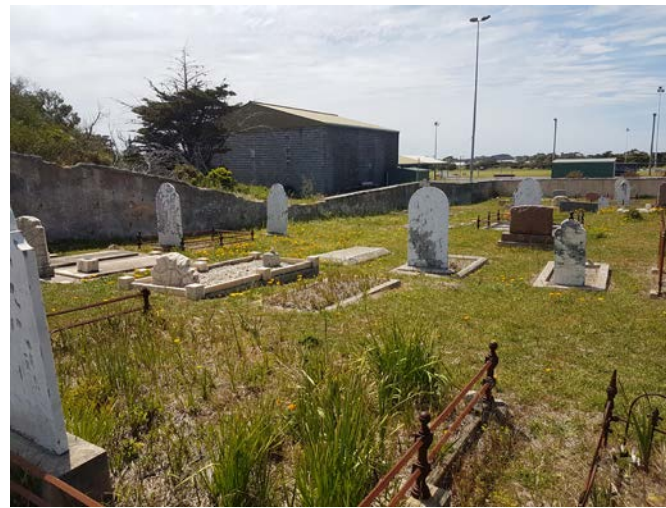
### 1 HISTORIC CEMETERY

The sports ground, buildings and facilities to the east and north east are located directly adjacent to the cemetery. The tall light poles and 2 storey height structures are visually prominent over the perimeter wall and grave markers. It is essential that shrub and buffer plantings are installed to the east and north of the perimeter wall to provide a visual screen.

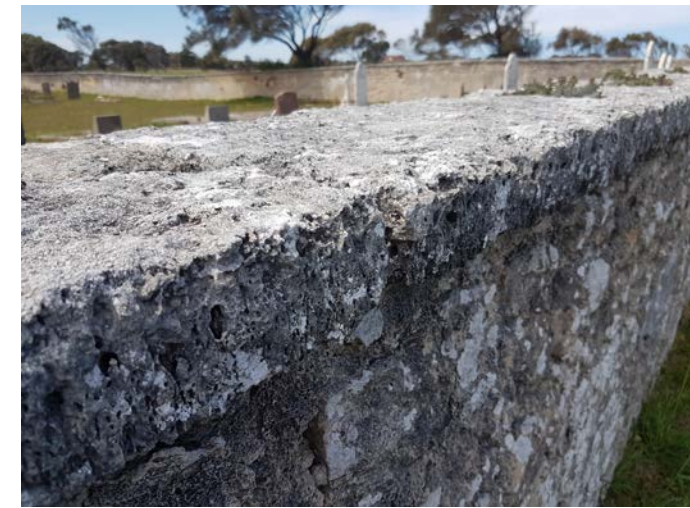
The lake stone capping is a key element of the perimeter wall representing the use of local unique materials. The stone has striking texture, formations, fissures and colours. There are portions of the capping that have been damaged and removed. It is understood that it is difficult to source equivalent replacement stone.

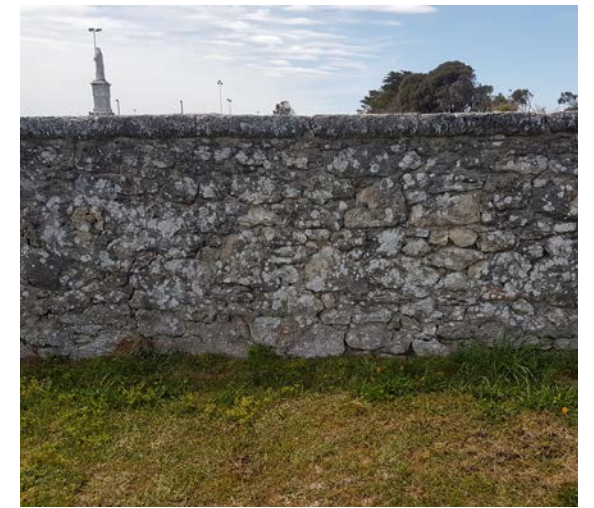
The perimeter wall surrounding the historical cemetery is a key representation of the character and heritage values of the cemetery. The wall has variation of height and respond to the adjacent landform on the northern boundary with a curved top profile. The wall display many example of repair using a variety of techniques. It is essential that ongoing repair work is undertaken in consultation with a qualified heritage architect / advisor.

- > Repair / reconstruct heritage wall in accordance with Richard Woods details and guidelines as required
- > Plant native shrubs and tree buffer to screen sporting facilities and buildings

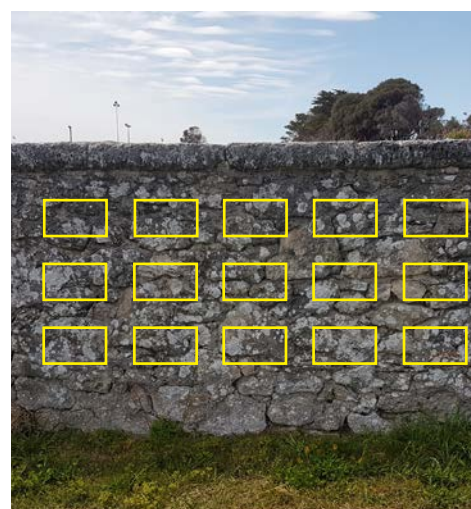
### 3 NEW NICHE WALL ON EASTERN BOUNDARY

- > Construct a new niche wall on the eastern boundary of the lawn cemetery to preserve key views on arrival.
- > The wall could be constructed in the same style as the heritage wall to reinforce the rectangular geometry.

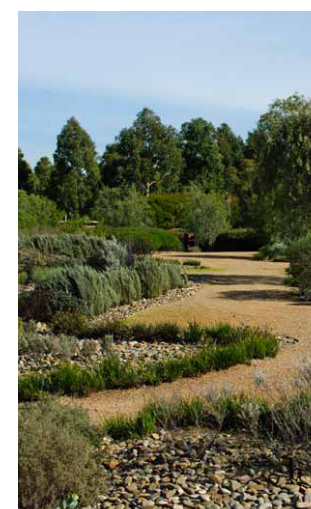
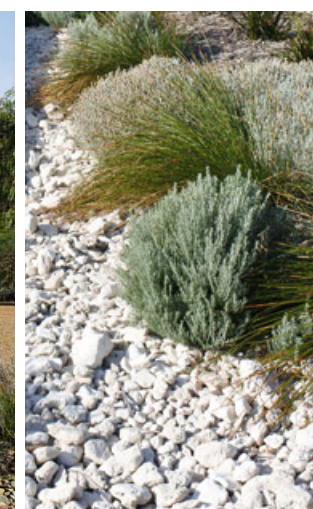
### 4 MEMORIAL COASTAL GARDEN

- > Consider utilising current clearing as a unique memorial coastal garden incorporating grave sites and places for interment of ashes.
- > Create a journey through native coastal plantings with seating, shaded areas, low stone walls and areas for contemplation.
- > Consider rotunda or shade structure
- > Will offer space for many new grave sites in a

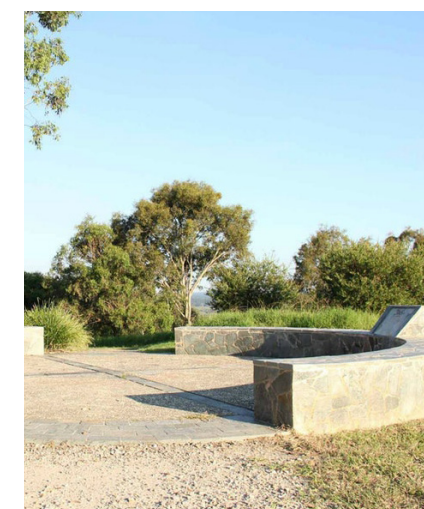
### 5 LOOKOUT

- > Continue paths to a lookout area with views over the cemetery and surrounding landscape.
- > Consider seating, low stone walls and interpretive signage.
- > Manage weeds and reinforce native vegetation.
