Hoopers Beach Robe Dune Erosion Assessment Report

Document Draft Report

1. Background

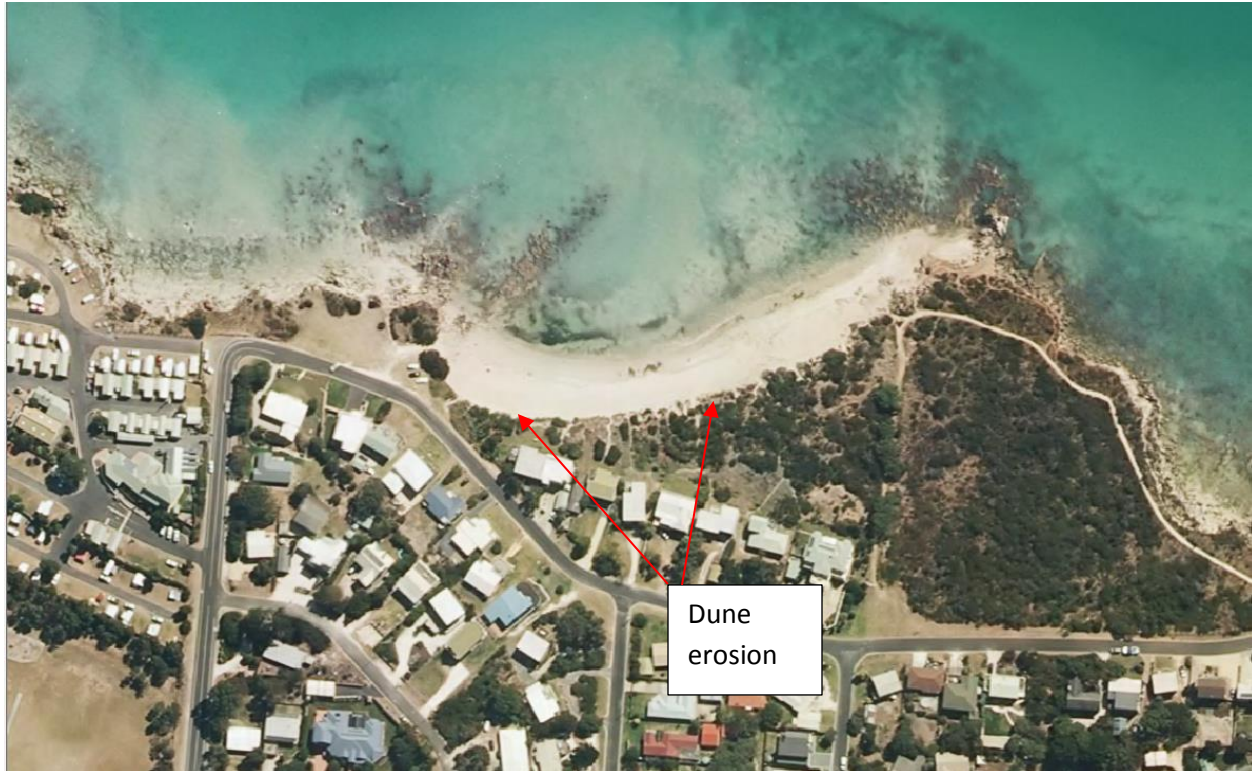
Figure 1-Study Locality Plan

The site is shown in Figure 1.

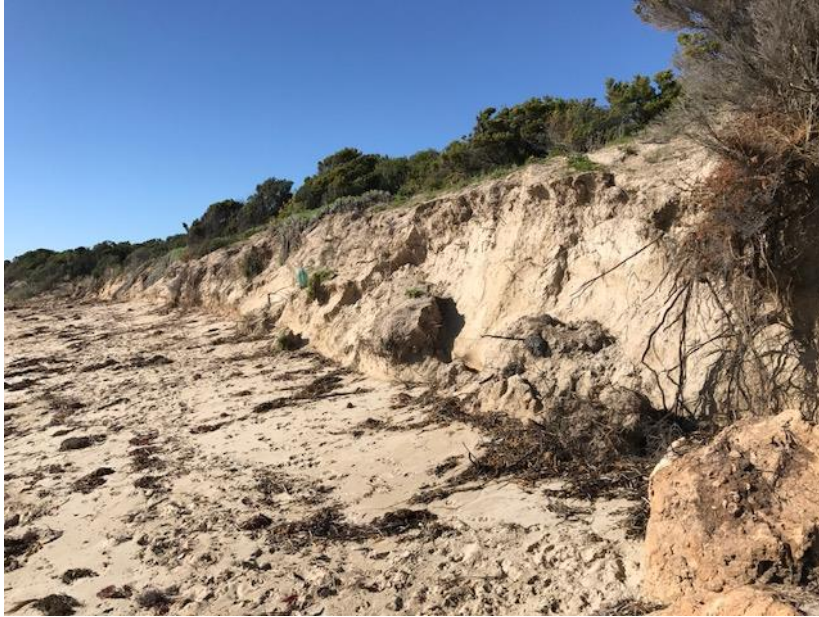
- There are several dune erosion scars along the length of the back of the beach zone, with the dune erosion scar at the western end in close proximity to the dwelling at the western end of the beach;
- There are several localized dune erosion hot spots at five existing informal beach pedestrian access points;
- The crown land zone between the top of the dune and the private dwellings is heavy vegetated with native coastal vegetation;
- There beach is exposed to long fetch waves from the north north-west.

View of eroded dune towards western end of Hooper Beach looking east

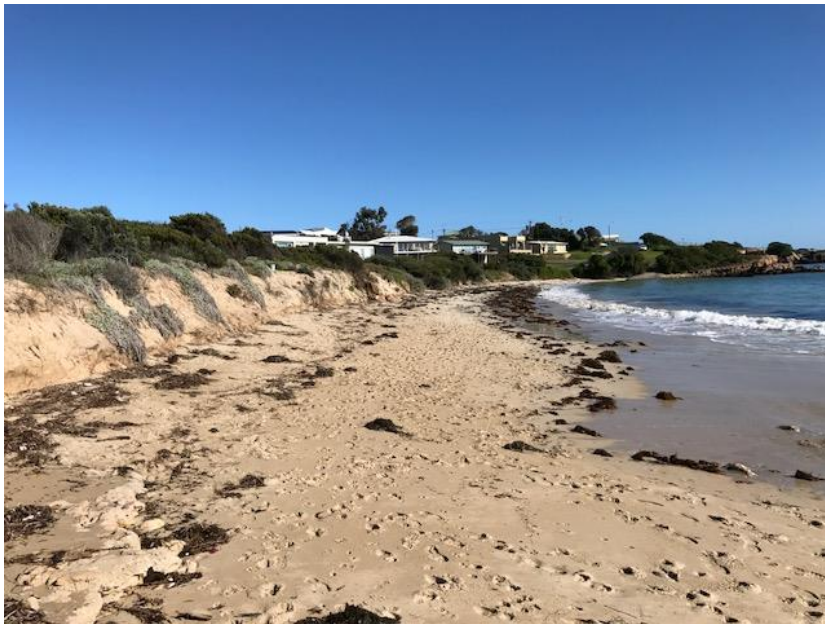
View of eroded dune at Hooper Beach from eastern end looking west

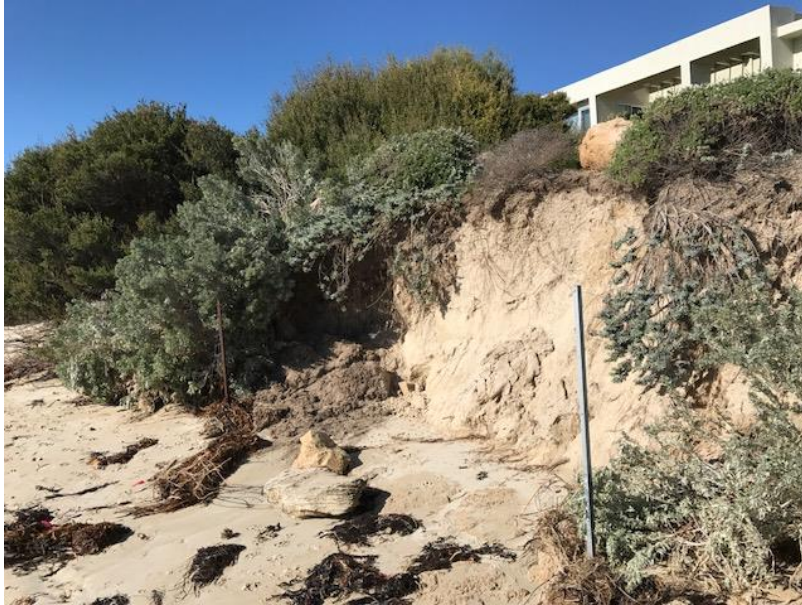
View of eroded dune near dwelling at western end of Hooper Beach

It is also noted that the current top of dune erosion line is approximately 6.8m from the western edge of the western most dwelling fronting Seafarers Crescent and also extends inland at five existing informal beach access points.

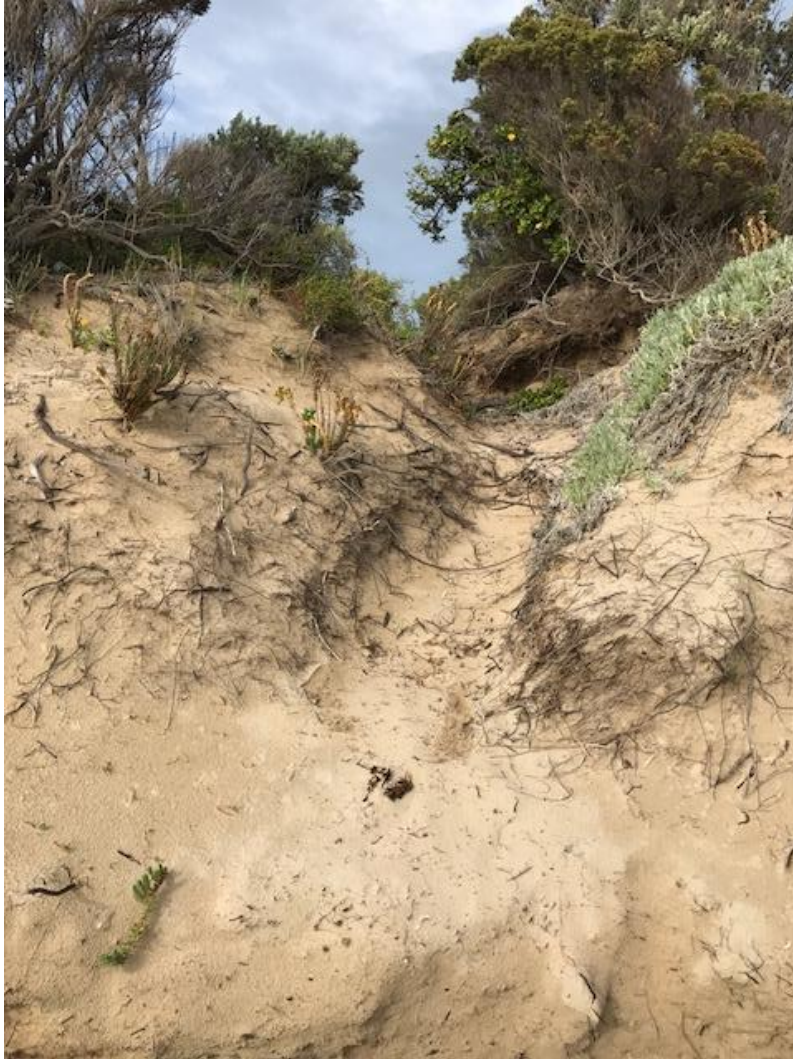
Example of localized dune erosion at informal pedestrian access

- Encourage abutting land owners and visitors to use existing beach access points at the eastern and western end of the beach;
- The development and implementation of a detailed monitoring program including methodology and trigger levels in consultation with CMB which could include installation of sand movement monitoring galvanised or marine grade stainless steel poles at the toe of dune and front of beach at sixty metre intervals along the beach to annually survey changes in beach level and toe position and inform triggers for longer term management options;

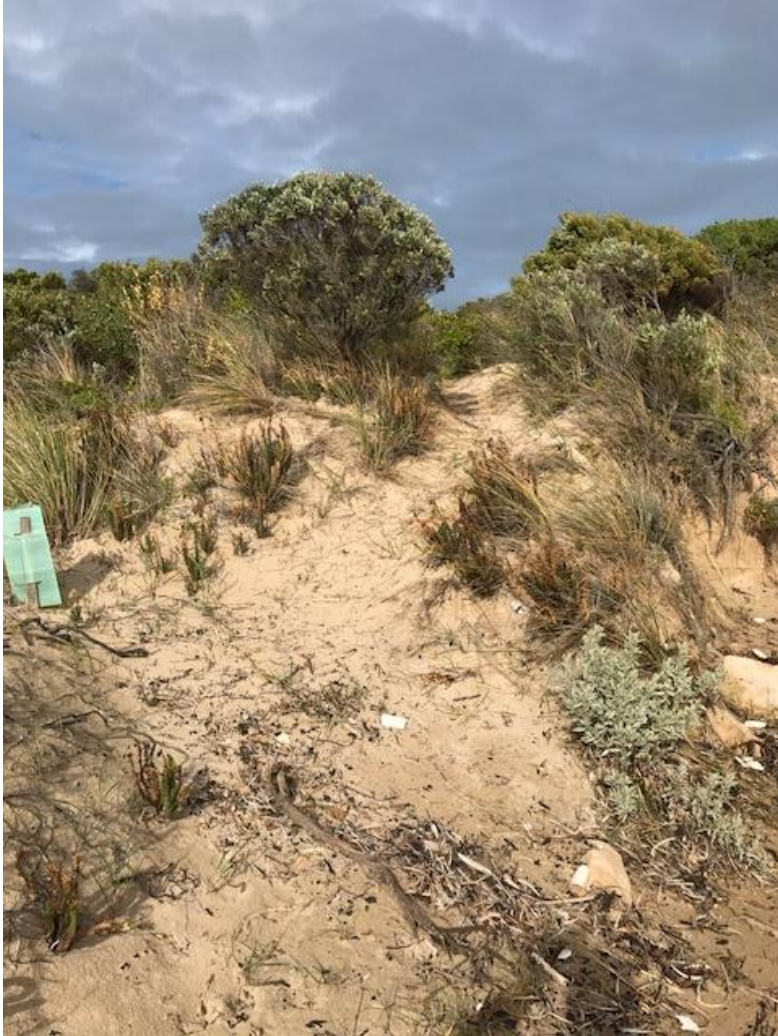
Example of localized dune erosion at informal pedestrian access

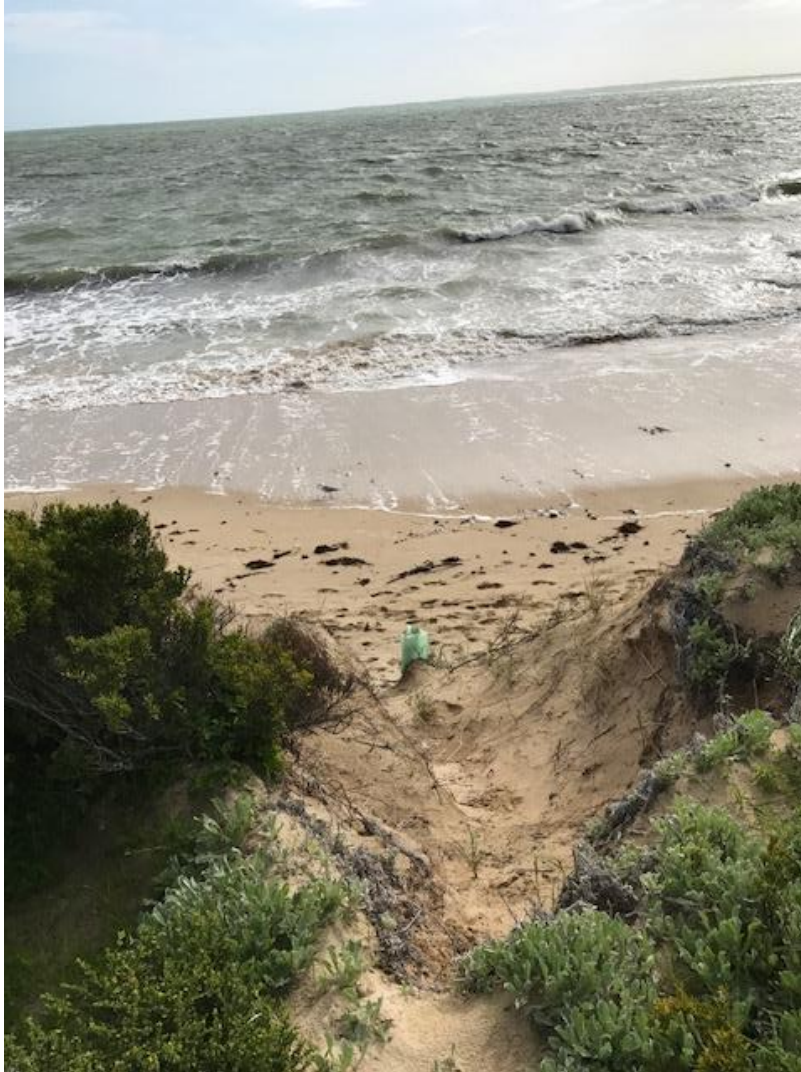
Example of localized dune erosion at informal pedestrian access interface

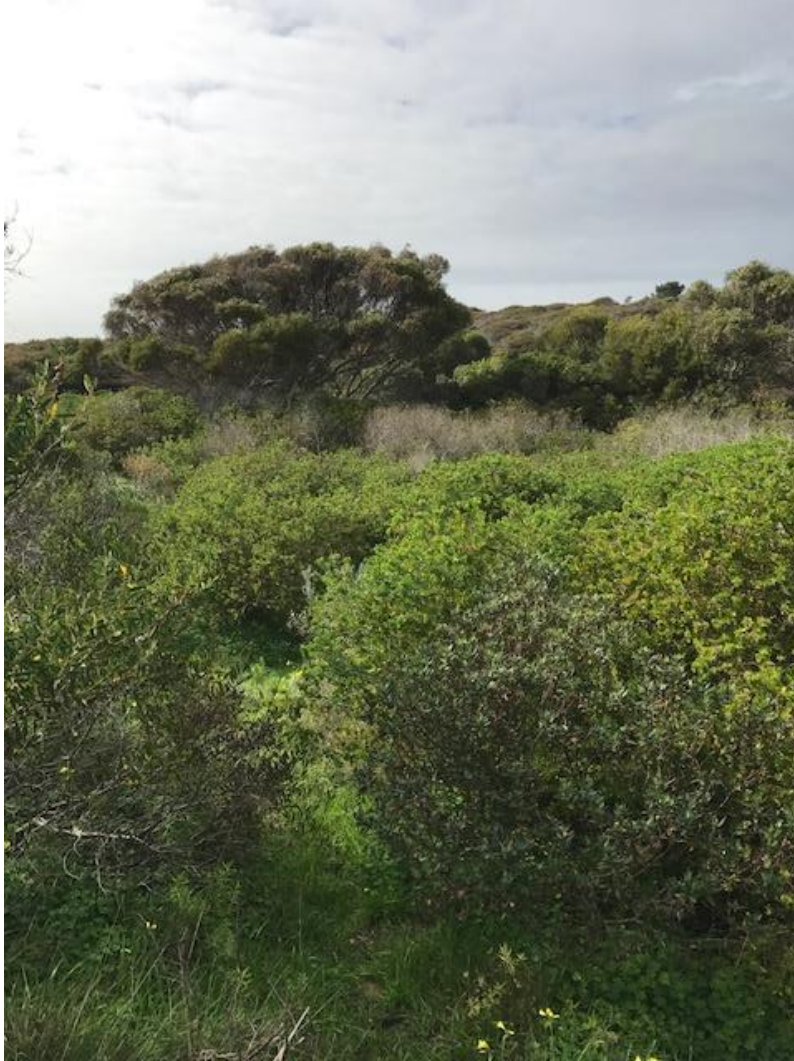
Example of existing dune vegetation

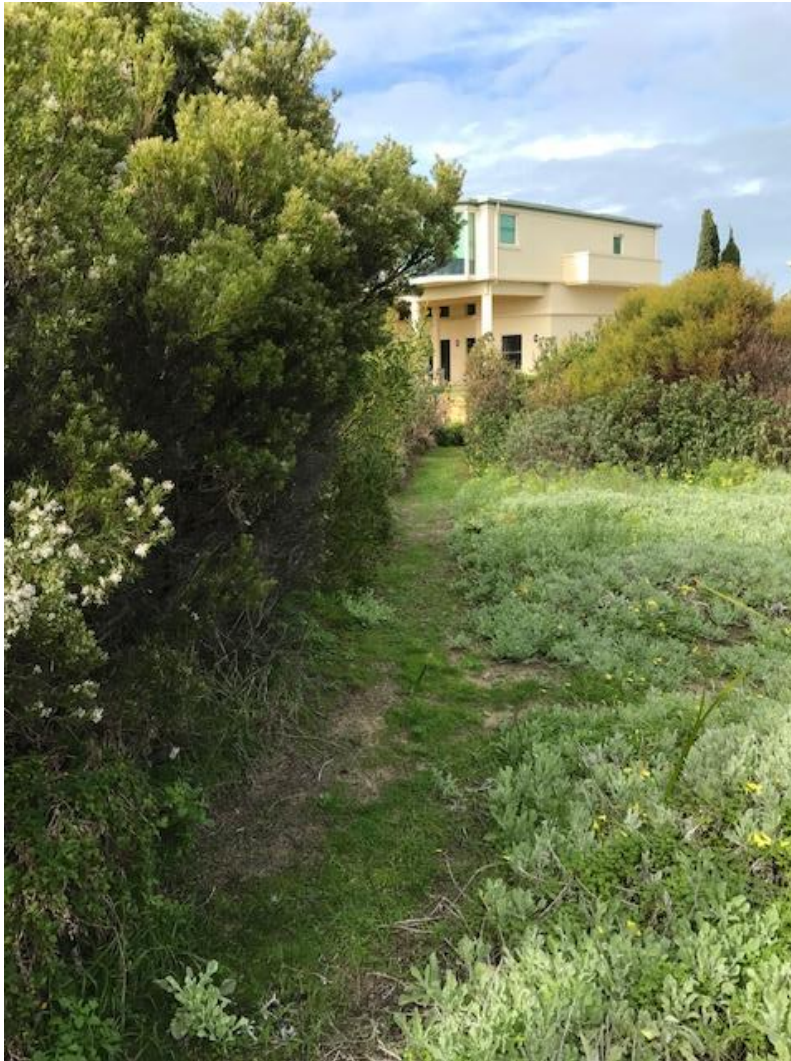
Example of existing dune vegetation and informal pedestrian access

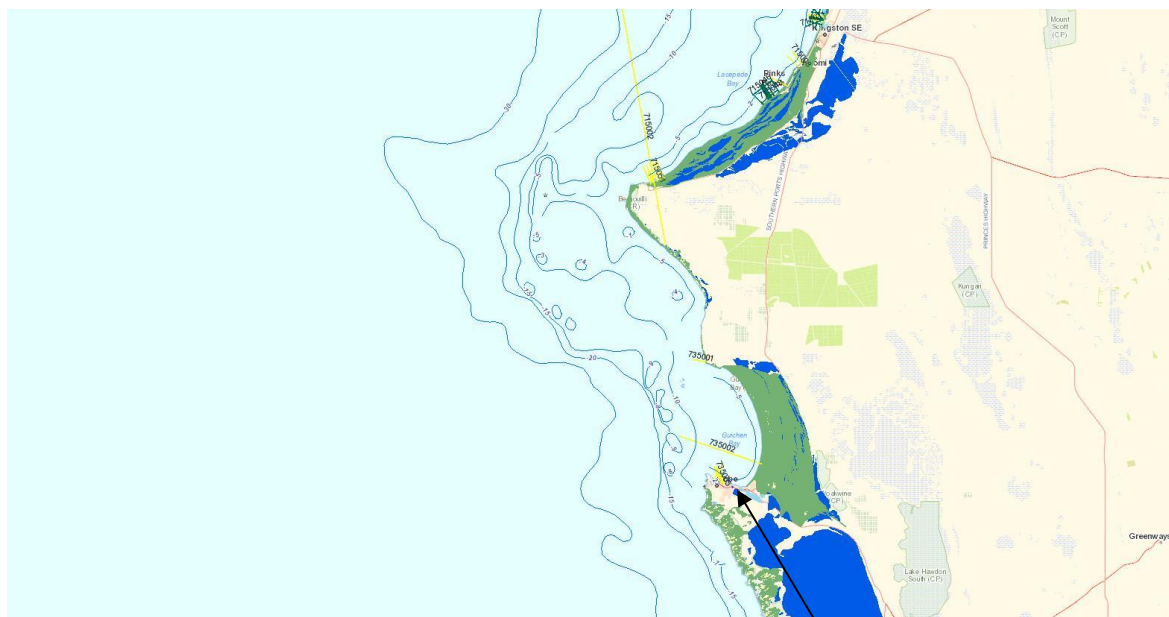
Figure 5-Local Bathymetry

The critical onshore shore-normal wind wave climate at Hooper Beach will be governed by local winds generated from the north north-west of Boatswain Point south of Cape Jaffa where the fetch is 22Km and an average water depth ranging from of 6-7.5m assuming depth limited conditions are considered representative for estimating Hooper Beach wind waves.

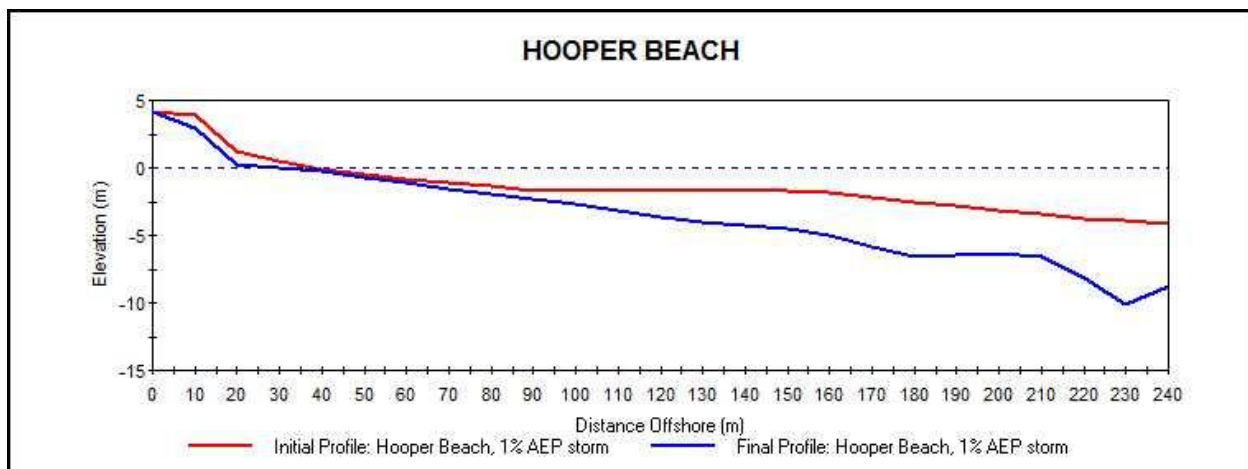
Figure 7-Storm surge erosion under 1%AEP storm

Short term storm based erosion has been assessed using S Beach as part of this study and the results are shown in Figure 7 based on the DN 50=0.2mm sand grain size determined from the laboratory Particle size distribution and the surveyed beach and dune profile.

The estimated volume of sand eroded from the front and back of the beach in such a storm over the 195m beach length is 10,200m³.

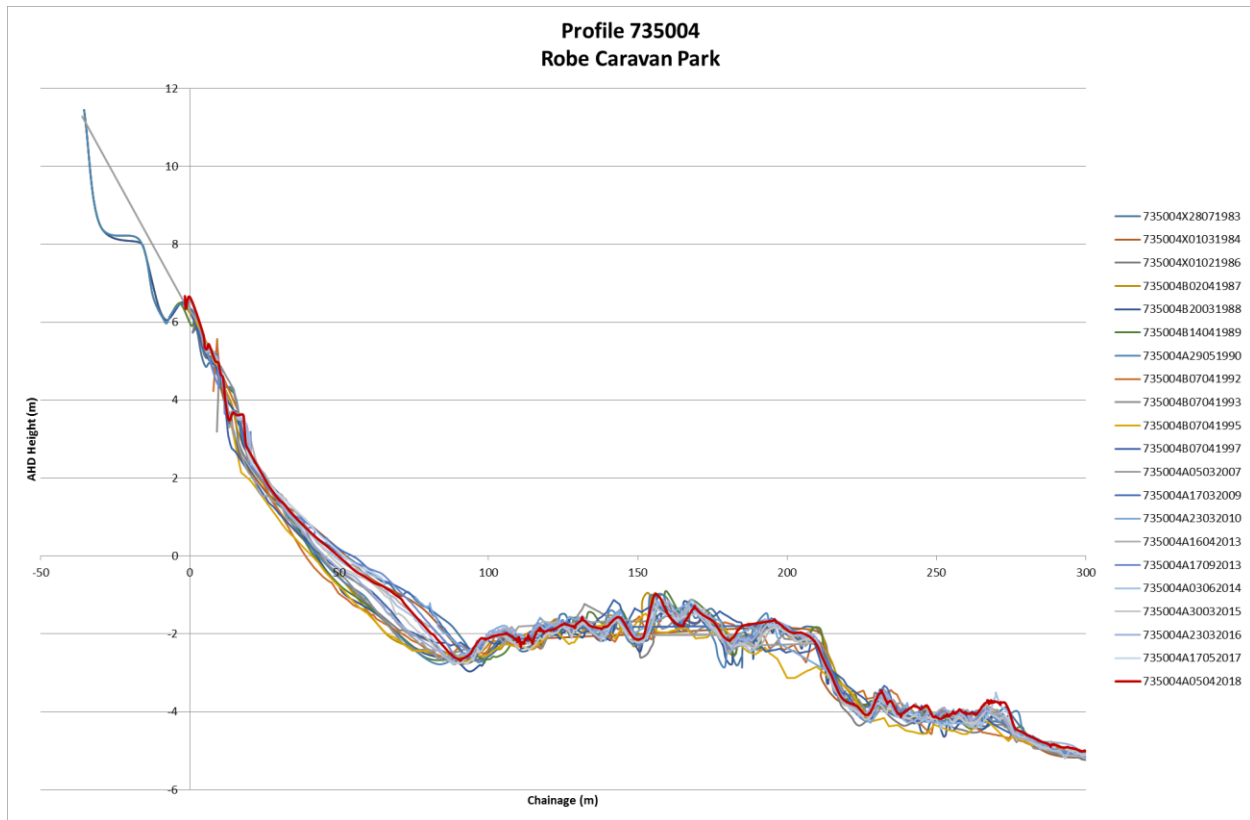
Fig 8-DEW Profile 735004

It should be noted that although the profile data does show a loss in recent times, the erosion currently experienced is still within historic levels.

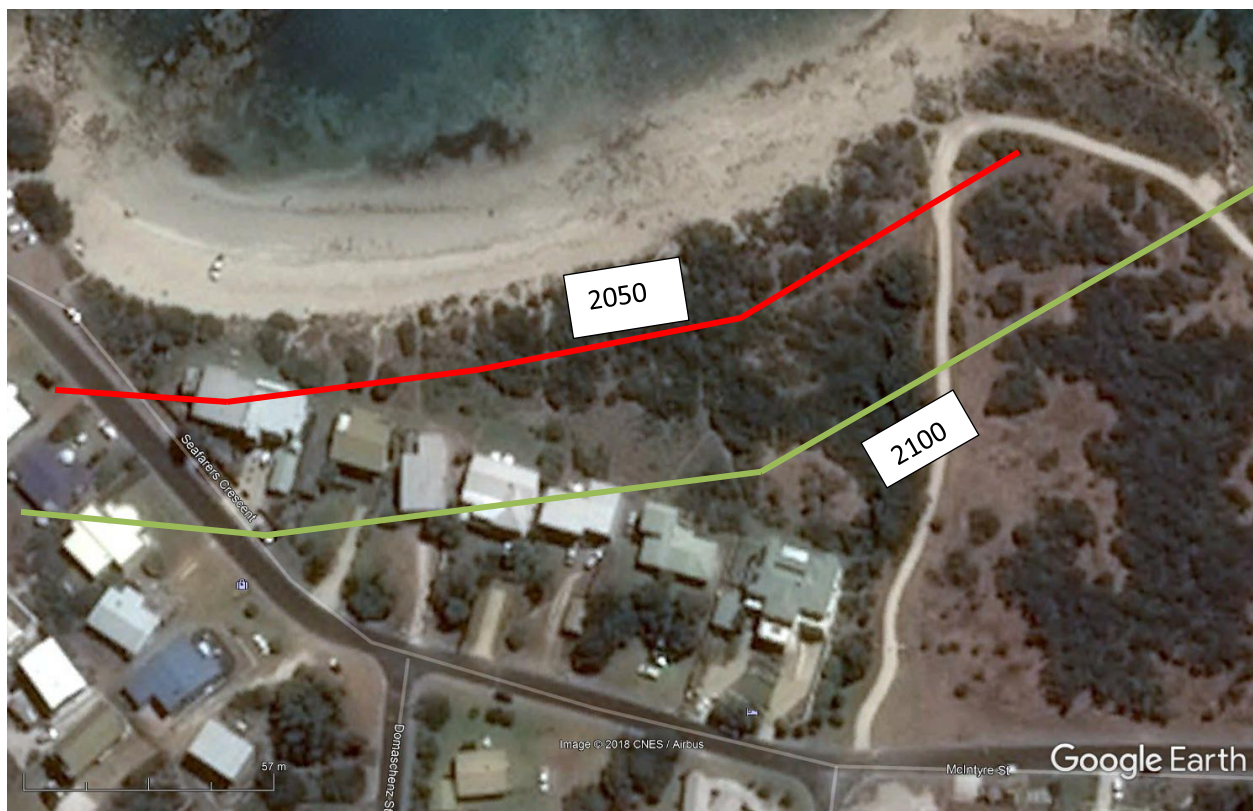
Figure 9 -Hooper Beach Long Term recession

The total estimated coastal recession in 2050 & 2100 allowing for short term erosion, long term recession and erosion from sea level rise is estimated at 18.2m and 47.1m respectively as shown in Figure 9.
