ANALYSES OF BEACH AND NEARSHORE PROFILES AND SHORELINE MAPPING FROM HISTORICAL IMAGERY, ROBE SOUTH AUSTRALIA

Patrick Hesp and Marcio DaSilva

**Beach and Dune Systems (BEADS) Laboratory
College of Science and Engineering
Flinders University
Bedford Park, SA, 5042**

June, 2020

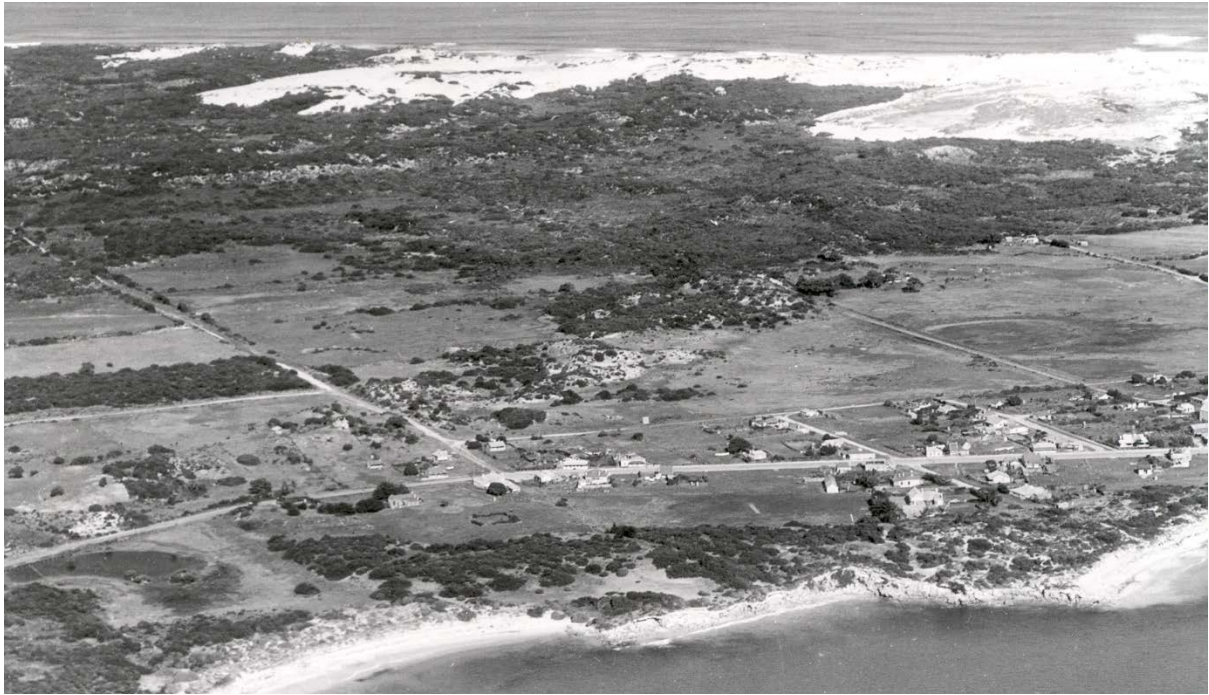
Figure 7: View across Robe in 1945 showing the active dunefield adjacent to West Beach.

West Beach comprises a high energy sand and reef dominated surfzone, backed by an erosional foredune and vegetated and active parabolic dunes and blowouts. Figure 7 illustrates the dunefield in 1945 and shows that the dunefield was very active with multiple parabolic dunes, deflation basins and blowouts present. By 1975, the dunes were still largely active, but by 2020, they are now significantly stabilised, although multiple active blowouts and some parabolic dunes are still present.

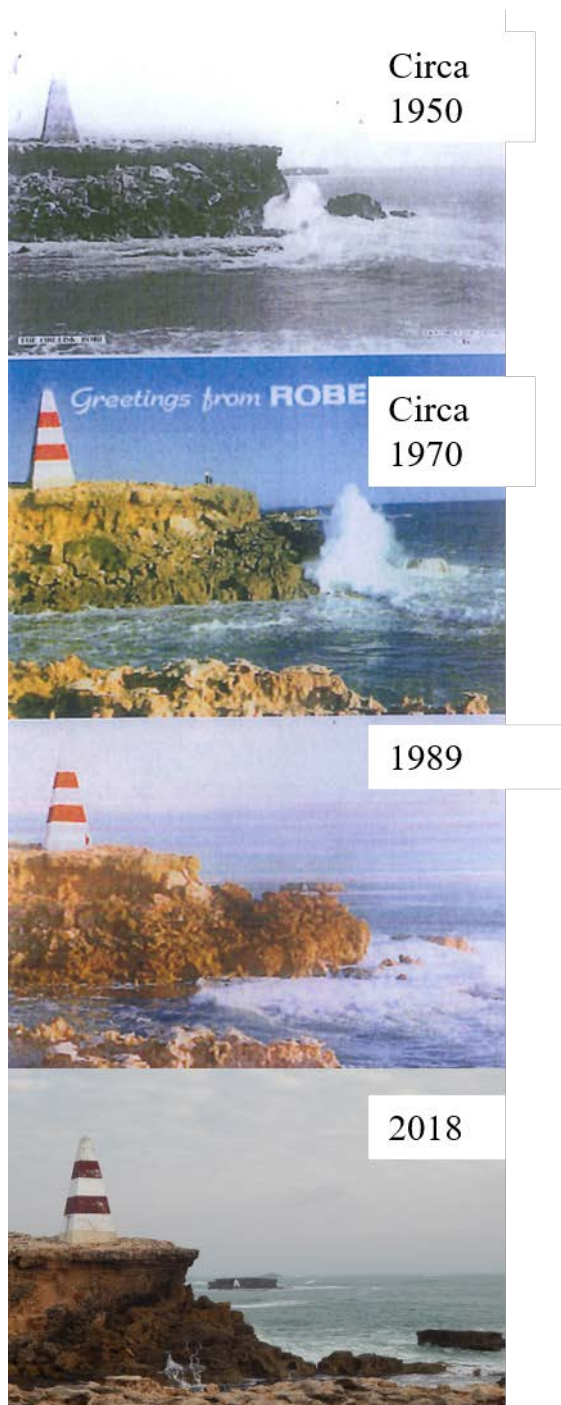
Figure 9: Photographs of the Obelisk from around 1950 until April, 2018 showing the retreat of the aeolian calcarenite cliffs. The cliff seawards of the eastern base of the Obelisk was $\sim 26.5\text{m}$ wide in 1950, and $\sim 8\text{m}$ wide in 2018, a rate of erosion of 0.27 m/year .

The Obelisk was built in 1855, has a 5m x 5m base and is 12.2 m high, and provides an excellent fixed spot from which to reasonably measure cliff line change in a high energy section of the rocky coast at Robe. Fotheringham (2009) estimated that the Cape Dombey headland is eroding at rates ranging from 30 mm/year (exposed locations) to 2mm/year (sheltered locations). Figure 9 illustrates the retreat of the headland adjacent to the Obelisk, and indicates that the headland has lost about 60% of its length seawards of the Obelisk since 1950 (a rate of 0.9% per year).

If the erosion rate of 0.9%/year estimated from the photography in Figure 9 continues unabated, the Obelisk will likely fail around 2060. If the erosion rate is closer to 0.24m/year to 0.27 m/year as estimated from comparison of the 1896 historical survey map and the photography in Figure 9, then the Obelisk will fail in around 2047 – 2050.

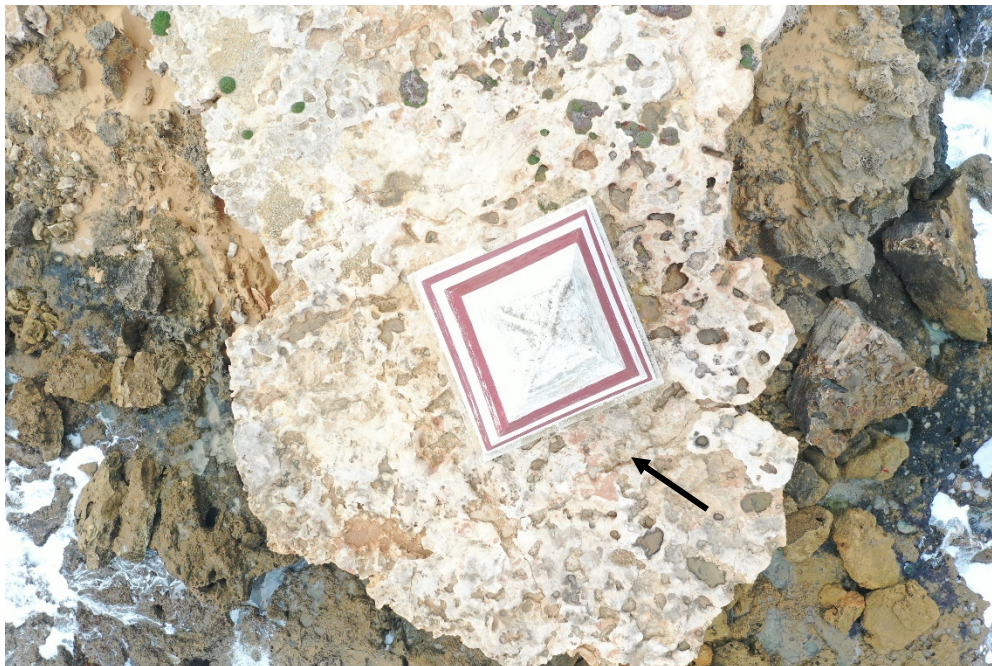
Figure 10: Vertical image of the Obelisk (base is 5m x 5m) taken on June 4th, 2020. Note the possible crack (arrowed) just 1.5m seawards of the eastern base.

Figure 10 illustrates the Obelisk in a vertical image taken on the 4th June 2020. It may be seen that the north and south facing margins of the Cape are narrower than the east facing portion, and the shortest distance to the southern edge of the Cape from the SE edge of the obelisk is only 1.92m. If these margins are eroded at the same rate as the east facing portion of the Cape, and fail first, then the Obelisk will likely fall in ~ 2028.

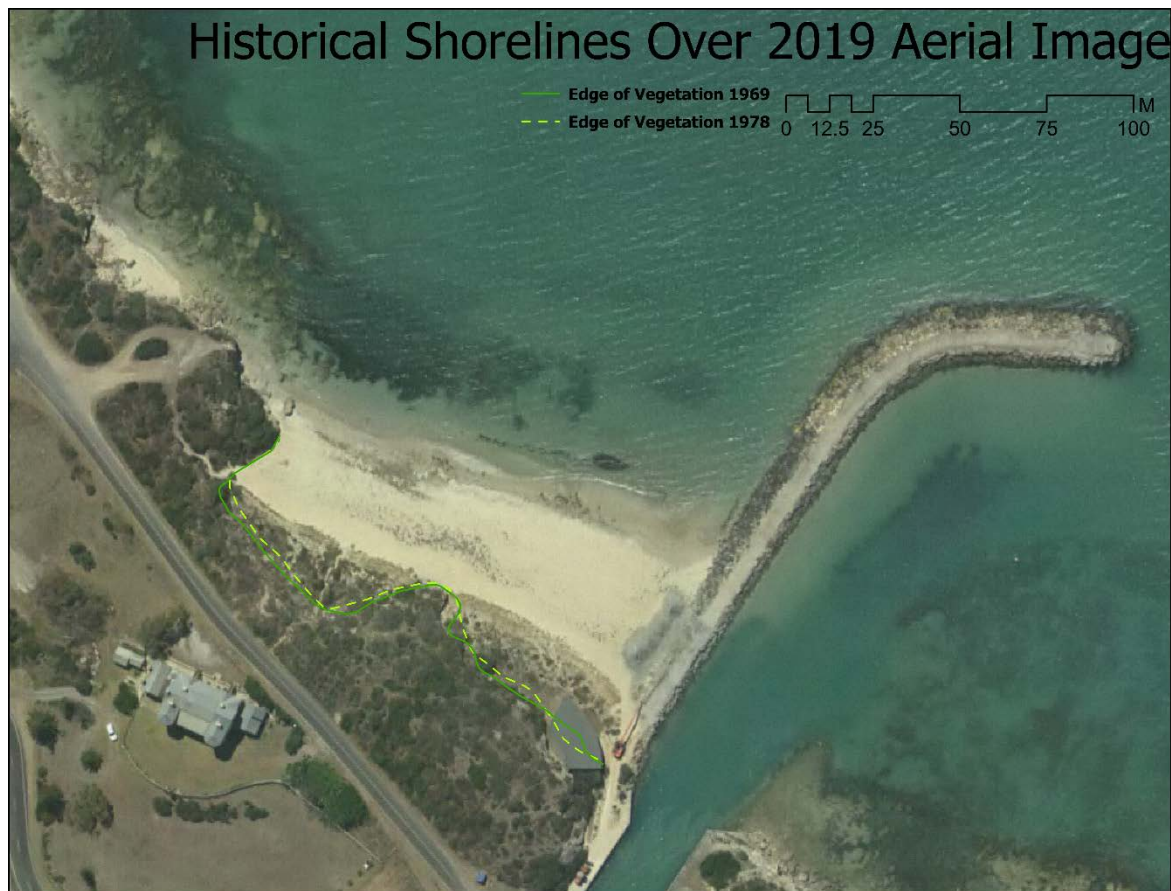
Figure 13: Karatta Beach in 2019 with 1969 and 1978 shorelines indicating the edge of vegetation overlaid on the aerial imagery.

Figure 13 illustrates Karatta Beach in 2019 with the edge of vegetation plotted on that imagery from 1969 and 1978. The shoreline has significantly accreted or prograded to the east and west of the centre of the beach.

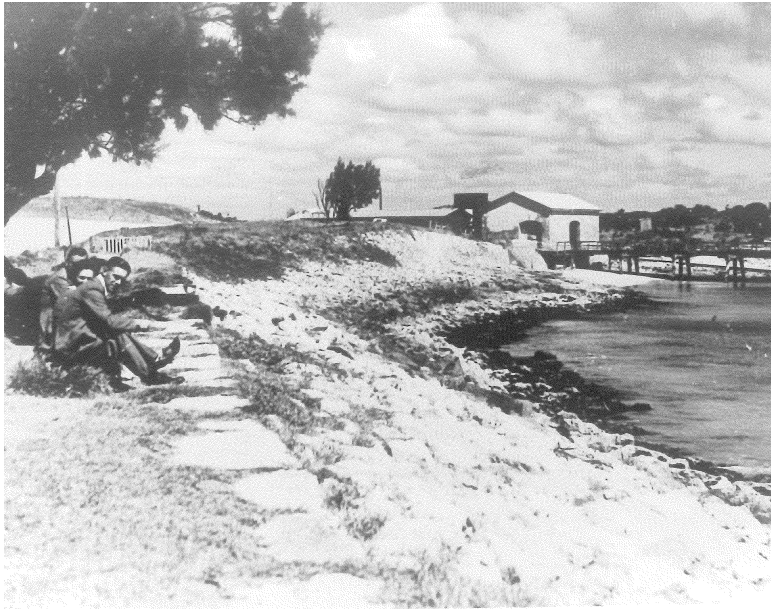
Figure 14: The Robe seawall in the 1930's.

The beach/rocky shore that extends along the front of Mundy Terrace east of the marina breakwater to the eastern headland (Figure 2) has two names, Town Beach and Front Beach, and is hereafter referred to as Town Beach. Town Beach originally has a “row of sand-hills of sufficient height to exclude the view of the sea (Bermingham, 1961, p.28). A bathymetric chart of the Robe area produced in 1870-1871 shows that Town Beach was a sandy beach at the time in front of the old seawall (Short and Hesp, 1980). In 1874, the townsfolk removed the dunes fearing encroachment, and erected a seawall. Following this, the beach eventually disappeared and the seawall failed several times (Fotheringham, 1976). Figure 14 illustrates the wall in 1930, and shows that very little sand, if any, was present at the base of the wall at that time.

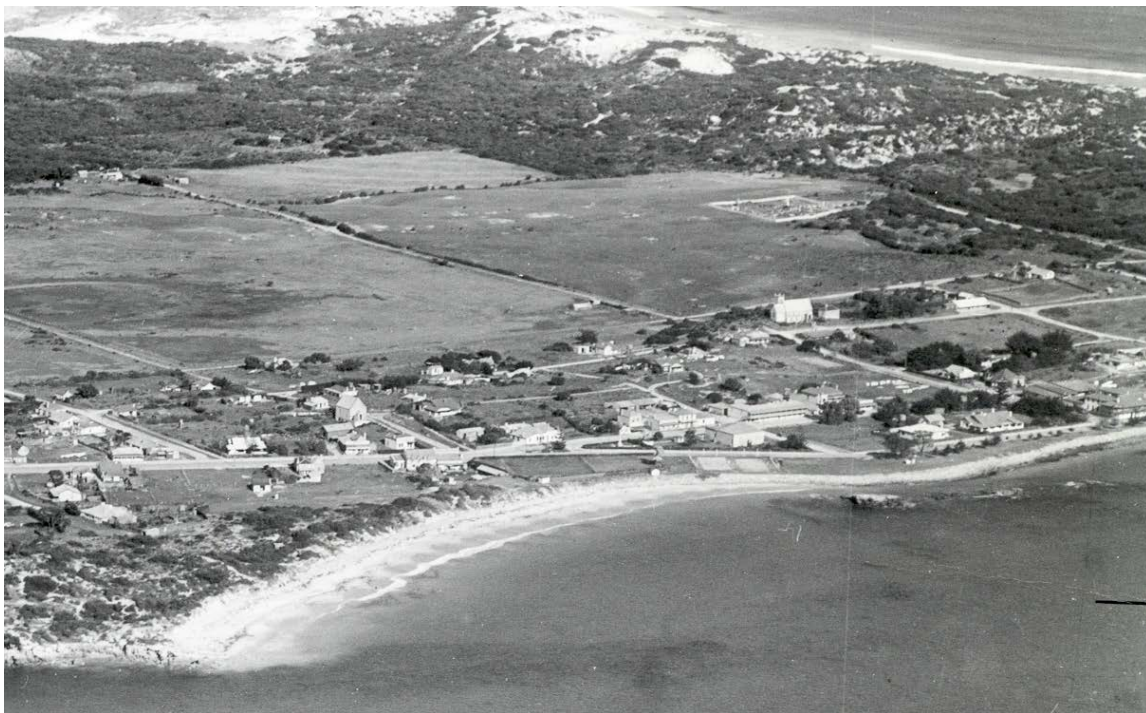
Figure 15: Town Beach in 1945.

Figure 15 illustrates Town Beach in 1945 and it may be seen that the dune system is still relatively intact from the middle towards the NE portion of the bay, but very narrow and partially disturbed/removed in the western margin of the bay.

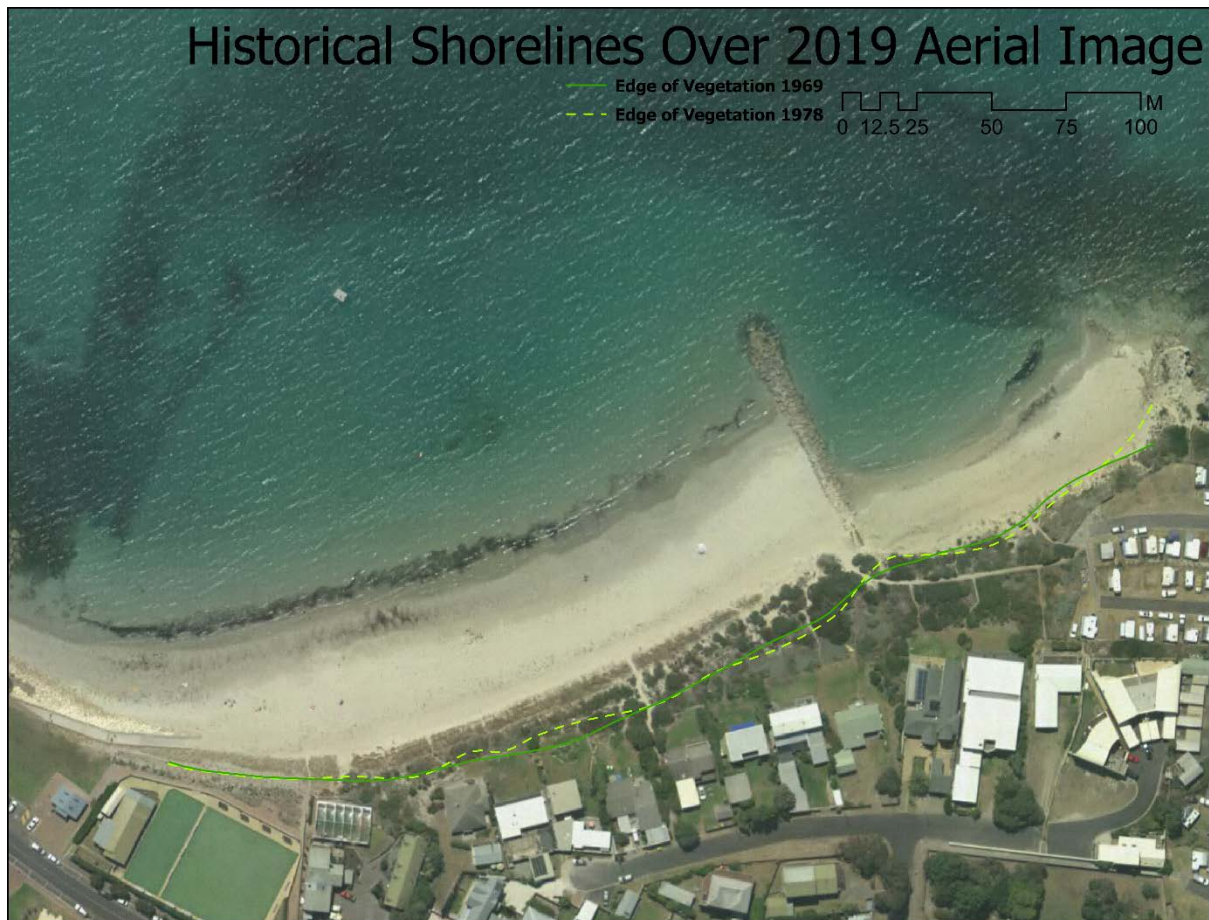
Figure 18: Historical shorelines of Town Beach from 1969 and 1978 overlaid on a vertical aerial photograph from 2019.

Figure 18 illustrates shorelines from 1969 and 1978 on the 2019 imagery. These shorelines were derived by mapping the seaward edge of vegetation. The western portion of the beach has built out since 1969-1978 as a function of the emplacement of the groyne, and the more eastern portion of the beach has remained roughly stable to mildly erosional in the very eastern end.

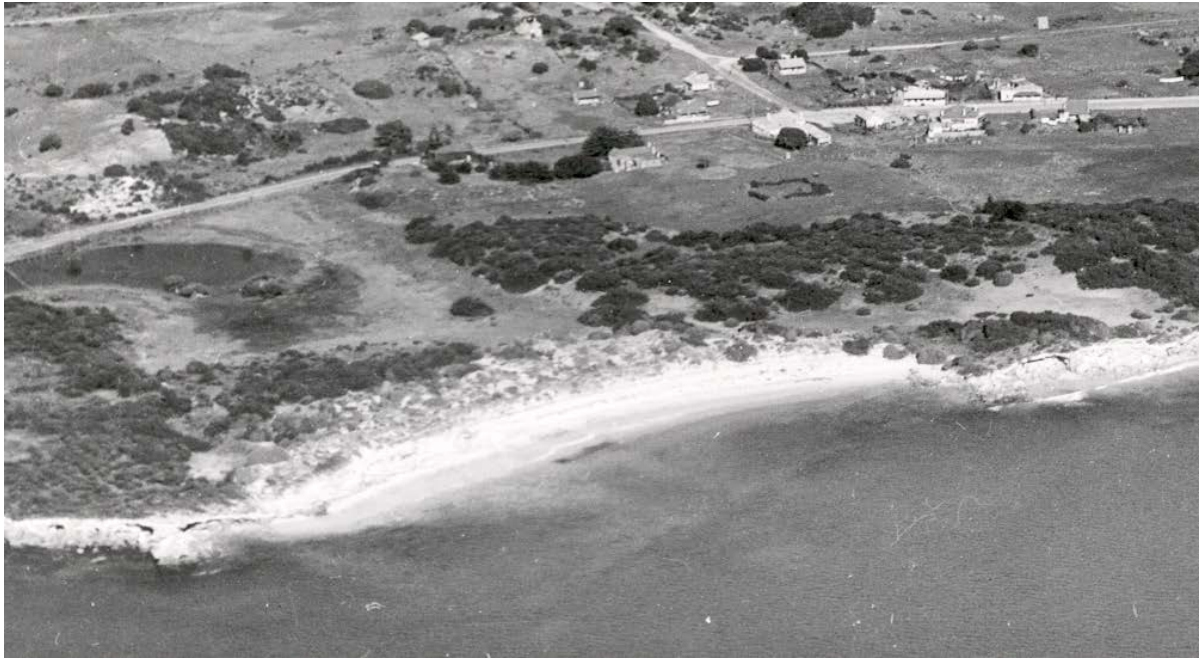
Figure 19: Hoopers Beach in 1945.

Hoopers Beach was not developed at all in 1945 (Figure 19), but by 1975 had several houses built on the foredune/back-dune complex (Figure 20).

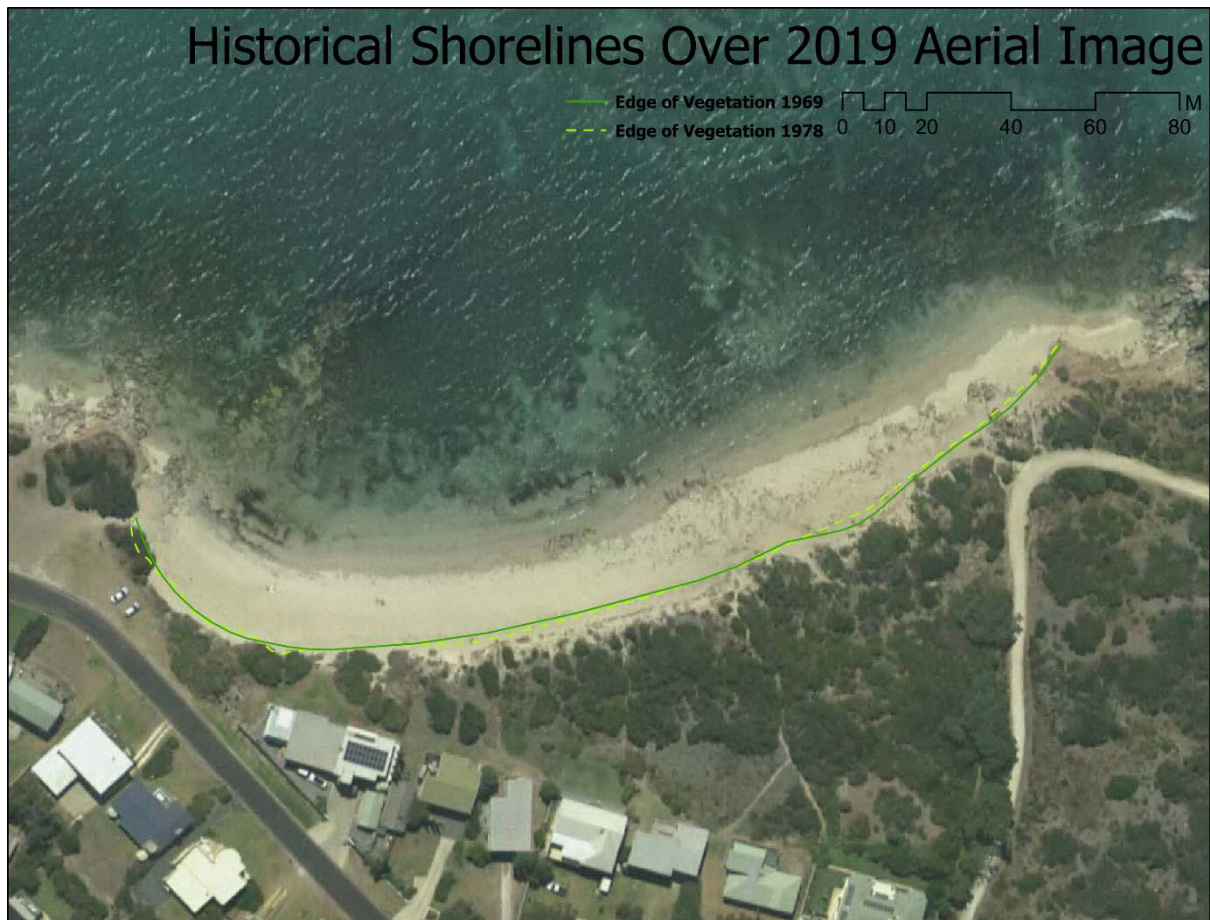
Figure 21: Historical shorelines of Hoopers Beach from 1969 and 1978 overlaid on a vertical aerial photograph from 2019.

Figure 21 illustrates shorelines from 1969 and 1978 on the 2019 imagery of Hoopers Beach. These shorelines were derived by mapping the seaward edge of vegetation. The analysis indicates long term retreat of the shoreline or edge of vegetation in 2019 of a maximum of ~4-5m compared to the earlier dates.

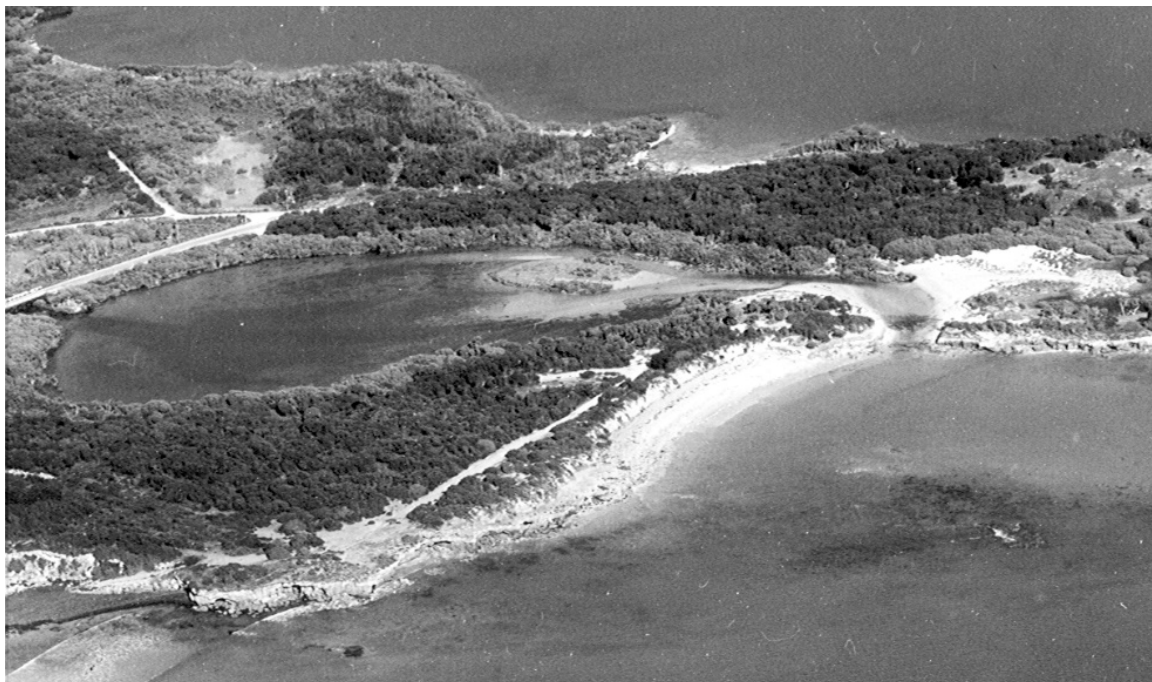
Figure 22: Fox's Beach, Fox's Lake, and the outlet in 1945. Note that the foredune is significantly cliffed or scarped at this time.

Fox's Beach is a small ~200m long pocket beach situated between two low limestone headlands at either end, and is adjacent to the outlet channel to Fox's Lake. A shallow reef extends NNW from the NNE end of the bay, and shore platforms extend along the NNW facing cliff margin on the SW side of the bay (Figures 2, 22).

The beach has been experiencing erosion for some time, and, for example, the foredune displays a significant scarp (cliff) in 1945 (Figure 22). By 1975, a scarp is also present and

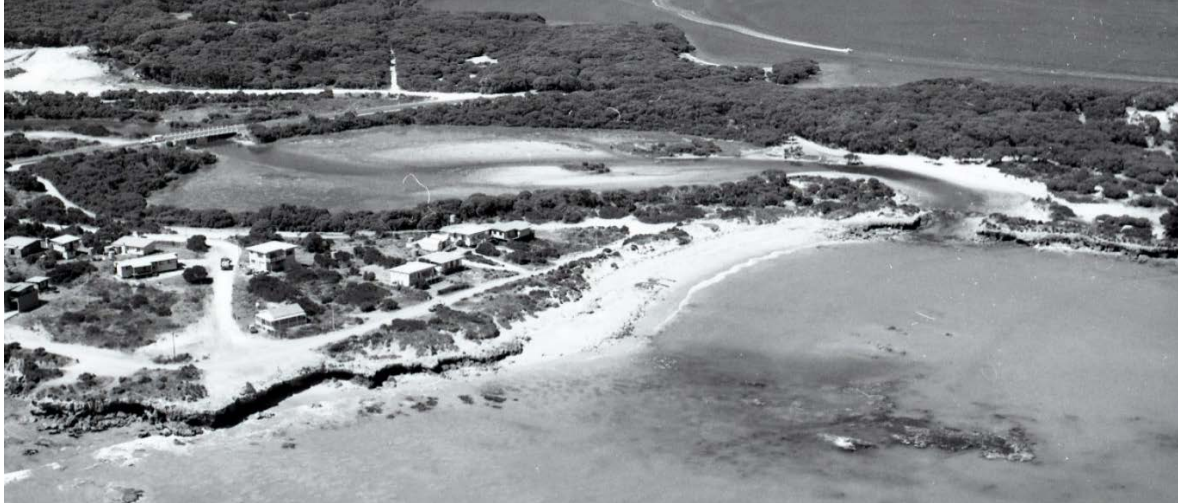
Figure 23: Fox's Beach, the Outlet and Fox's lake in 1975. The cliffs at either end of the beach are more prominent perhaps suggesting lowering of the sand surface since 1945.

the foredune has less vegetation cover and is more erosional, particularly at the southern end (Figure 23). The rate of erosion accelerated from ~ 2015 according to Mr. R. Sweetman, former CEO (DC Robe). Civil and Environmental Solutions (2018) stated that the existing back of beach position is approximately 2.5-3m landward of where it was in 2015, and that the estimated eroded volume at 2018 was 2000m³ since 2016.

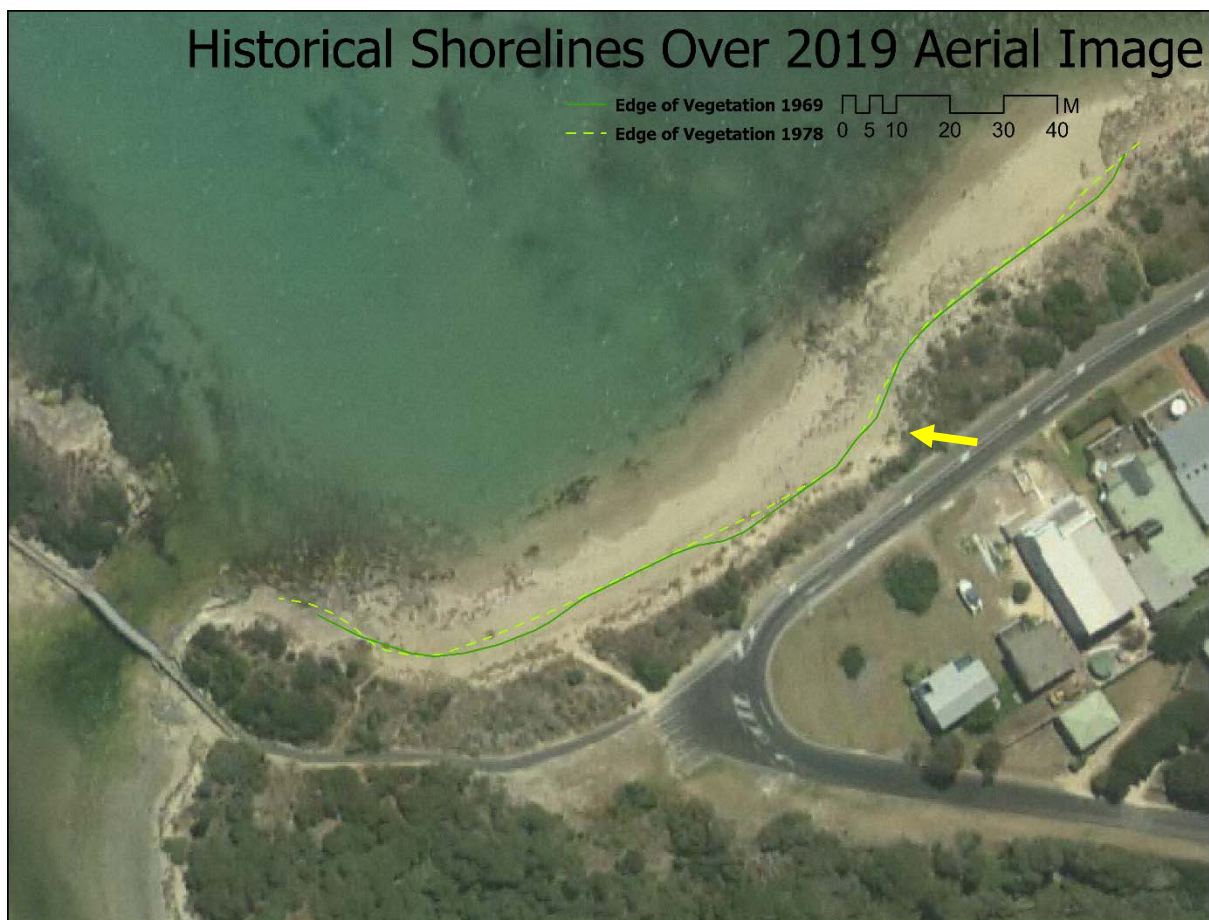
Figure 24: Shorelines from 1969 and 1978 on the 2019 imagery of Fox's Beach.

Figure 24 illustrates 1969 and 1978 shorelines derived by mapping the seaward edge of vegetation over the 2019 imagery. As indicated by the DEW topographic profiles, there has

been significant erosion since 1978. In particular, as erosion has proceeded, the NW reef is acting as a pseudo-groyne and erosional ‘edge effects’ are occurring in the NW corner of the bay (arrowed) which is now retreating more rapidly.

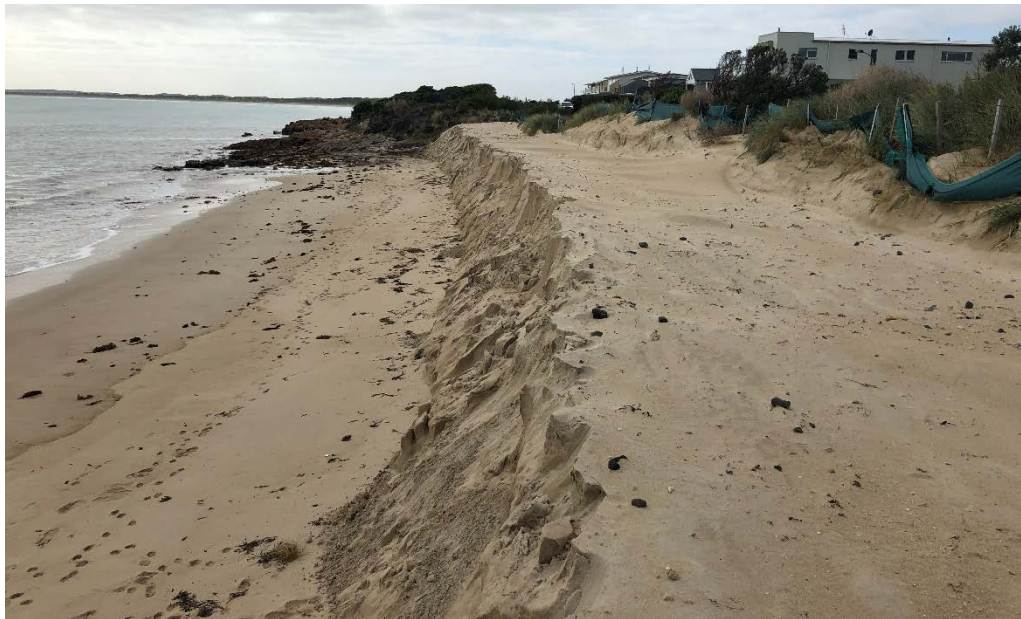
Figure 25: Scarped nourishment fill on the 3rd June, 2020 at Fox’s Beach.

As noted above, and also by Civil and Environmental Solutions (2018b), the large storms of 2016 combined with record tide levels produced significant erosion along this, and other Robe beaches. Fox’s Beach was most recently nourished with sand from Karatta Beach on the 23rd May, 2020. A storm which occurred in the week of 25th to 31st May, 2020 eroded a significant portion of the nourishment fill resulting in a pronounced scarp (Figure 25).

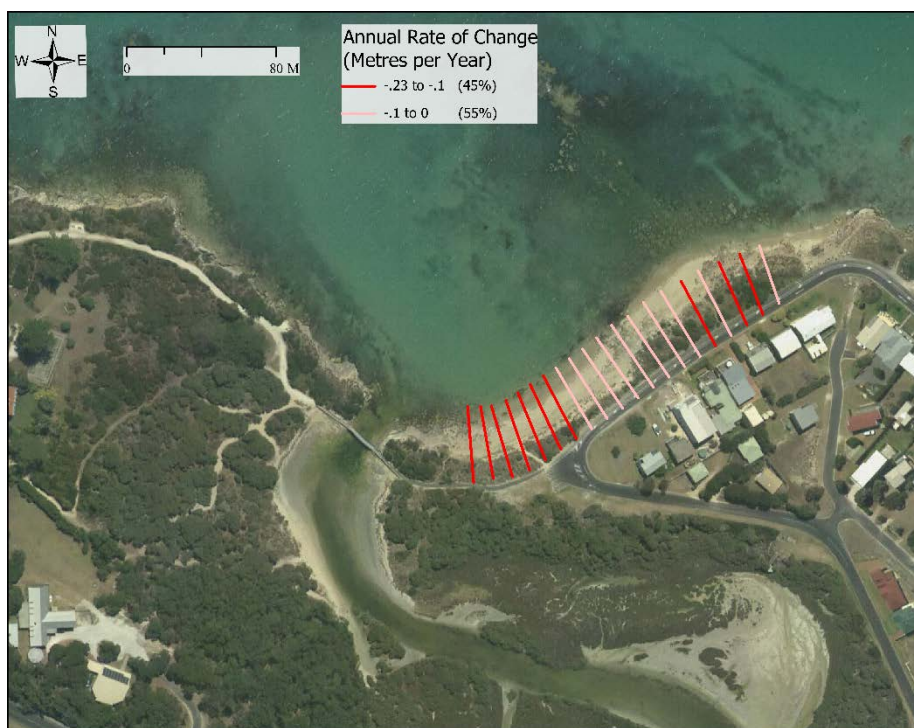
Figure 26: Shoreline change at Fox's Beach determined from an analysis of changes in the edge of vegetation on the aerial photography from 1946 to 2019.

Figure 26 illustrates beach changes from 1945 to 2019 and indicates that the rates of erosion vary alongshore depending on whether reef, rock platform and cliff is present or not. The highest rates of erosion (up to 0.23 m/year) have occurred on the sandy beach portion.

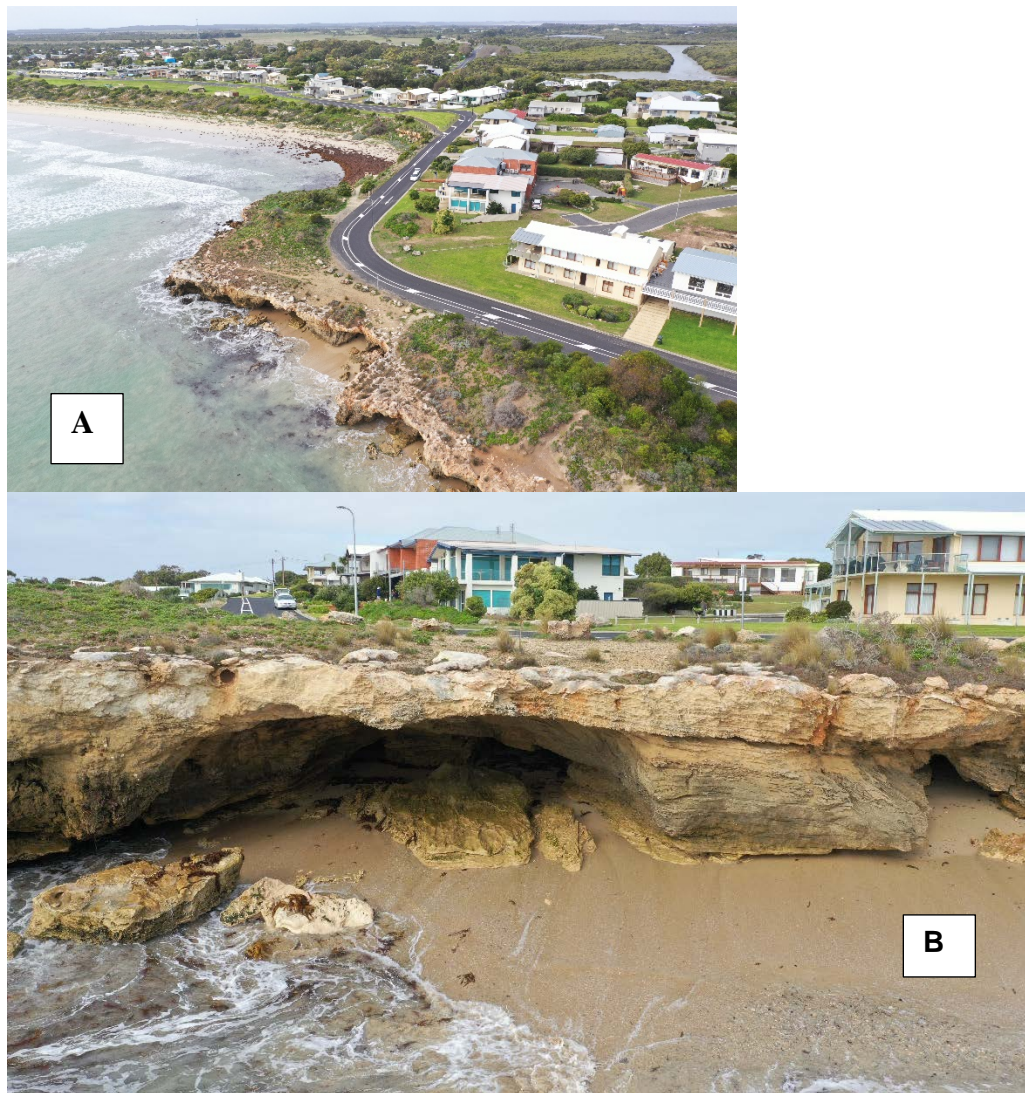
Figure 27; (A) General view of the cliff and caves fronting the corner of the Esplanade; (B) view into the caves that extend several metres towards the road under the overhang. Photos taken June, 2020.

The limestone cliffs just north of Fox's Beach and extending around the front of the corner of the Esplanade display several deep caves with wide overhanging calcrete sections above them (Figure 27). There are some large solution pipes in this area also. It is unknown how deep these caves may penetrate inland, and the risk to road stability may possibly be significant.

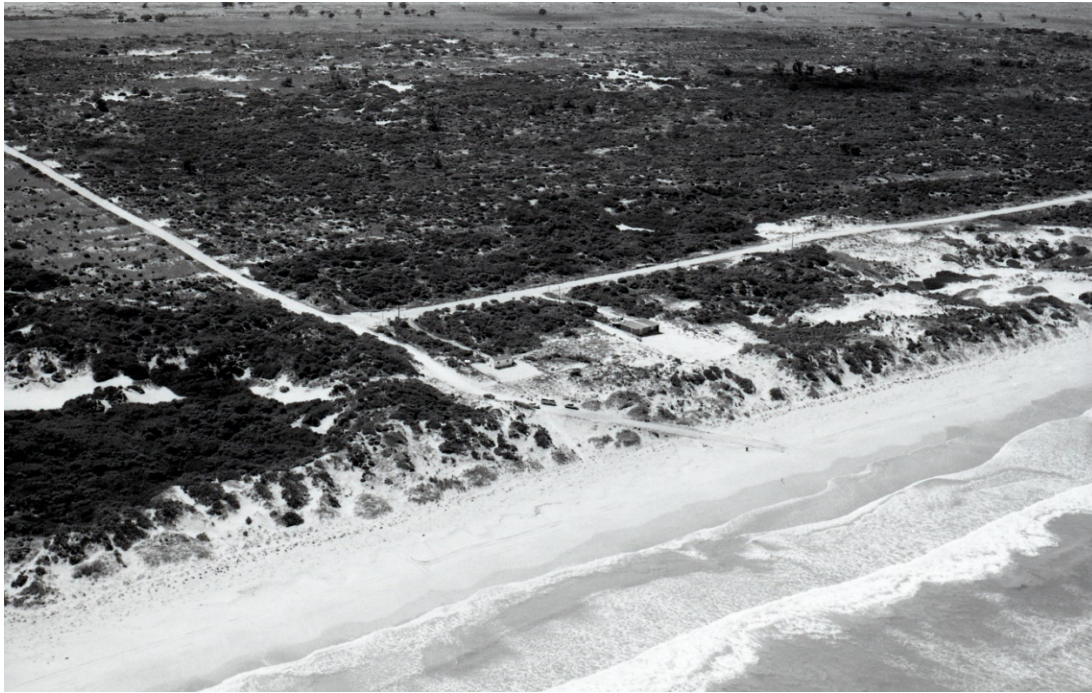
Figure 28: Long Beach access road, mid Guichen Bay, 1975. The foredune displays a relatively steep seaward slope and multiple blowouts along its length.

The Guichen Bay coastal plain is fronted by a small active foredune which lies seaward of a much larger relict foredune. The latter was active in 1975 (Figure 21), and partially active in 1978 when Short and Hesp (1980) visited the site (Figure 28). The modern, much smaller active foredune formed sometime after that period indicating there may be a continuing small sediment supply into the Bay, or that the new foredune formed following a period of erosion of the larger, older, now relict foredune. If the latter is the case, then the modern foredune merely represents sediment being returned to the beach post-storm(s).

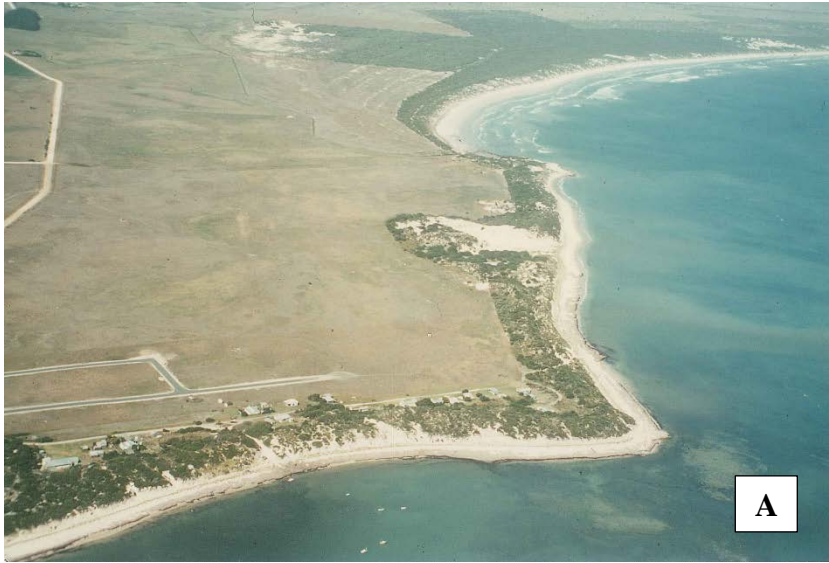
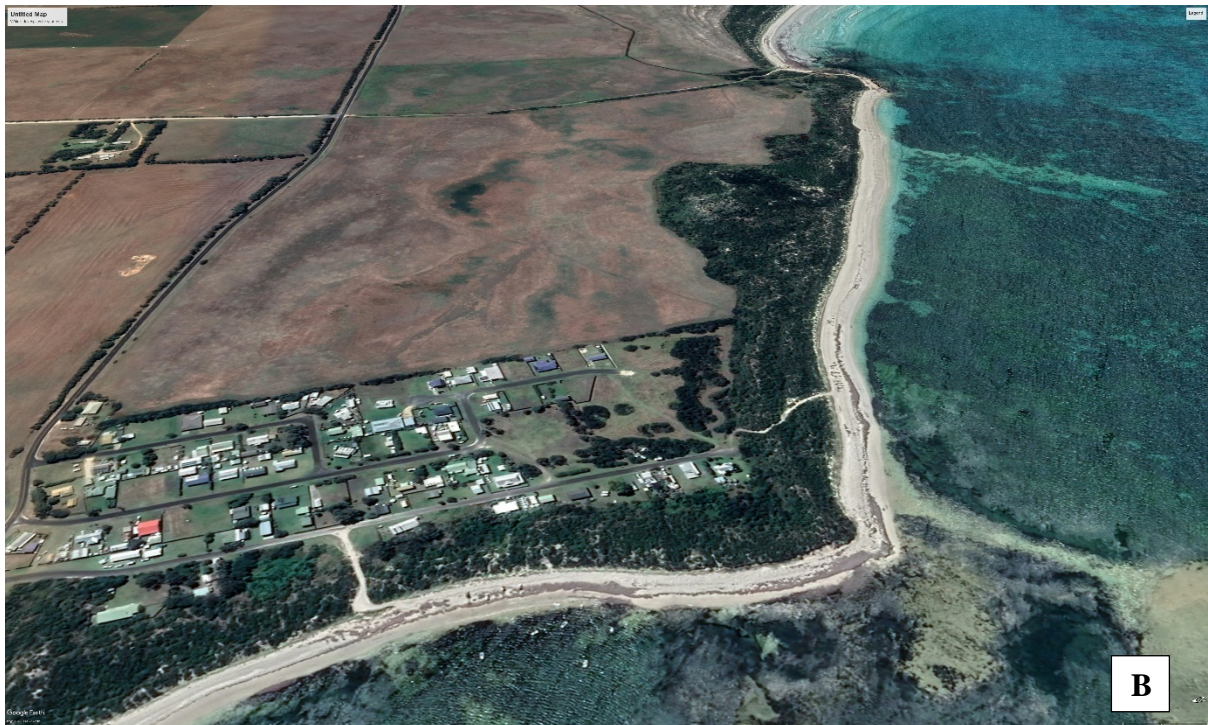
Figure 35: Boatswain and Cape Thomas. (A) photograph taken in 1979, and (B) Google Earth image in 2018. Note the increase in vegetation cover, and the vegetation colonisation of the blowout east of Boatswain by 2018.

The Department of Environment and Water (DEW) have monitored a survey line or profile at Boatswain since 1977. The line crosses a narrow sandy beach and then crosses a reef dominated nearshore zone (Figures 6 and 35). The profiles show that there has been around 2.2m recession at the dune toe between 1977 and 2010 which equals an erosion rate of ~0.06 m/year (Figure 36). The rate of erosion between 2010 and 2018 has increased to ~0.1 to 0.2 m/year for the toe of the foredune at +2m AHD and dune slope at +4m AHD respectively.
