# **Report on the Condition of the Building Fabric with Recommendations**

**February 2023**

**The Robe Institute,  
Smillie Street, Robe**

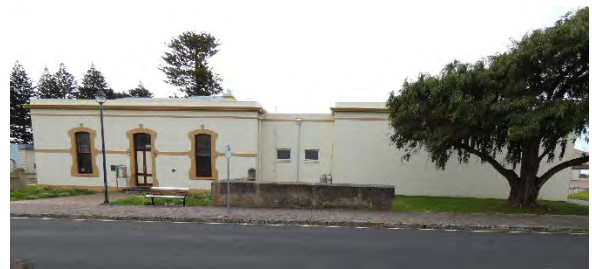
The roofs are all finished with full length corrugated galvanized steel roof sheets that, from distant inspection, appear to be in good condition, albeit some of the roof screws are badly rusted.

Above: Views of the roofs along the south elevation from the ground are difficult due to the parapets and low roof pitches.

A thorough high level inspection of the roofs and rainwater goods should be carried out as soon as possible to ascertain their detailed condition. Also, a CCTV survey of the underground drainage should be undertaken to ensure that all storm drains are running clear.

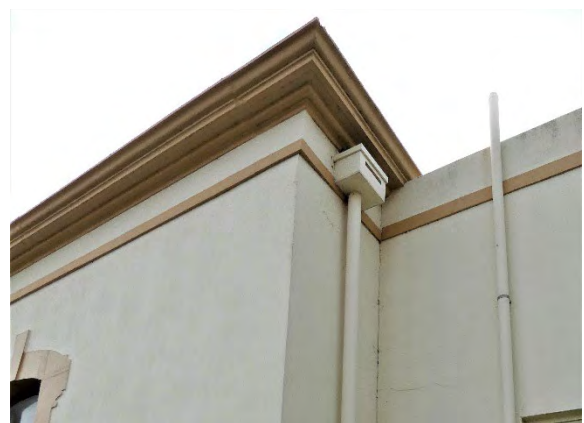
**Above:** Galv rainwater head at the east end of the roof of the original building along the south elevation.

When required, all existing gutters, downpipes and rainwater heads should be replaced in Z600 Heritage Galv.

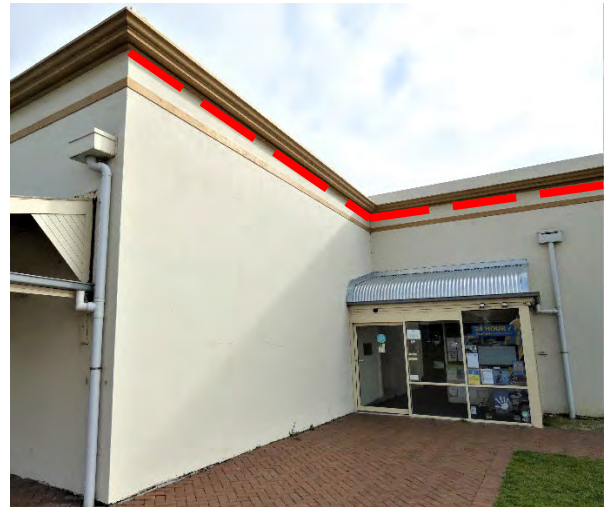
The library roof is L-shaped and pitches down to parapet box gutters along the north and east sides of the inside corner either side of the entrance to the library and visitor centre. Again, these box gutters drain to Galv rainwater heads.

Above: View of corner entrance to the library and visitor centre. The dashed red lines show where the parapet box gutters run. Note the rainwater heads that the box gutters drain to.

Obviously when the roof sheeting requires to be replaced, much or all of the existing flashings and box gutters will need to be renewed also. At that time new overflows should be formed through parapets to avoid overflowing into the building in the event of blockages.

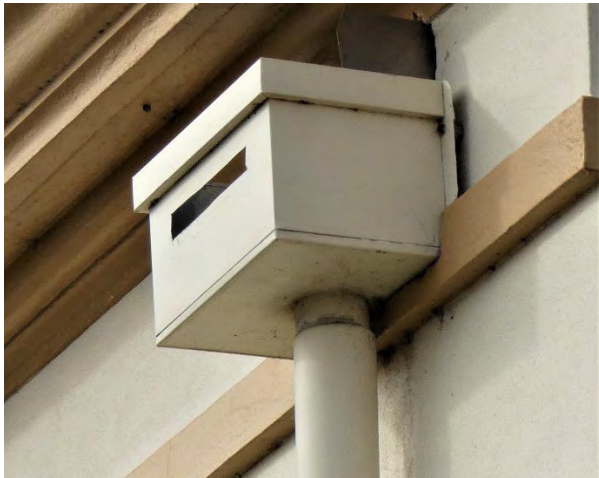
Above: Galv rainwater head with uPVC downpipe on the south west corner.

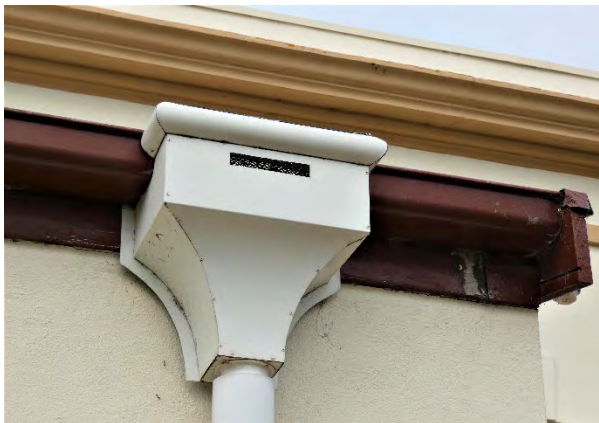
Above: There are several new Colonial-style Colorbond rainwater heads installed during works around 2015. One is to the west kitchen extension; the other is midway along the south elevation.

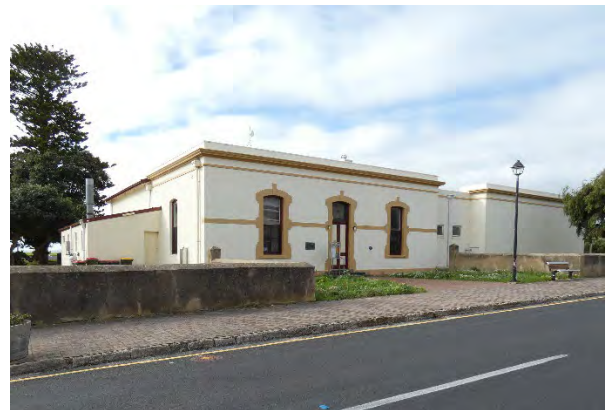
The uniform cement render and paint applied to all external walls gives the overall building a sterile appearance and fails to acknowledge the delineation between that more recent extensions and the original part of the Institute that was formally finished with fair-faced stonework.

**Above: The uniform render and paint does not delineate the newer extensions from the original Institute building.**

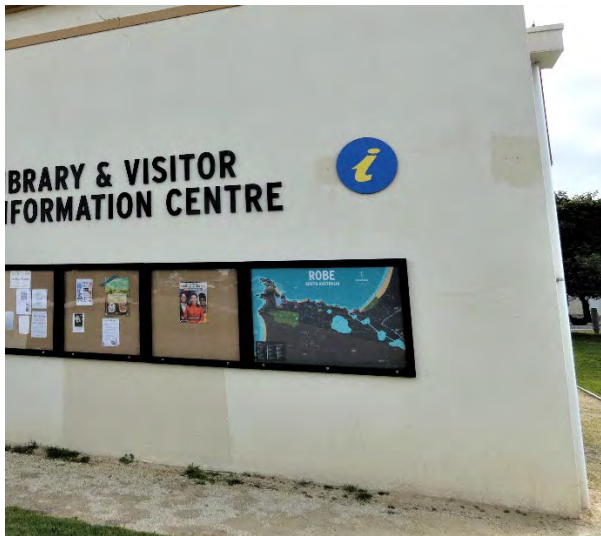
**Above: Inconsistencies in paint colours suggest past alterations to signage.**

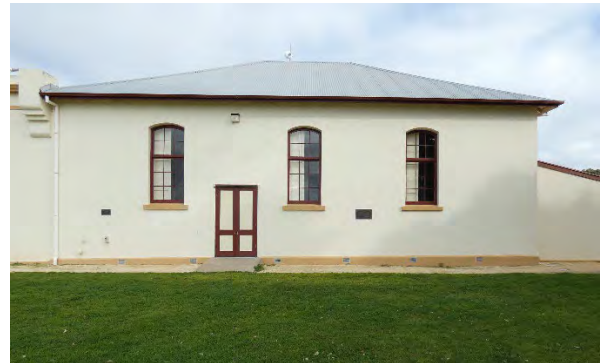
The north elevation of the hall has a doorway that may have been a later addition to provide a fire escape.

**Above: North elevation of hall with a doorway that appears likely to have been a later addition.**

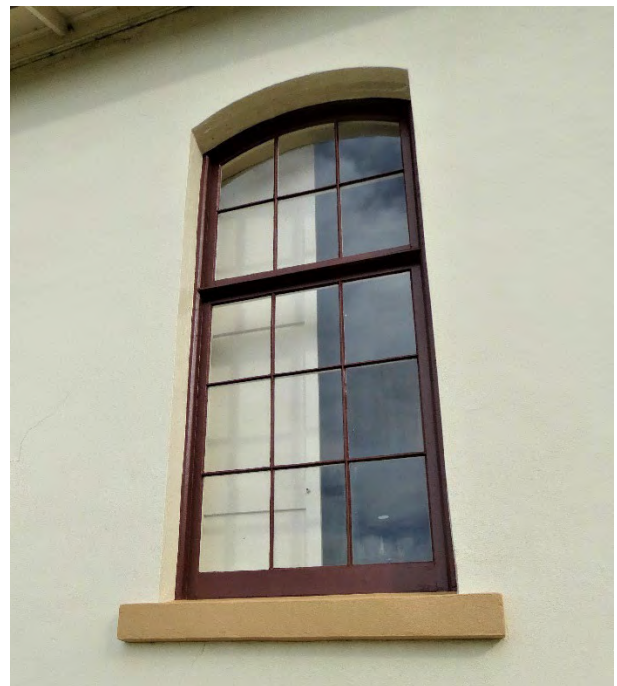
The hall windows along the north elevation appear to be in reasonable condition, although they are inoperable as they are painted shut. These windows all have internal wooden shutters.

**Above: Hall window along north elevation. Note the internal timber shutter.**

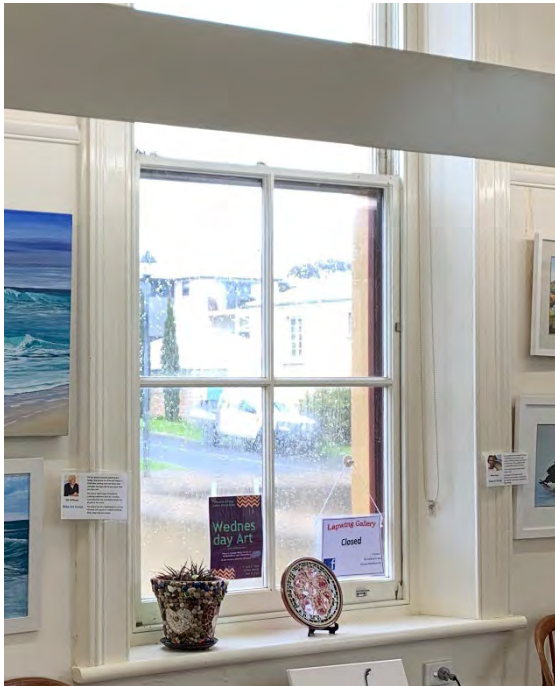
be in reasonable condition and the bottom sash appears to open, albeit the pulley ropes have been painted. The bottom sash is protected with an insect mesh screen.

**Above: Window to the west room/ gallery.**

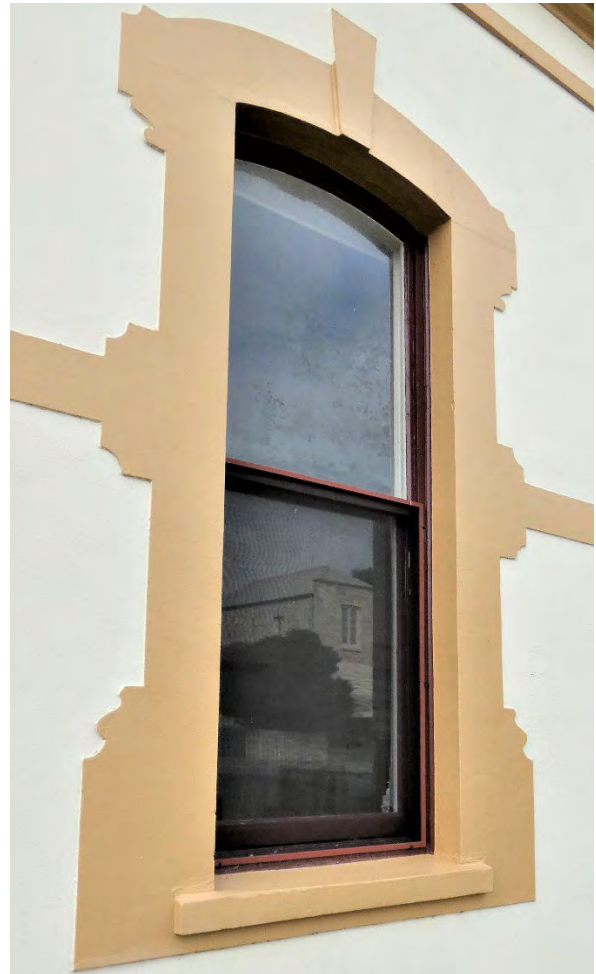
The window to the east/ Kathleen Brown Room appears also to be operable and in good condition. The bottom sash has no astragals and is again covered by an insect mesh screen.

**Above: Window to the east/ Kathleen Brown Room.**

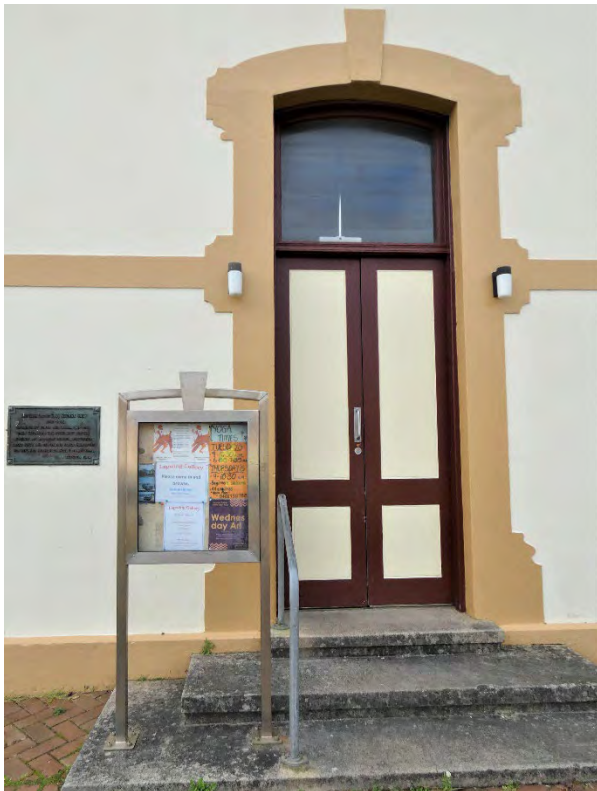
The entrance door to the original Institute building does not appear to match that in early photographs and is likely to have been replaced due to wear and tear, possibly during works in 1983. Although of relatively poor quality it appears to be in good condition.

Above: Current main entrance door.

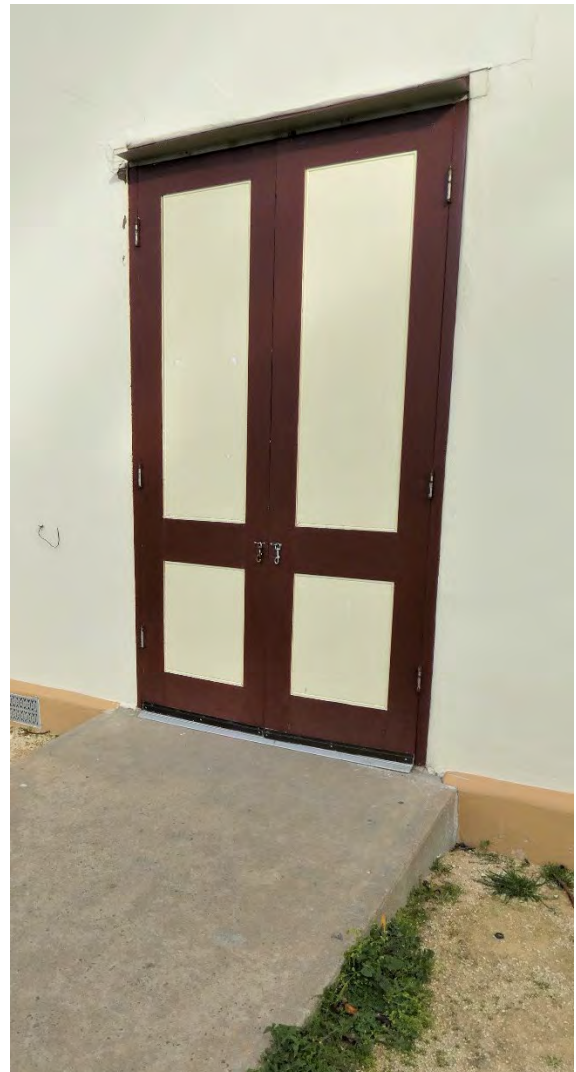
The doorway formed in the north elevation of the hall is again of poor quality and is likely to have been installed around the same time as the front entrance doors were replaced. The doors are in reasonable condition.

Above: Fire escape doors along north elevation of hall.

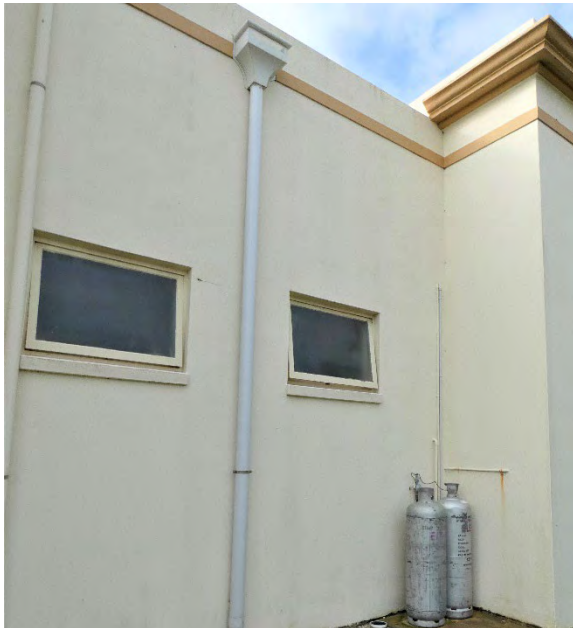
The timber windows to the toilets along the south elevation are in reasonable condition.

**Above: Toilet windows along south elevation.**

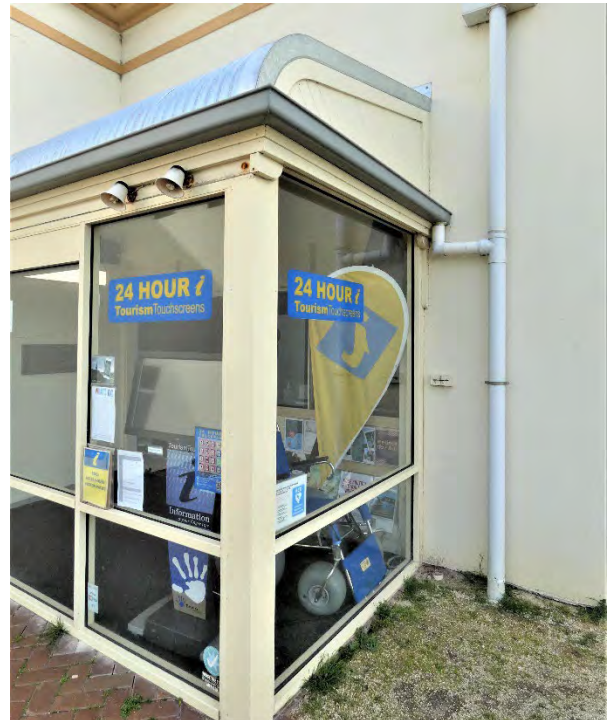
The door and partially glazed side screen under the east verandah of the library, and the projecting timber-framed main entrance to the library/ visitor centre, both require maintenance as the paintwork looks thin and external metal fixings and fixtures are rusted.

**Above: Projecting timber-framed main entrance to the library/ visitor centre.**

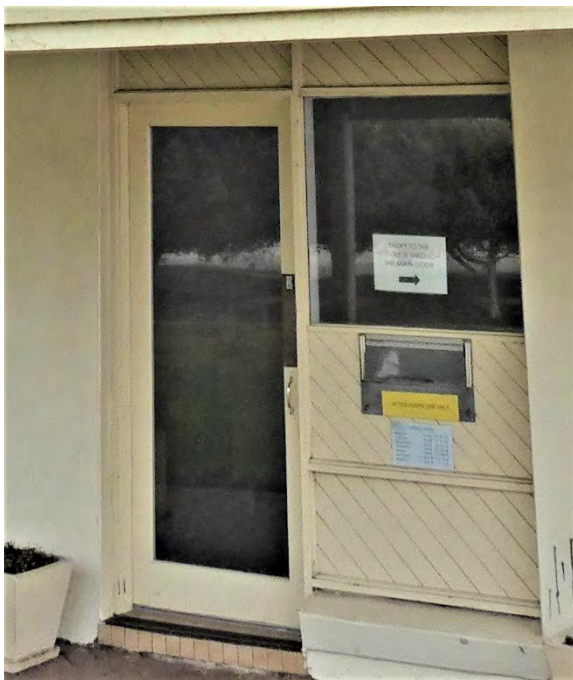
**Above: Door and partially glazed side screen under the east verandah.**

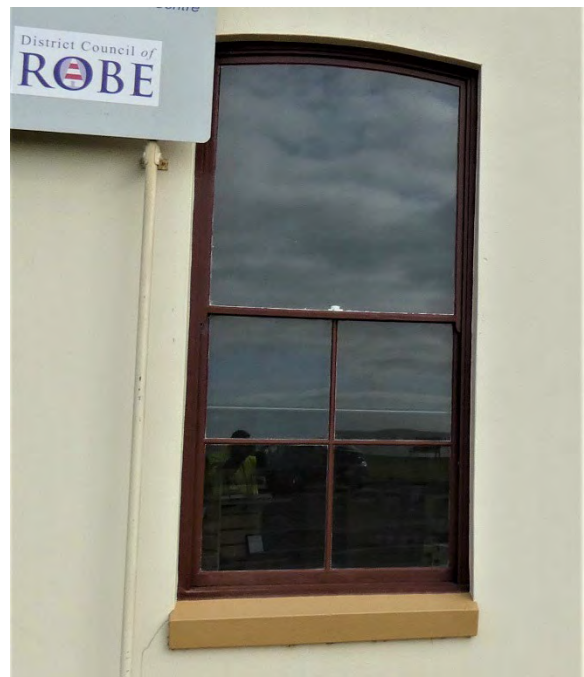
There is a sash and case window to the north elevation of the library extension that matches those to the adjacent hall. It appears to be in reasonable condition.

**Above: Window to the north elevation of the library extension.**

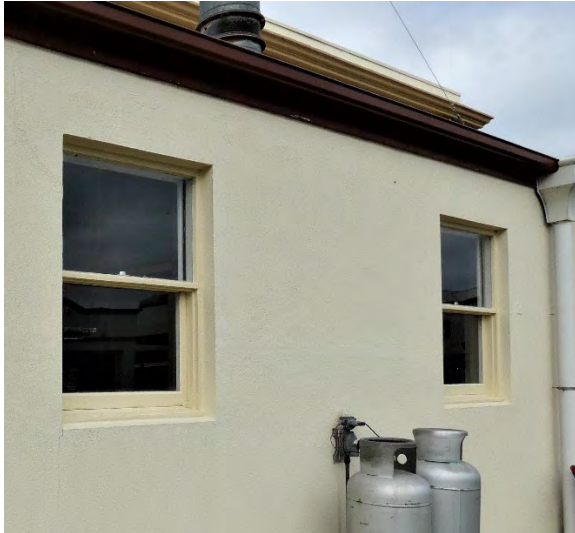
There are modern timber sash and case windows to the west extension of a somewhat squat proportion. They are in reasonable condition.

Above: Modern timber sash and case windows to the west extension.

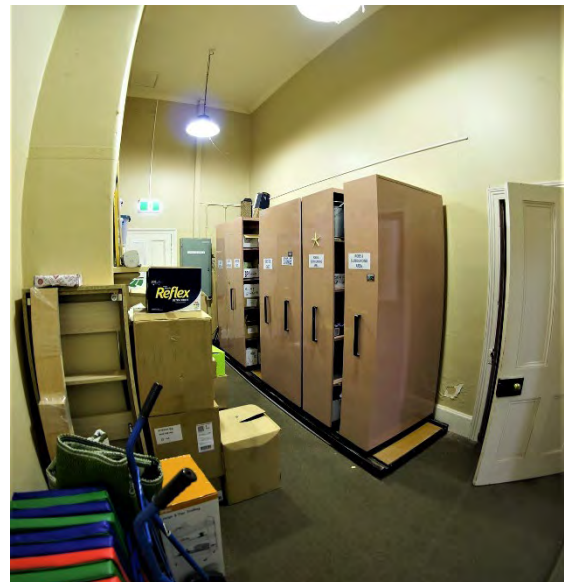
Damp can also be seen in the base of wall behind the compactus in the storage area to the north of the Kathleen Brown Room. This may again be combination of rising and falling damp – perhaps rising up from the ground because of a lack of dpc, and falling due to a failing valley gutter above.

**Above:** Storage area containing the compactus.

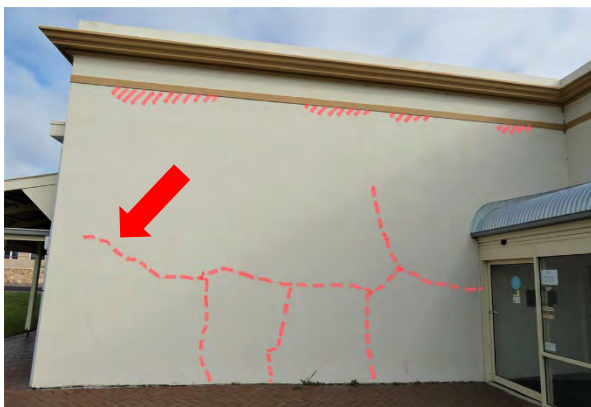
On the other side of the north elevation wall leading to the main entrance into the library/ visitor centre, where the render is cracked, the paint is blistering internally. The parapet box gutter may be failing above and/ or moisture is being drawn through the wall cracks.

Above: North elevation wall leading to the main entrance into the library/ visitor centre.

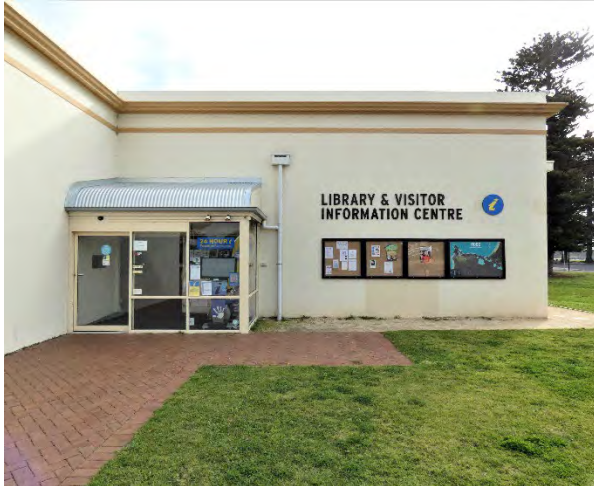
**Above: Unattractive approach to the library and visitor centre entrance.**

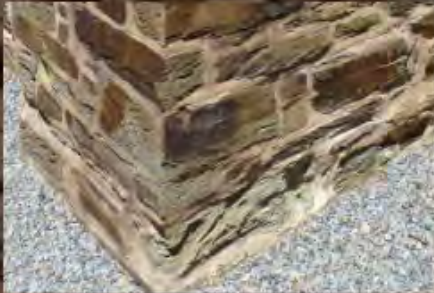
Above: Salt-damp deterioration at the base of a heritage building wall in North Adelaide.

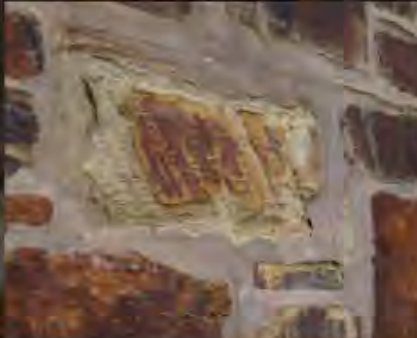
decades have largely been carried out using cement which is hard, inflexible and unbreathing. This exacerbates salt-damp and accelerates the decay of stone and brick, especially when masonry materials are naturally soft. Current practice is now to remove cement pointing and cement repairs from traditional masonry walls and replace it with lime mortar.

The hard, unbreathing cement pointing here has caused salt-damp deterioration to the adjacent blue stone.

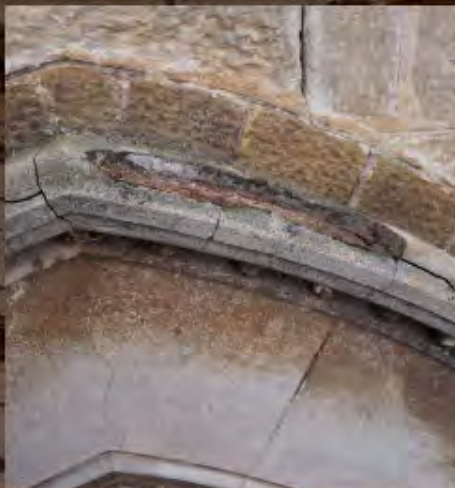
Metal fixings embedded within stonework to secure decorative features can rust resulting in 'oxide jacking' – the process of expansion that iron undergoes as it rusts – putting surrounding stonework under enormous pressure, leading to cracking and disintegration of masonry.

Above: Embedded iron fixing rusting and cracking a surrounding stone moulding that is now in danger of falling from height.

It is therefore important that stonework, particularly at high level, be inspected annually, and at least using high powered binoculars from the ground, to check for evidence of cracks and potentially unstable masonry. While there are hundreds of cases annually of people injured or killed in the UK by falling masonry, unlike South Australia, Great Britain is not an area prone to earthquakes.

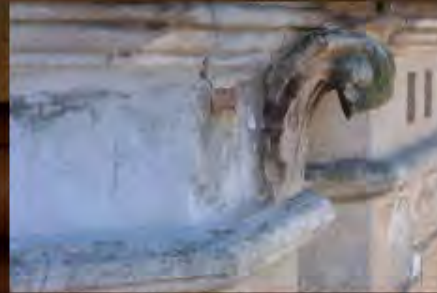
Above: Decorative stonework on an Adelaide heritage building. Note the exposed and rusted iron fixing with a surrounding cement repair. This is where stone features have formally been located and have either been removed for safety reasons or have fallen off.

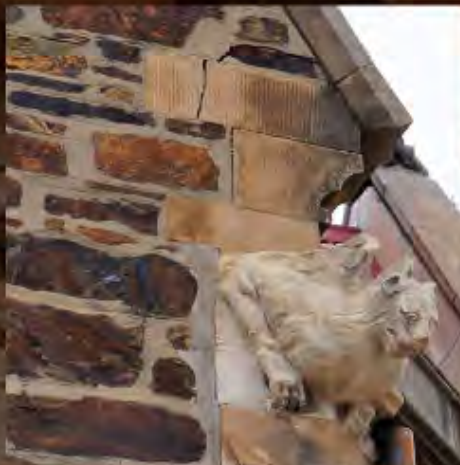
Above: As a result of movement, cracking has taken place between the hard cement pointing & the stonework. The lack of flexibility of the pointing has also led to the cracking of the 'kneeler' stone.

The cement's inability to accommodate movement causes it to crack along the joints and sometimes forces the stonework to split because it is weaker than the cement.

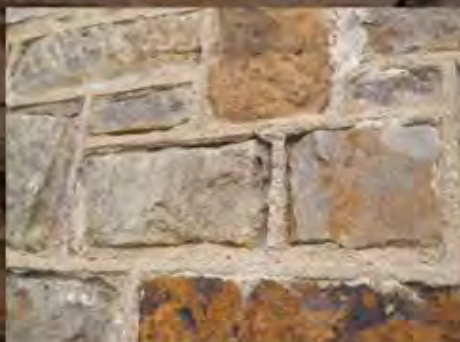
Below: Hard cement pointing causes accelerated erosion of the adjacent stonework, as seen below in a South Australian heritage building where the stone has eroded away leaving the cement joints more exposed.

Another issue with cement pointing is that because it is generally harder than surrounding masonry the brick or stone erodes more quickly as water is thrown off the cement and onto the masonry. In a traditional lime-pointed wall the sacrificial joints are softer and erode first.
