**Robe Obelisk**

## **Landslide Stability Assessment**

**District Council of Robe**

Ref No. 20181771

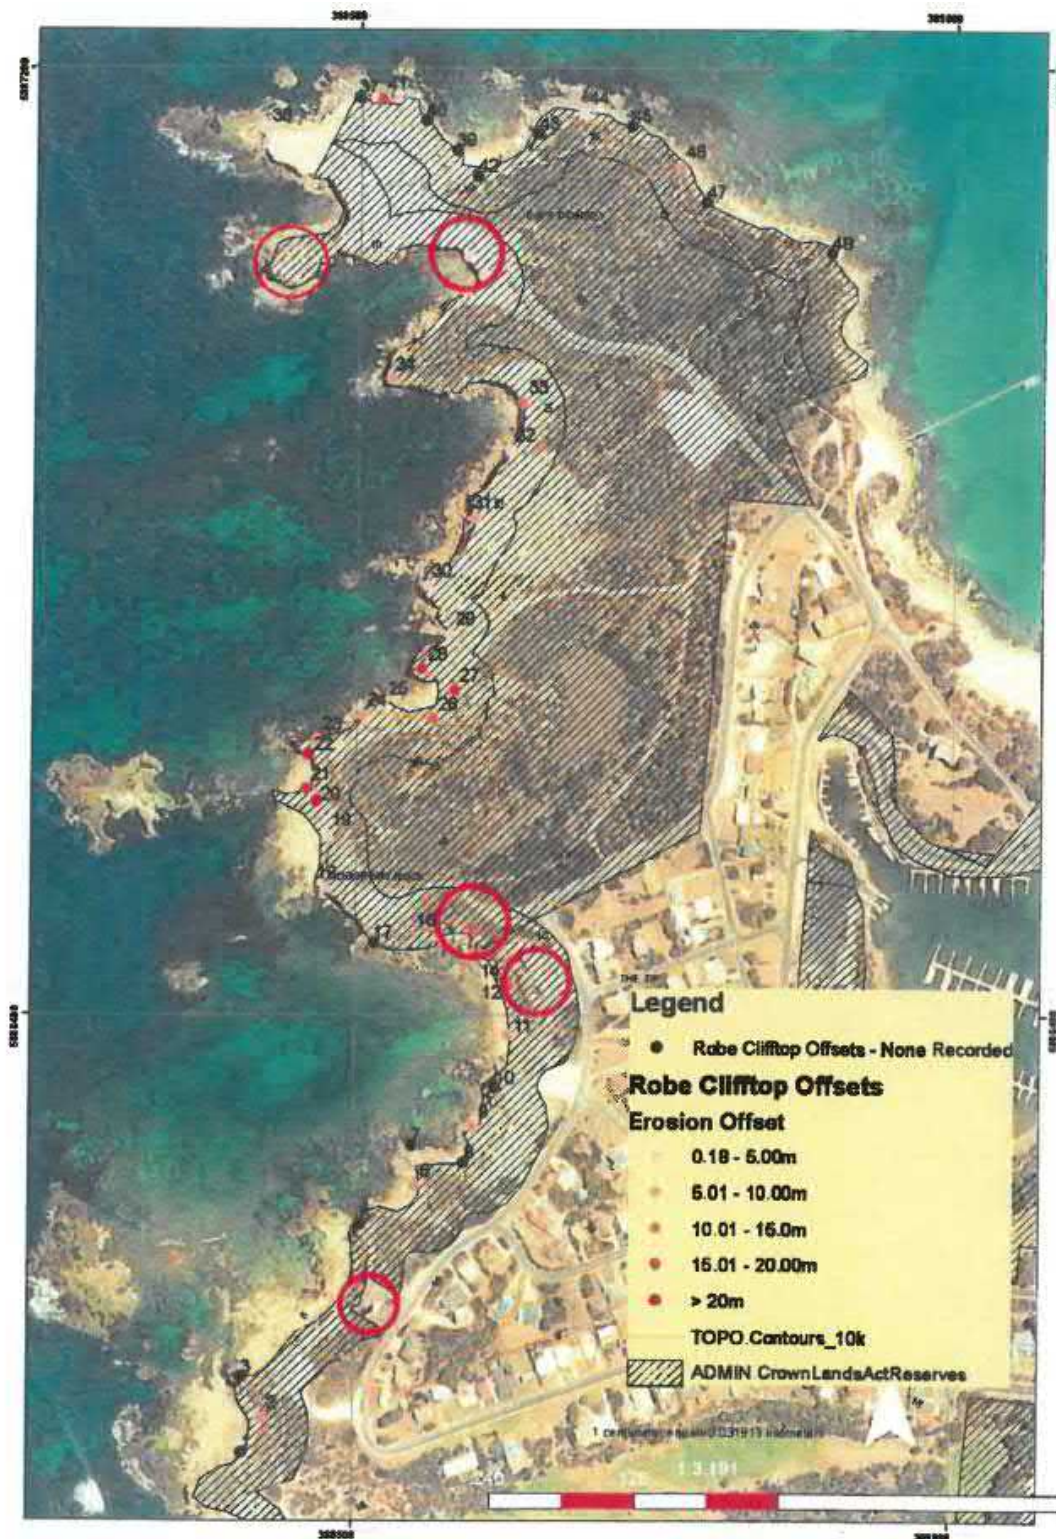
- A comparison of the landform type (Embayment, Promontory, Straight) and Wave Exposure (Exposed, Sheltered) was undertaken to identify the effect that erosion has on each site type with a recommendation that a 30-metre buffer should be planned for along the exposed coast.

**Figure 1** 2008 image showing the 48 sites where the cliff top position was compared. Sites are coloured according the extent of erosion (in metres) that was measured. Black indicates no erosion. The red circles show assets located within the 30 metres risk zone - Fotheringham. D, 2009

- Recommendations;
  - Cliff top edge is to be resurveyed at Cape Dombey to detect change since 1987
  - The cliff top between Robe and long beach is surveyed for future erosion monitoring

- A strategy is developed to manage erosion where assets are at risk
  - That cliff stability and cliff top erosion rates are reassessed at a future date based on the results of a resurvey and sea level rise data.

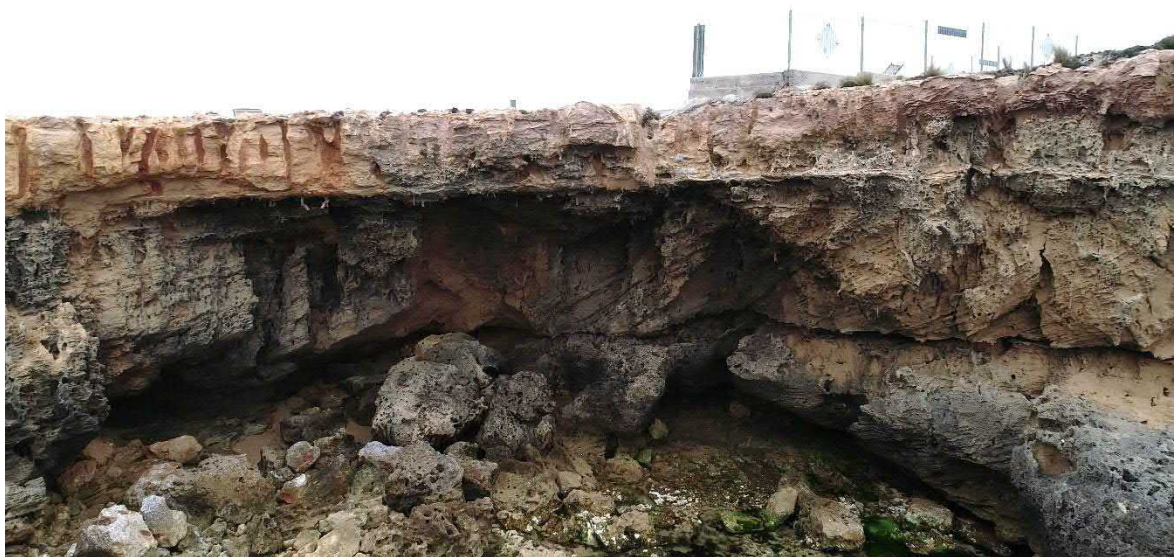
As seen in Figure 2, Figure 3 and Figure 4 the cliffs around the Obelisk car park are undercut. The undercutting is caused by wave and water erosion and will be ongoing. Because the drone requires satellite coverage for navigation, and because its sensors limit how close it can come to solid ground, we were unable to fly below undercut areas to assess how far they extend under the carparks. However, our judgement based on our observations through camera zoom lenses and from the drone flying as close to the undercuts as we judged prudent suggest that they do extend to underlie portions of the carpark. This imagery is documented in Appendix B and C.

We do not know how far the current undercuts extend although we think they may go under the car park. Based on literature the cliff appears to be receding at 1-3cm/year but consideration of photography from 1950 to 2006 indicates that this may be an underestimation.

It is not obvious how fast the undercuts are getting bigger (although we're sure they are) and we don't know how strong the ground is. In combination this means that it is impossible to estimate the risk of cliff collapse to the car park and its users. However, that risk is clearly higher than for a carpark set on solid ground and is clearly increasing over time.

**Figure 2 CH 370 – Obelisk Main Car Park North Side – Undercut of Cliff Face**

Based on the overview provided in Section 2.1.1 and again in regard to discussions with Council on their risk appetite, we recommend that Council controls public access to the present Obelisk carpark.

It might be assumed that the undercut extends 10 m in from the cliff edge at the observed (and video'd/photo'd) location on the northern side of the carpark, and 10 m from the whole of the cliff edge on the southern side. Our observations suggest undercutting for that whole length, but the undercut is so close to the water level along much of it that we cannot know how far back it goes. Where we could look into the 'caves' our observations suggest that the undercut extends more than 5 m behind the cliff face, possibly up to 8 m in places and potentially more.

If it is assumed that the undercut extends 10 m from the cliff face then an exclusion zone could be set out at that distance on the assumption that the failure would probably generate a vertical face in the cliff, consistent with our observations of the cliffs near the Obelisk generally.

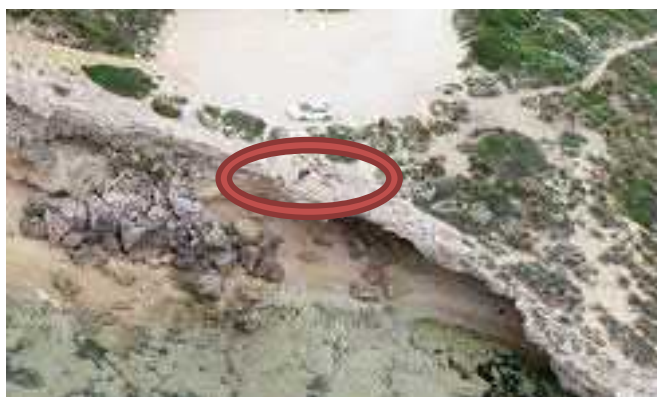
Figure 8 shows an aerial view of the carpark near the southern end of the Coastal Walking Trail. The nearby cliffs are undercut. There are indications (debris heaps) to the north of the existing undercut suggesting the relatively recent collapse of a previously undercut area. As far as we can tell, the existing undercut does not extend below the Southern carpark. However, we estimate the thickness of the rock arch over the existing undercut to be no more than about 1.5 m in places. Sightseers can be observed standing on top of that arch. (Figure 9)

**Figure 9** CH 2250 – Southern Carpark – People Standing on top of undercut Cliff

We recommend that Council take practicable measures to restrict, and if possible prevent, public access to the area of the arch near the Southern carpark. It may also be prudent to install signage describing the inherent risks of accessing the area. At present there would appear to be not justification for closing the carpark, although it would be useful to obtain survey to demonstrate how far the undercutting extends as the footage from this site visit is hard to determine how far this extends.

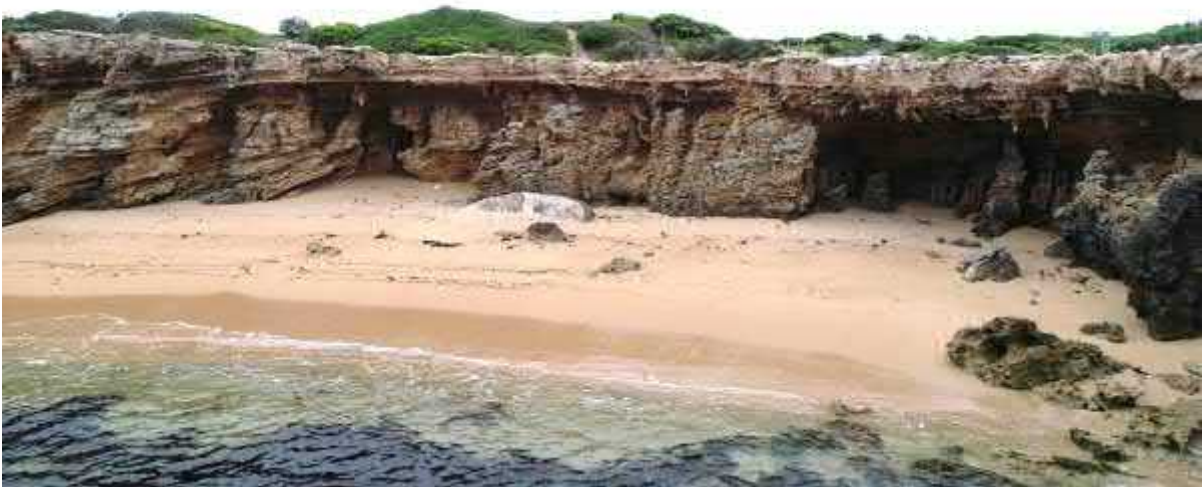
*RZ1\_0 - Cliff Overhang (Right Side) - Chainage 50*

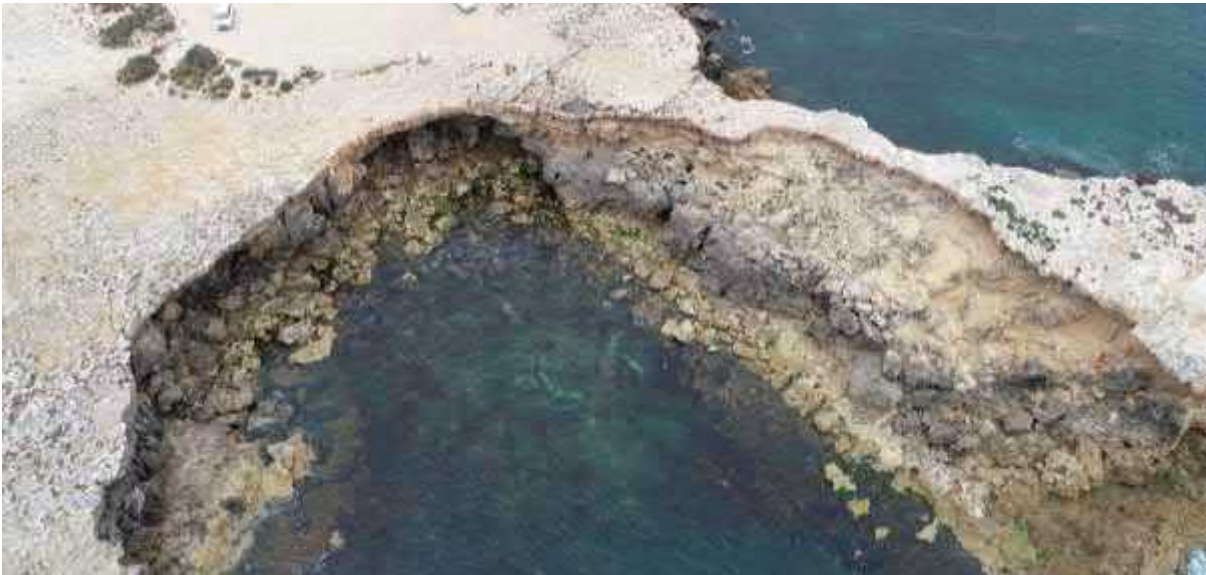
*RZ2\_0 - Obelisk Main Car Park North Side - Chainage 370*

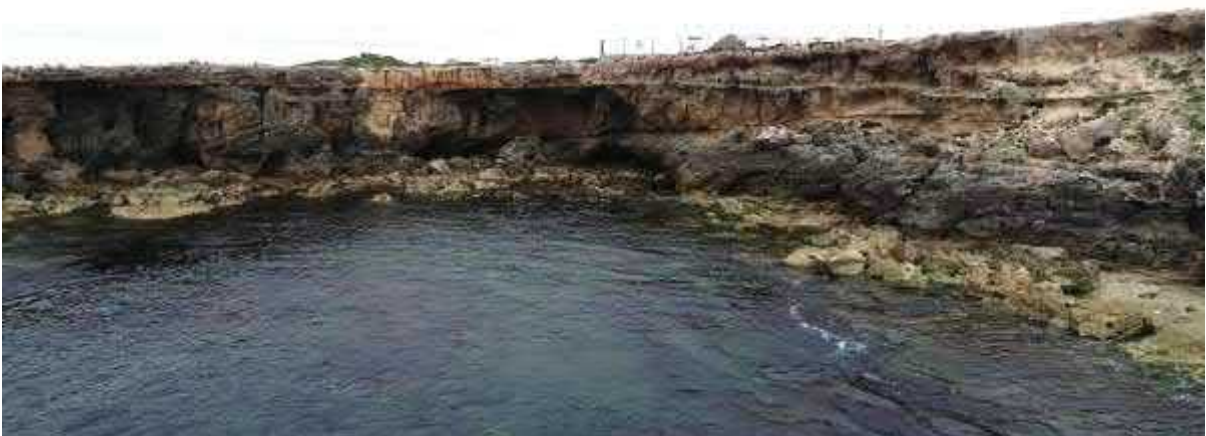
*RZ2\_1 - Obelisk Main Car Park North Side - Chainage 370*

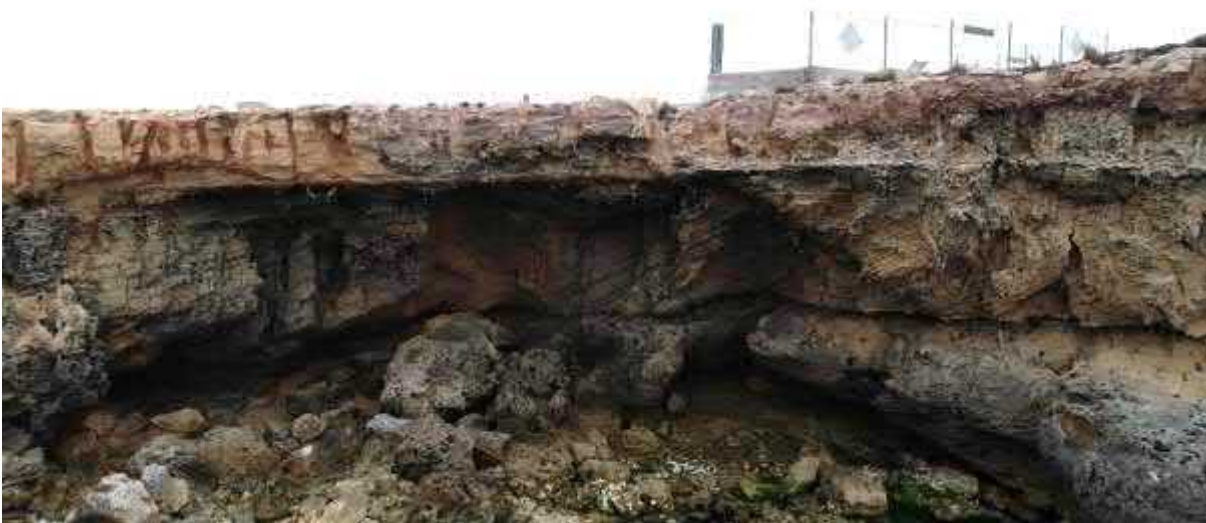
***RZ2\_2 - Obelisk Main Car Park North Side - Chainage 370***

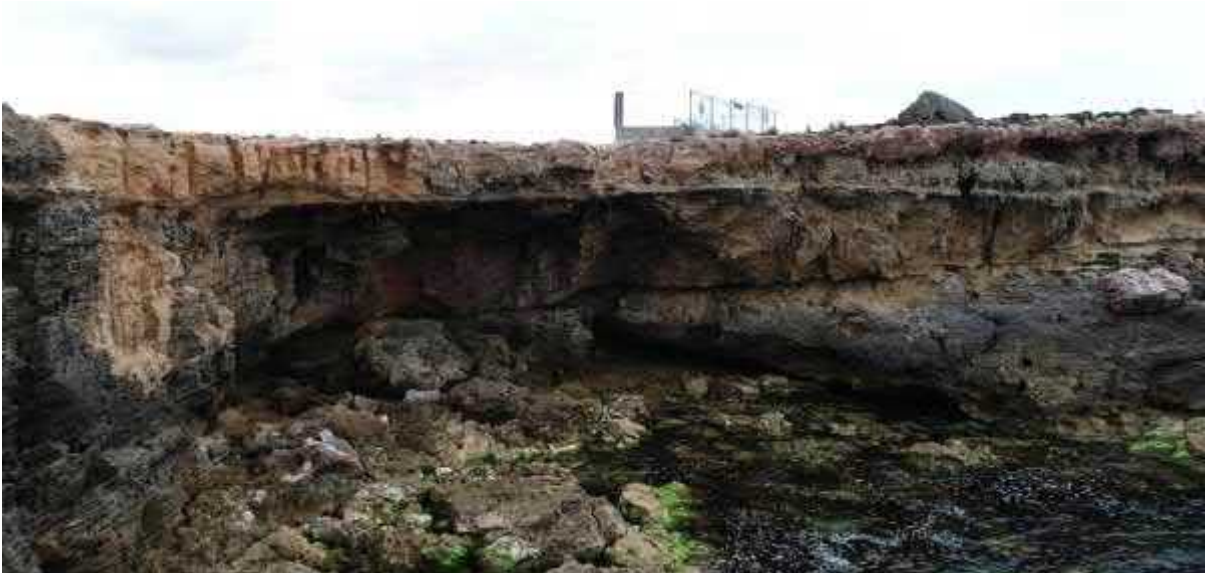
***RZ2\_3 - Obelisk Main Car Park North Side - Chainage 370***

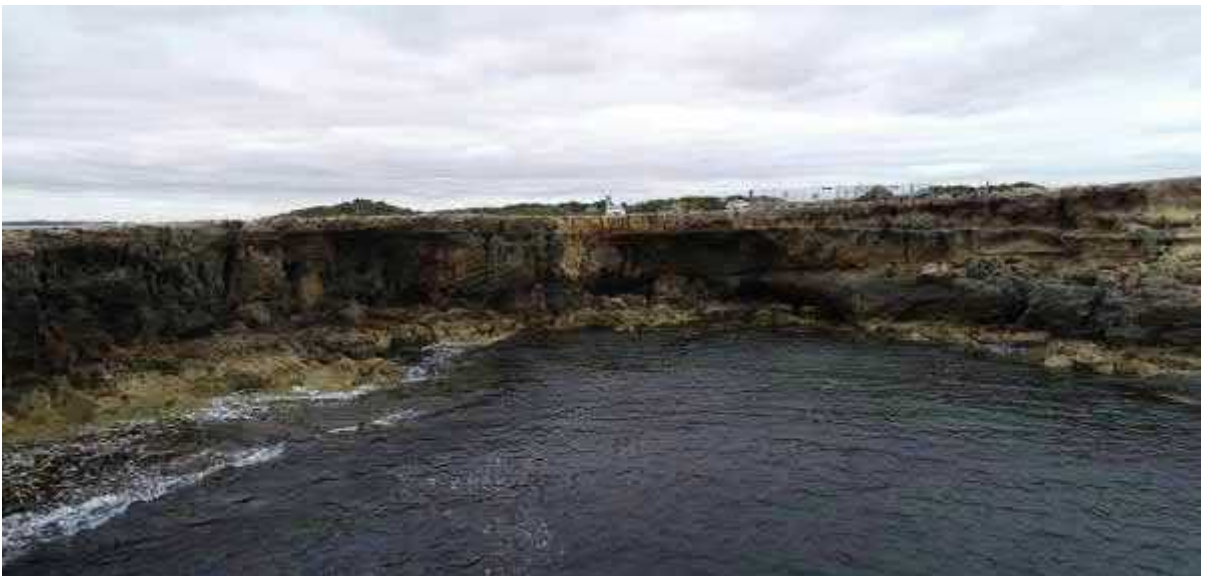
***RZ2\_4 - Obelisk Main Car Park North Side - Chainage 370***

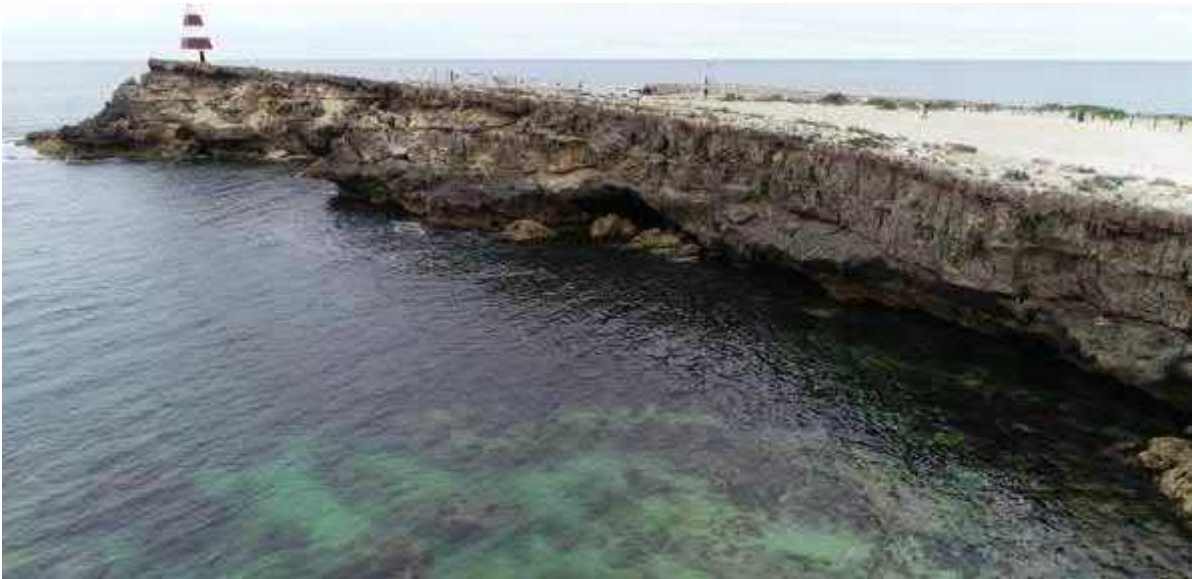
***RZ3\_0 - Obelisk Main Car Park South Side - Chainage 630***

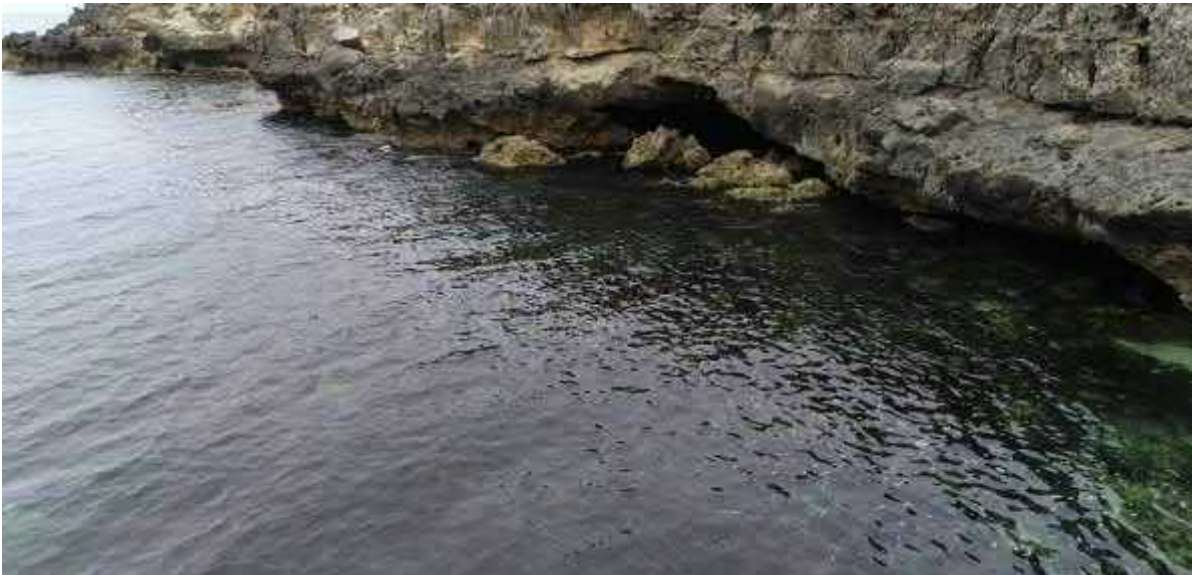
***RZ3\_1 - Obelisk Main Car Park South Side - Chainage 630***

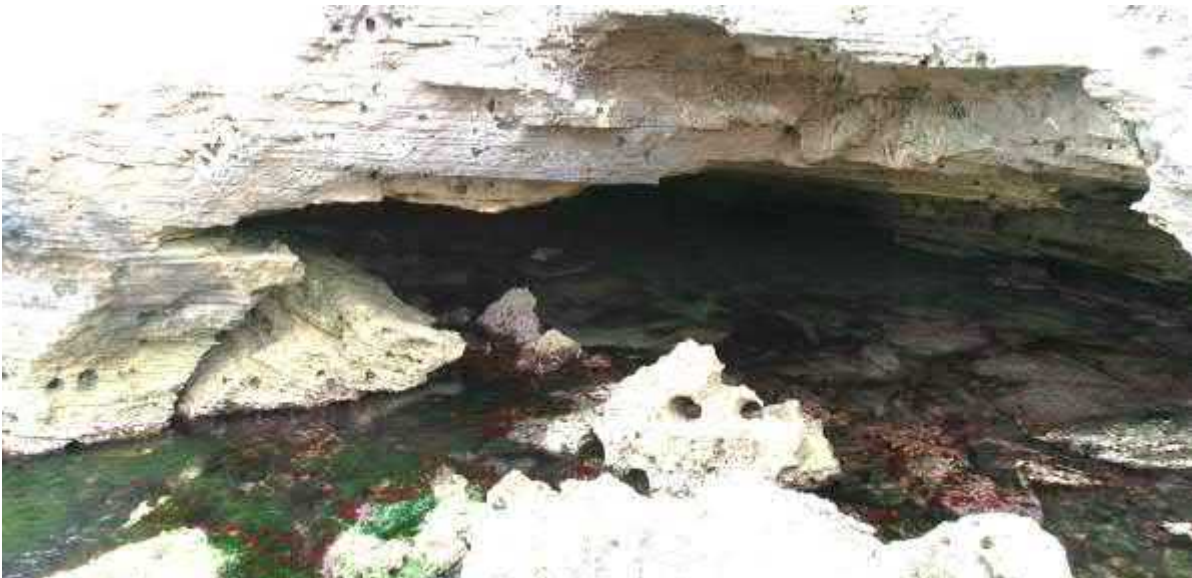
***RZ3\_2 - Obelisk Main Car Park South Side (Adjusted Brightness) - Chainage 630***

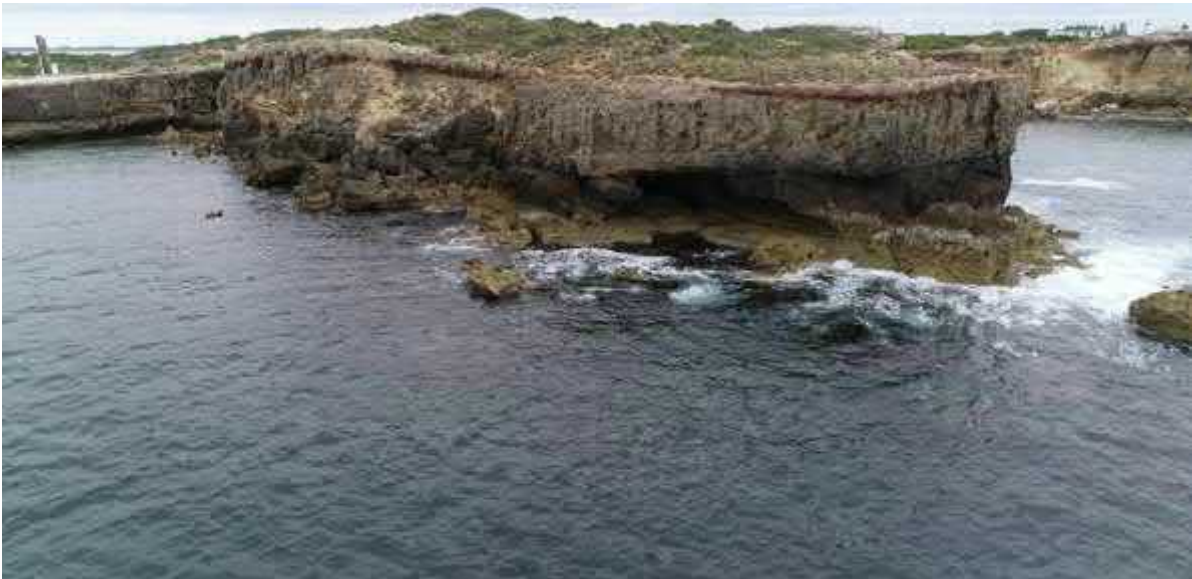
As far as we can tell the undercutting could be underneath the informal walking path documented in Figure 11. It is believed that the risk of collapse will increase as erosion persists at the foundation of the cliff face.

***RZ5\_0 - Cliff Undercutting - Chainage 825***

We suggest that council introduces additional signage at the entrance to the informal walking path as it is a risk that the public will take this walking trail. It is thought that the risk of current collapse is not high but will occur as erosion persists and undercuts the foundation. It should be monitored as the stability over time is compromised.

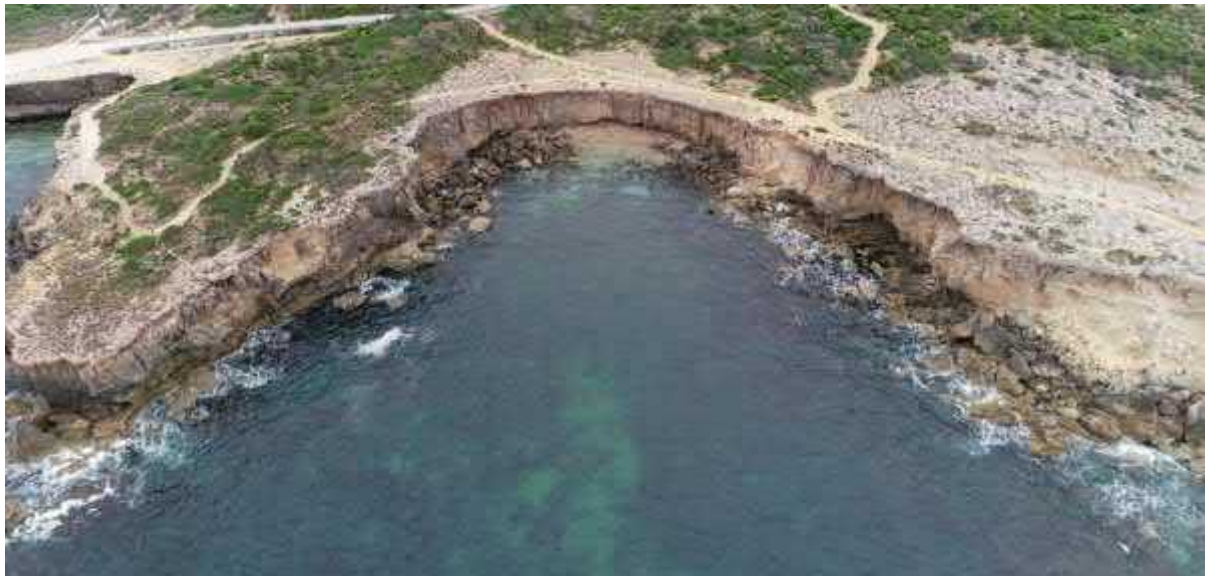
***RZ6\_0 - Cliff Undercutting (Right Side) - Chainage 1000***

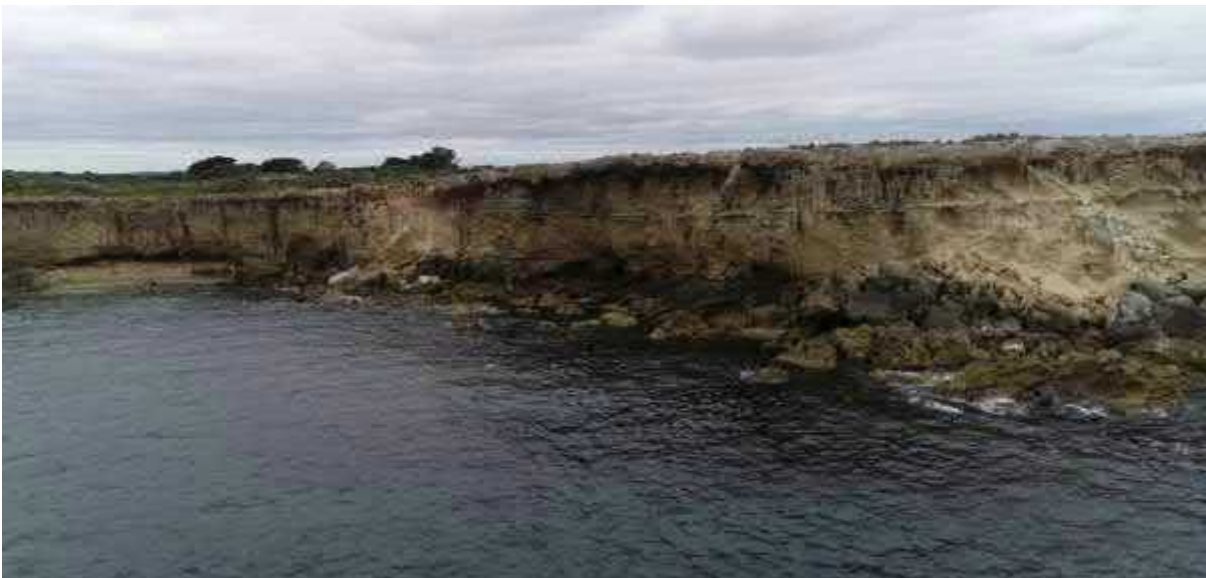
***RZ6\_1 - Cliff Undercutting - Chainage 1000***

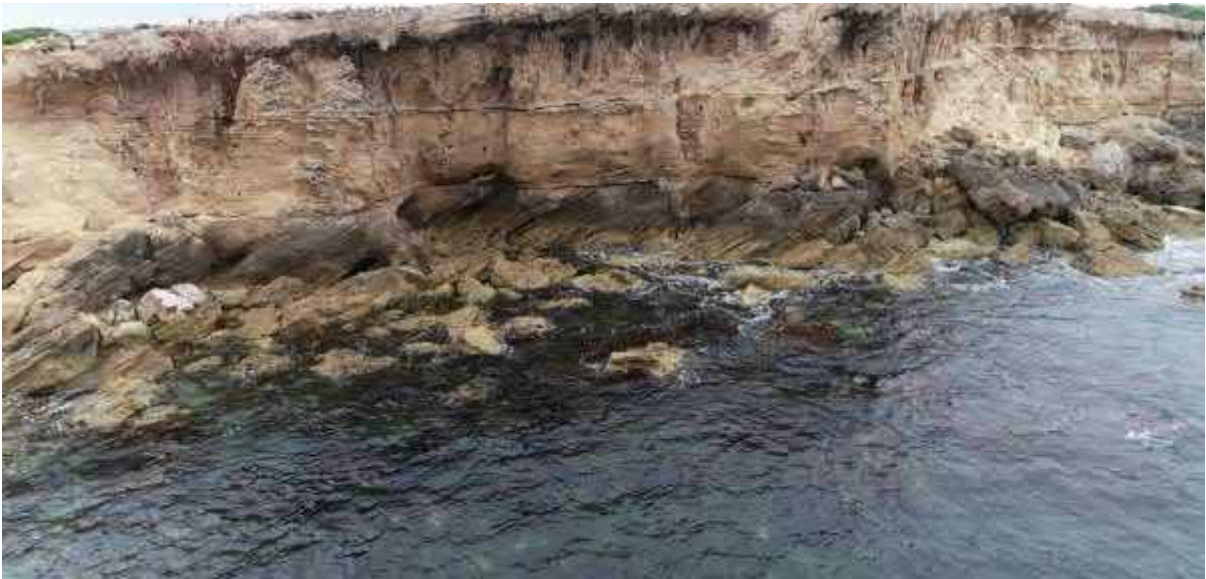
***RZ6\_2 - Cliff Undercutting - Chainage 1000***

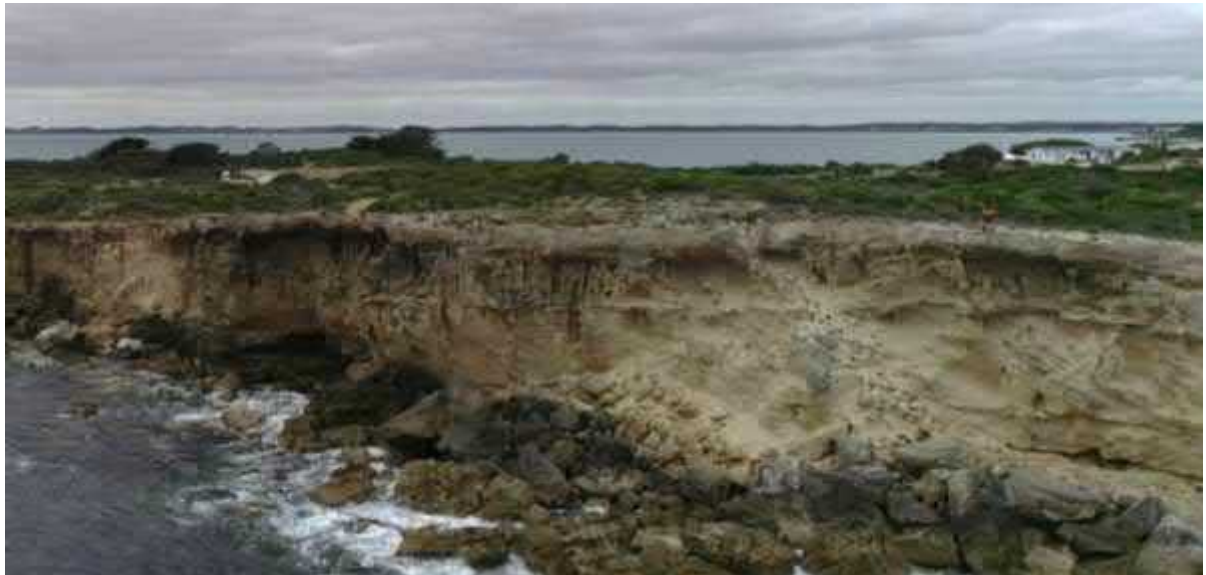
***RZ6\_3 - Cliff Undercutting - Chainage 1000***

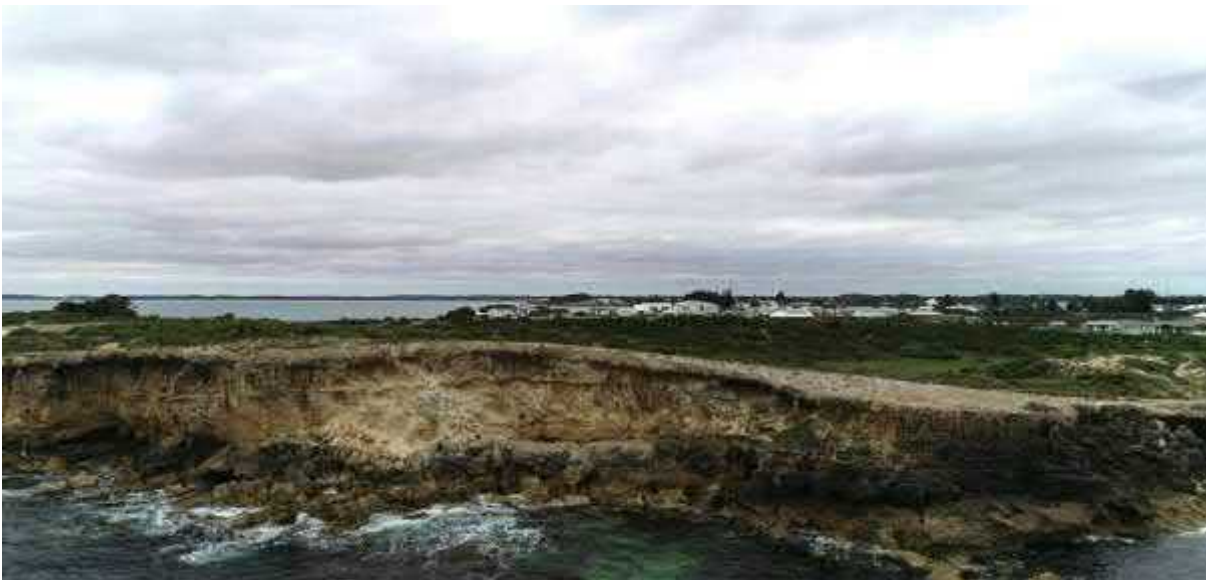
***RZ7\_0 - Cliff Overhang - Chainage 1100***

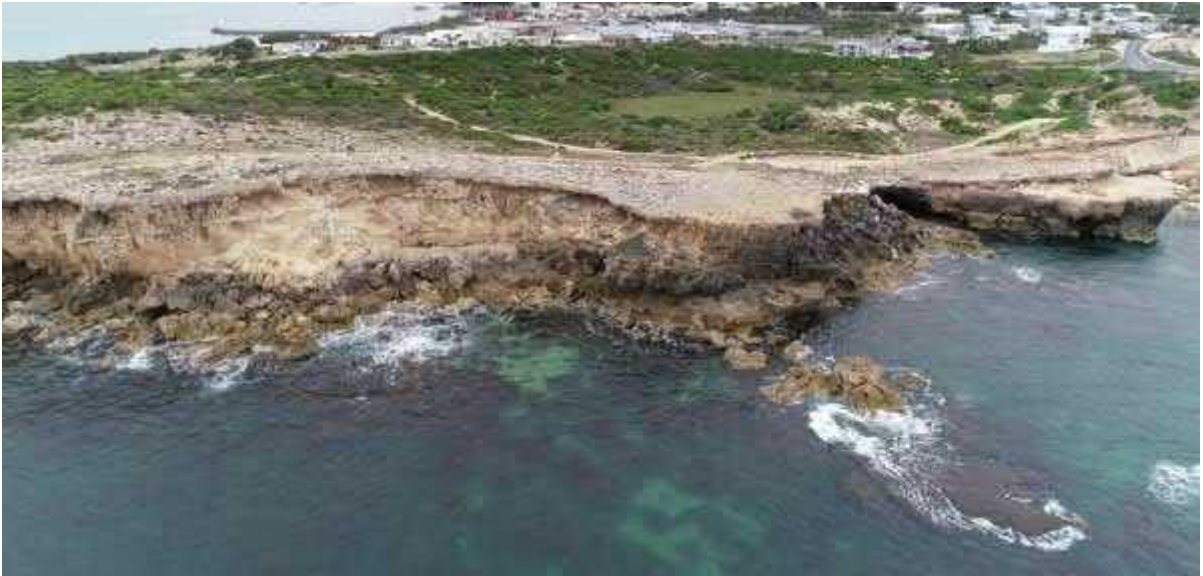
***RZ7\_1 - Cliff Overhang - Chainage 1100***

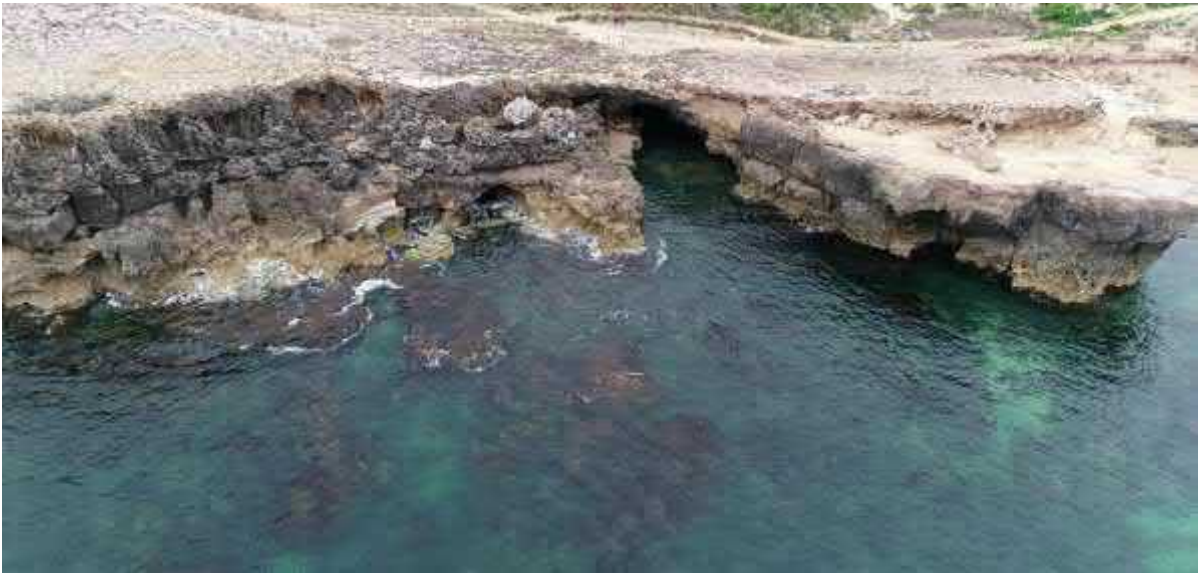
***RZ8\_0 - Blow Hole Undercutting of Cliff Face- Chainage 1200***

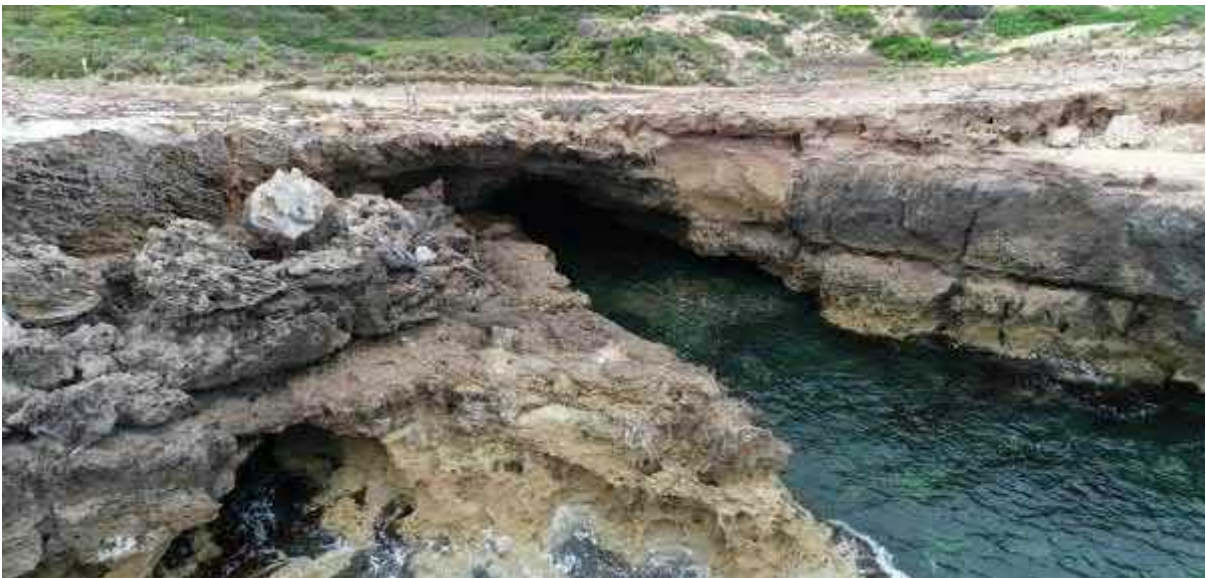
***RZ8\_1 - Blow Hole Undercutting of Cliff Face- Chainage 1200***

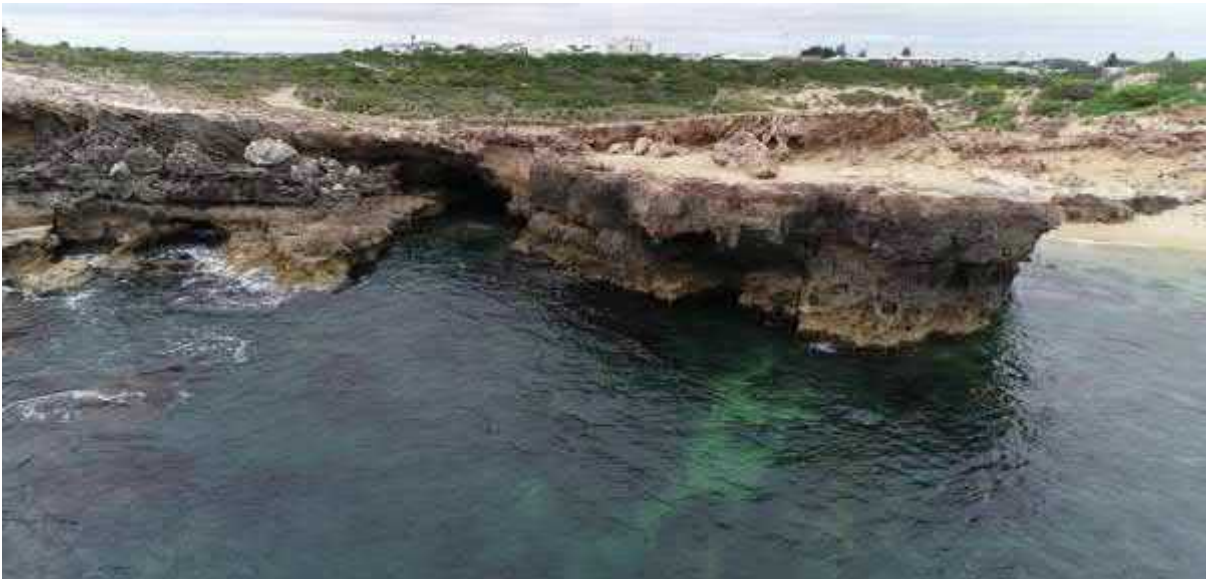
***RZ8\_2 - Blow Hole Undercutting of Cliff Face- Chainage 1200***

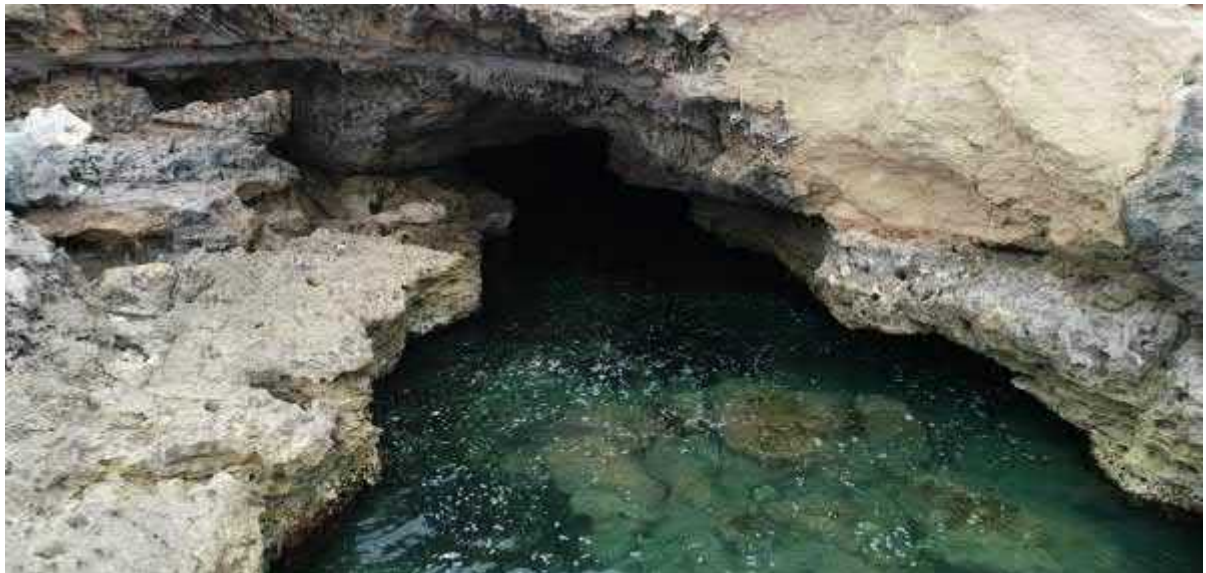
***RZ8\_3 - Blow Hole Undercutting of Cliff Face- Chainage 1200***

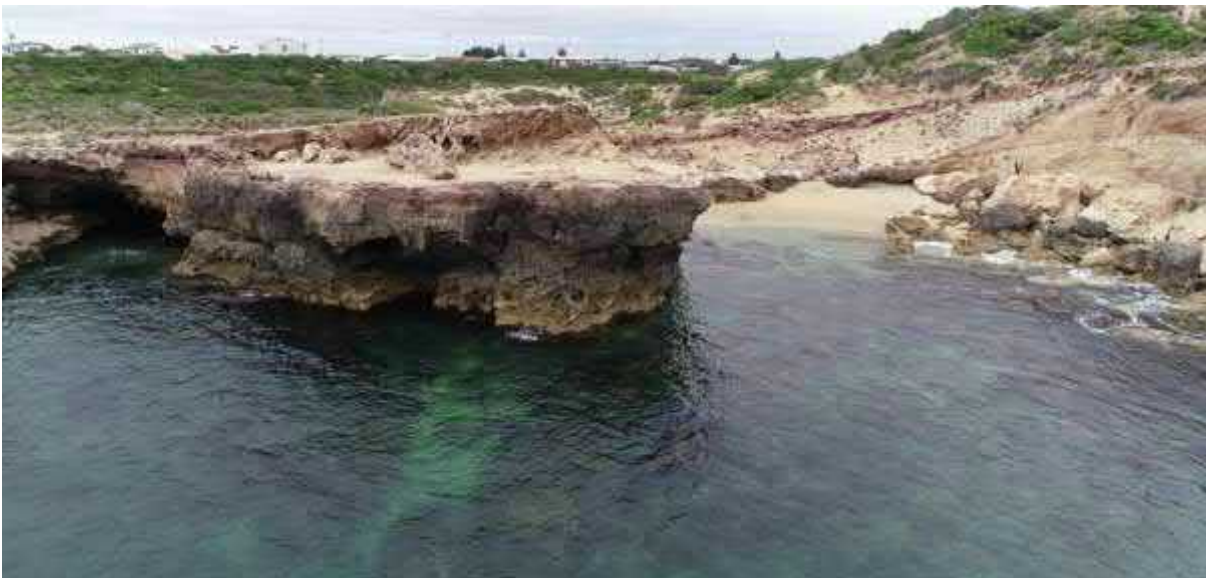
***RZ9 - Undercutting of Cliff - Chainage 1220***

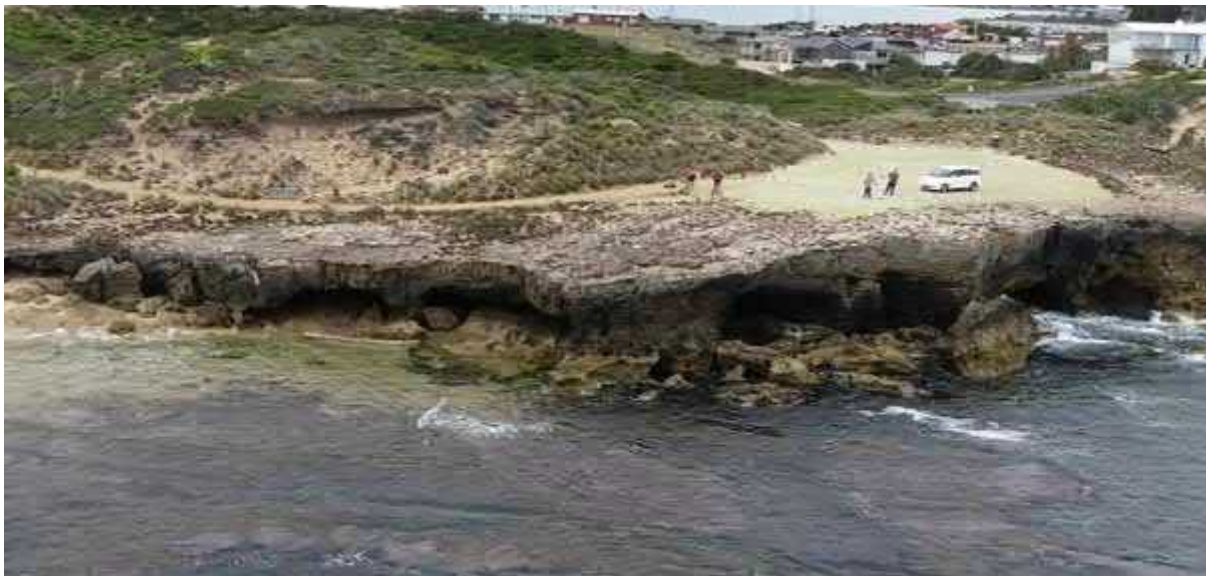
*RZ11 - Undercutting of Cliff (North Side of Carpark) - Car Park 2 - Chainage 1580*

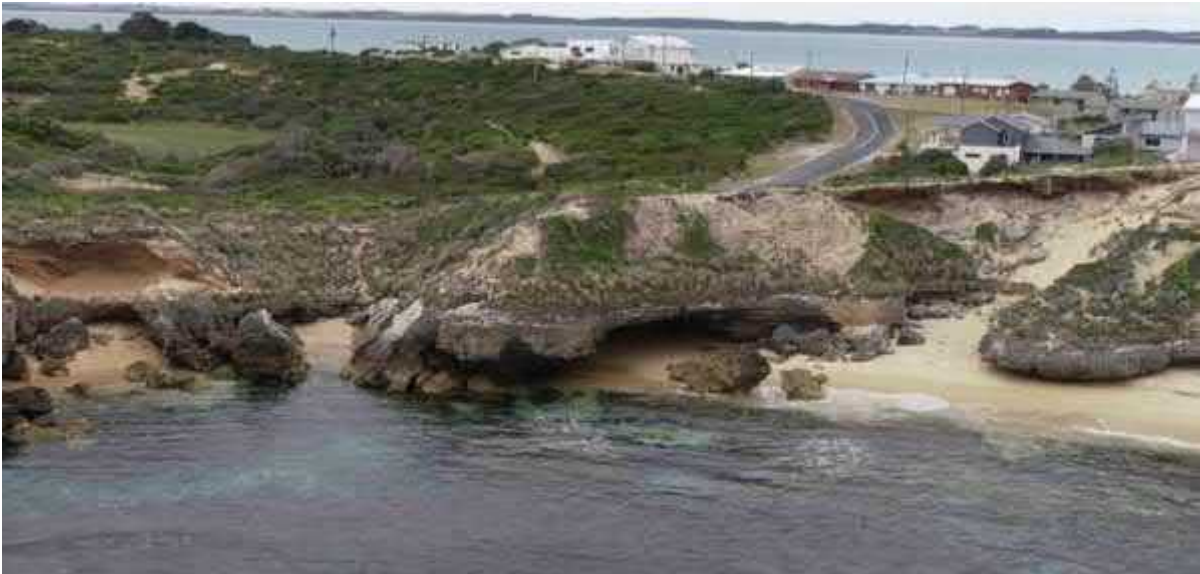
*RZ12\_0 - Undercut of Cliff Face with large soil mass above - Chainage 1750*

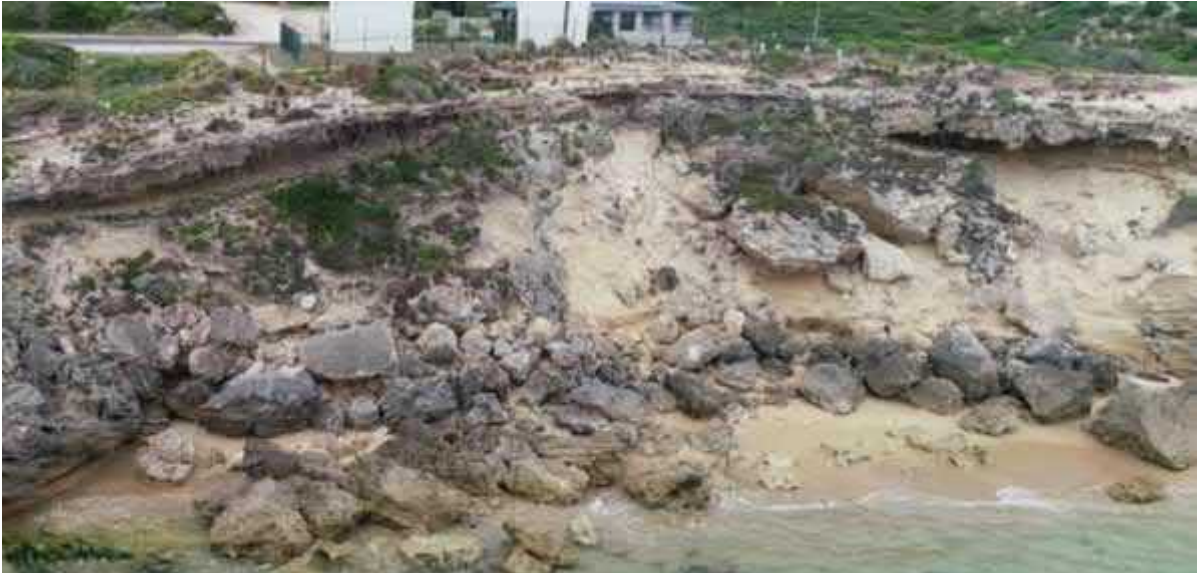
*RZ13\_0 - Overhanging of Cliff Face - Chainage 1900*

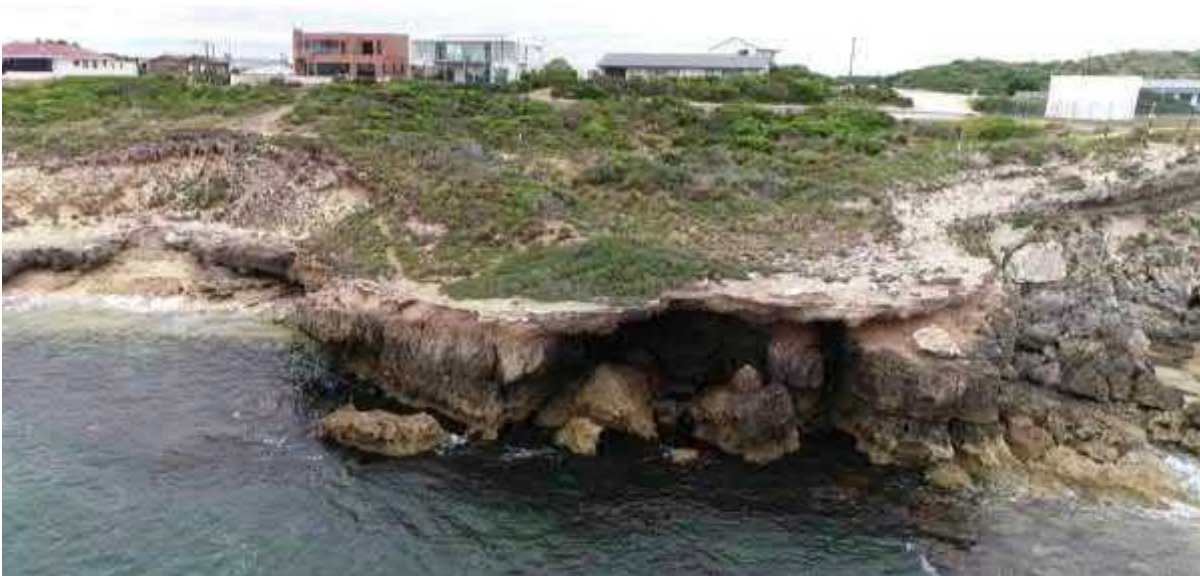
*RZ14\_0 - Undercutting of Cliff - Chainage 2150*

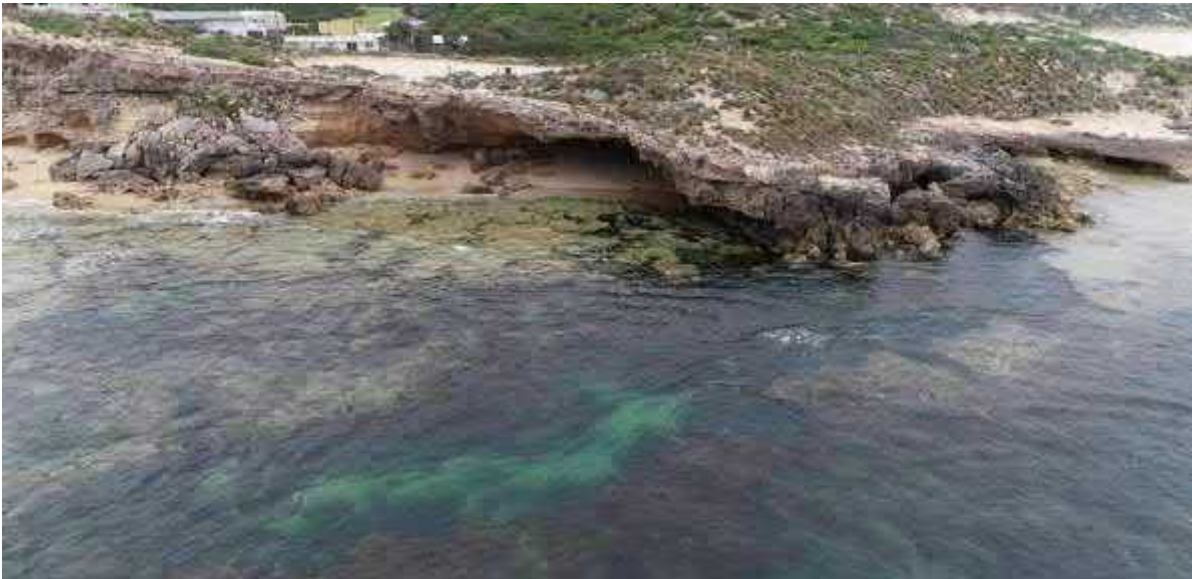
***RZ15\_0 - Obelisk Nature Walk - Southern Carpark - Undercutting of Cliff - Chainage 2250***

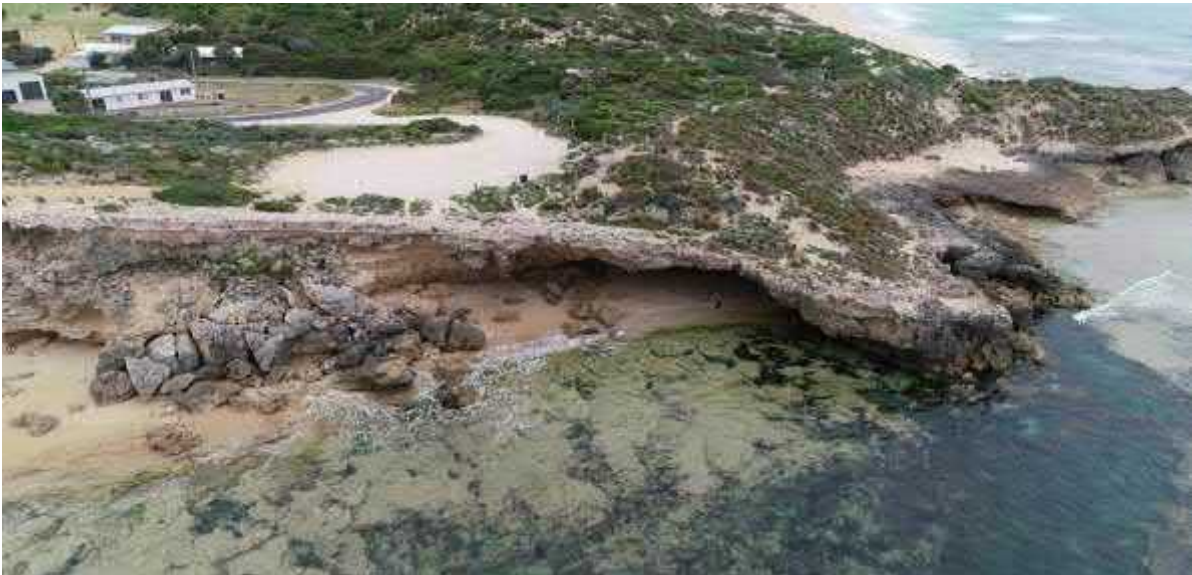
***RZ15\_1 - Obelisk Nature Walk - Southern Carpark - Undercutting of Cliff - Chainage 2250***
