**Robe Obelisk**

## **Landslide Stability Assessment**

**District Council of Robe**

Ref No. 20181771

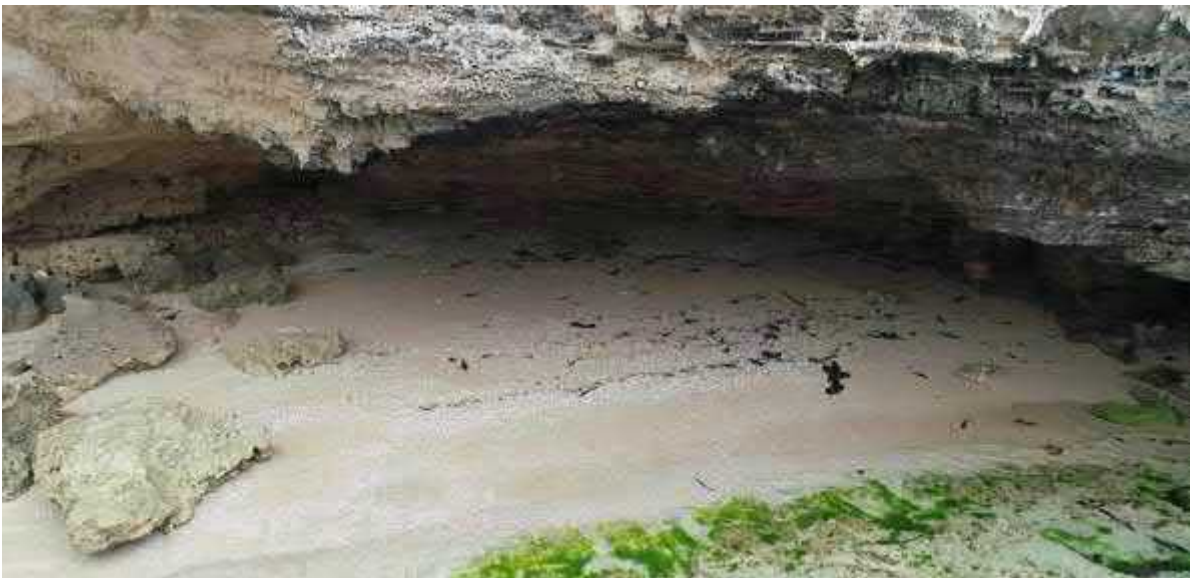
***RZ15\_2 - Obelisk Nature Walk - Southern Carpark - Undercutting of Cliff - Chainage 2250***

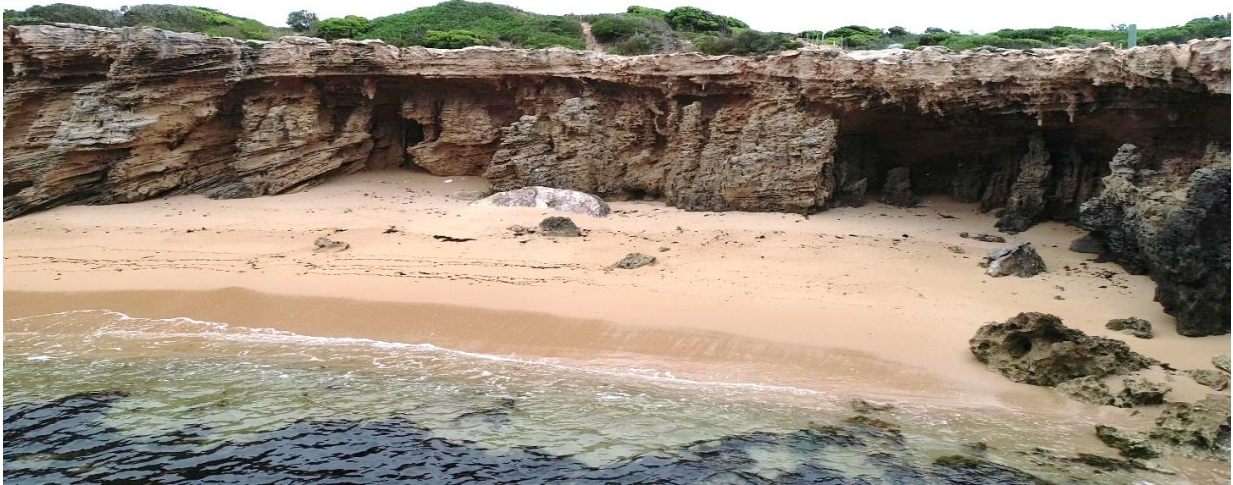
***RZ1\_0 - Cliff Overhang (Right Side) - Chainage 50***

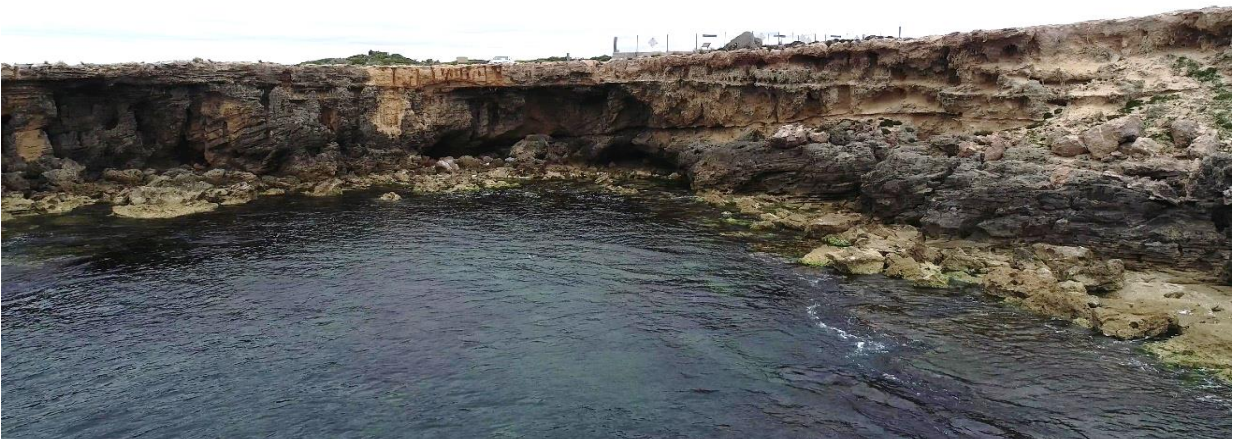
***RZ2\_1 - Obelisk Main Car Park North Side - Chainage 370***

Based on the overview provided in Section 2.1.1 and again in regard to discussions with Council on their risk appetite, we recommend that Council controls public access to the present Obelisk carpark.

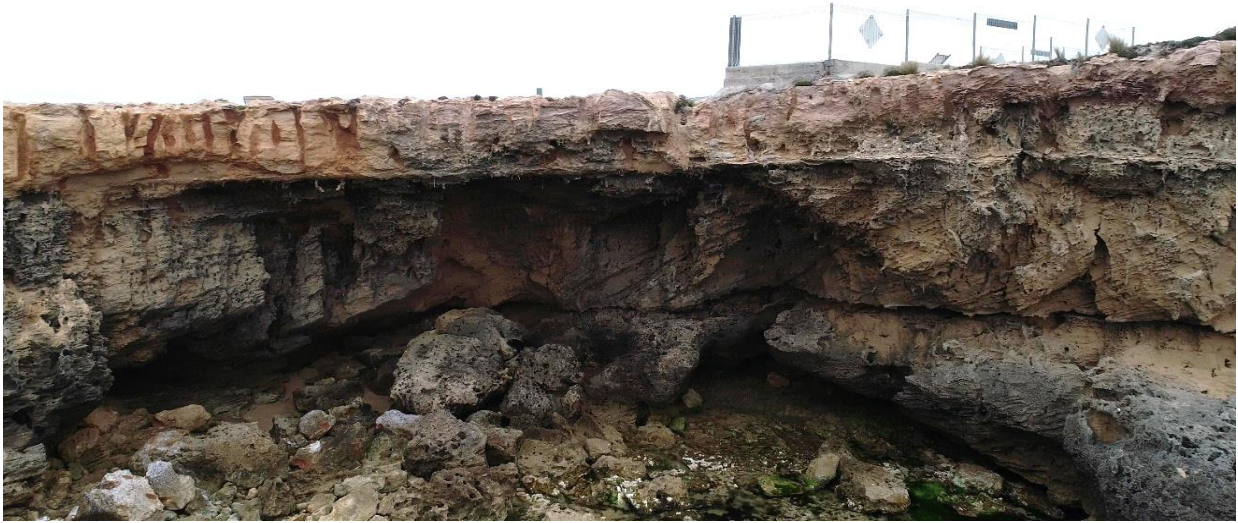
***RZ2\_2 - Obelisk Main Car Park North Side - Chainage 370***

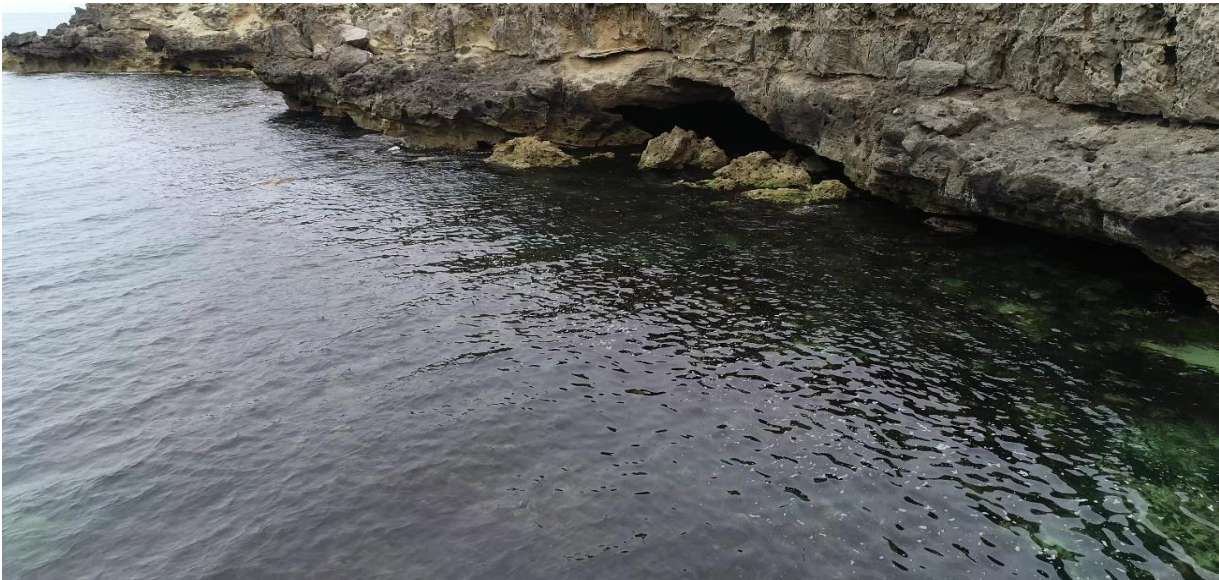
***RZ3\_1 - Obelisk Main Car Park South Side - Chainage 630***

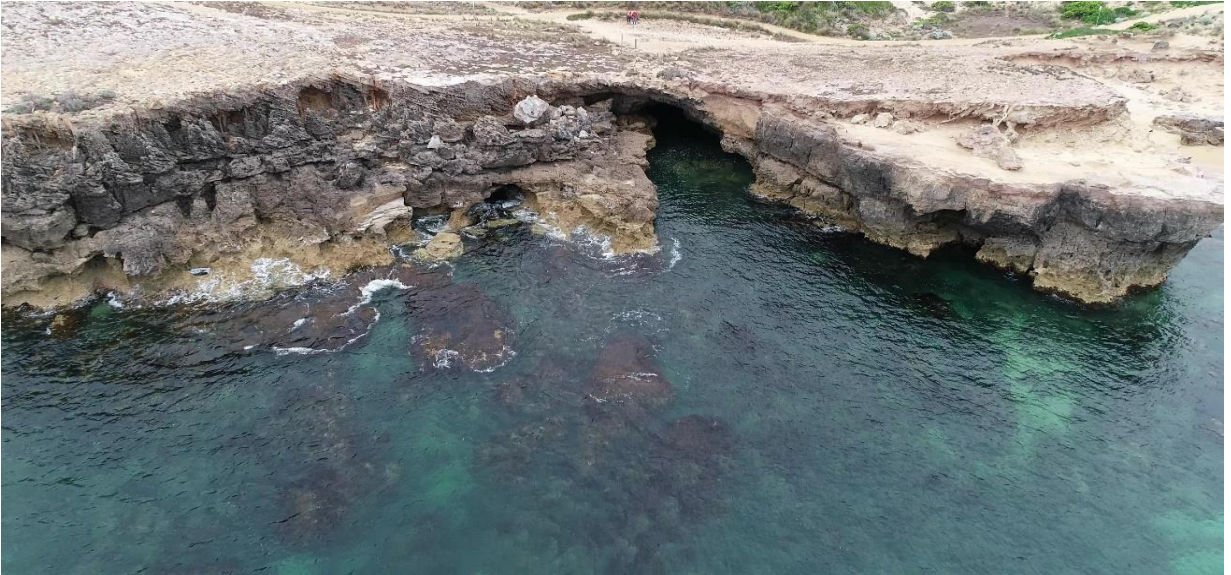
***RZ8\_0 - Blow Hole Undercutting of Cliff Face- Chainage 1200***

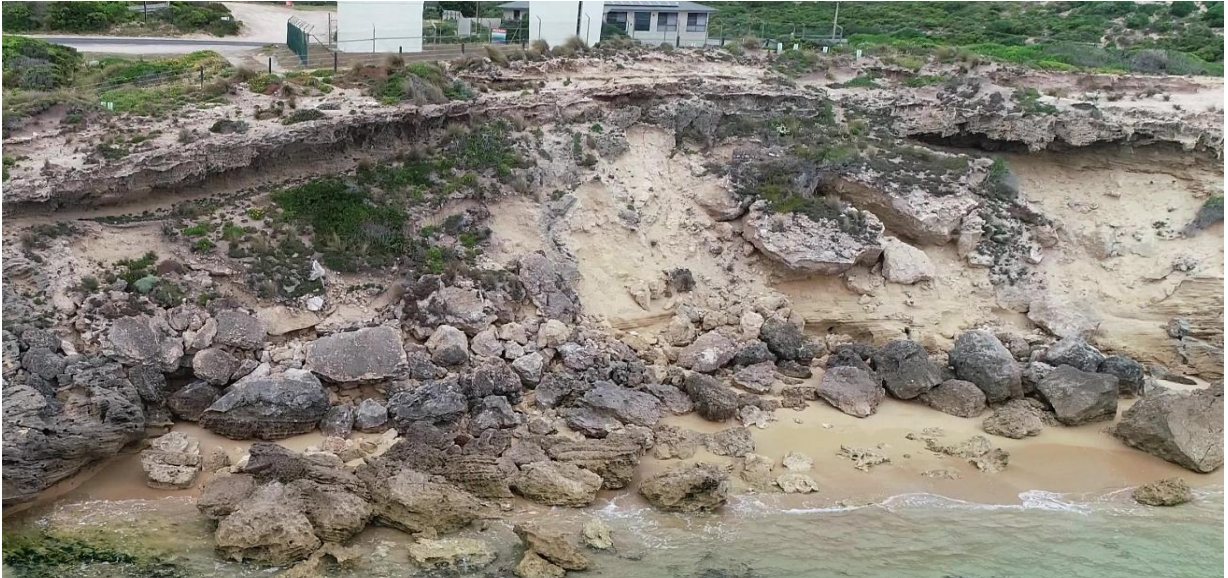
***RZ13\_0 - Overhanging of Cliff Face - Chainage 1900***

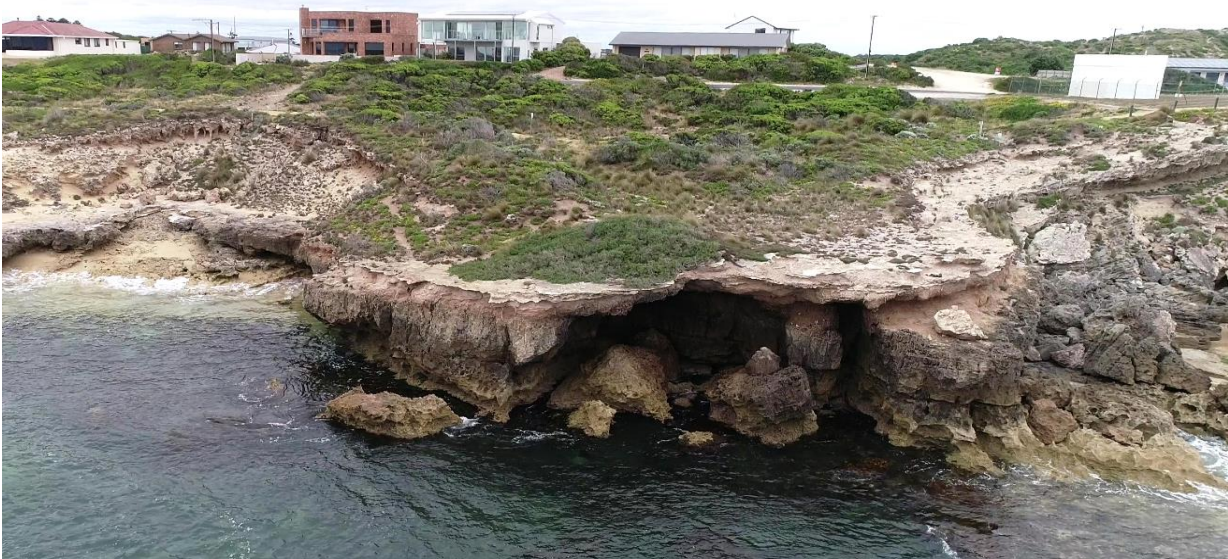
***RZ14\_0 - Undercutting of Cliff - Chainage 2150***

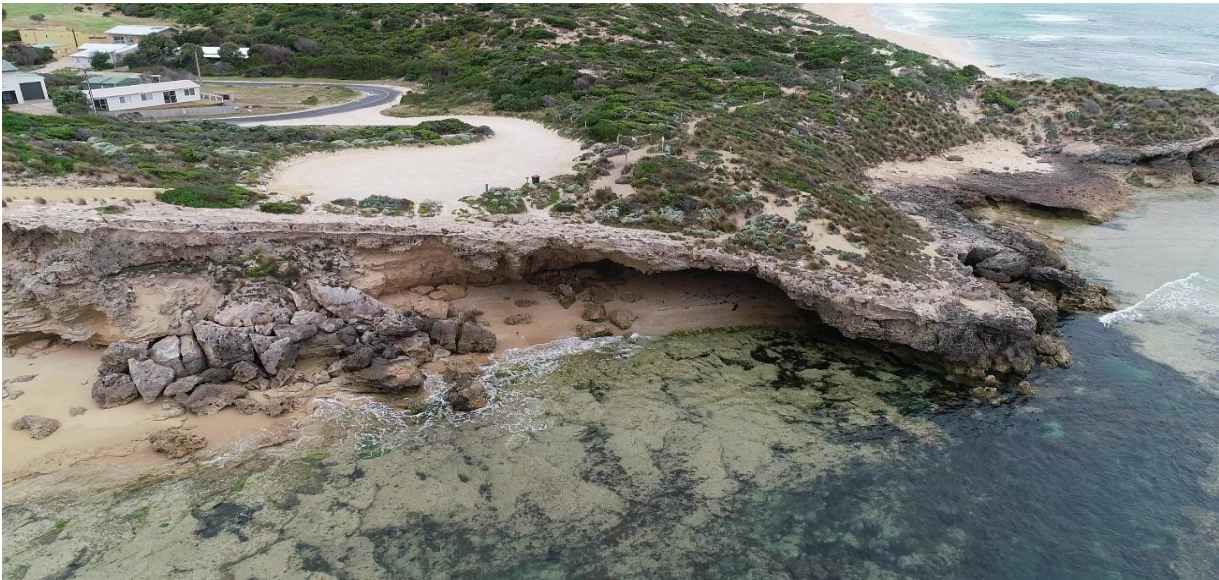
***RZ15\_1 - Obelisk Nature Walk - Southern Carpark - Undercutting of Cliff - Chainage 2250***

We recommend that Council take practicable measures to restrict, and if possible prevent, public access to the area of the arch near the Southern carpark. It may also be prudent to install signage describing the inherent risks of accessing the area. At present there would appear to be not justification for closing the carpark, although it would be useful to obtain survey to demonstrate how far the undercutting extends as the footage from this site visit is hard to determine how far this extends.
