Robe Coastline Monitoring Roadmap

Prepared for the
Robe District Council
July 2020

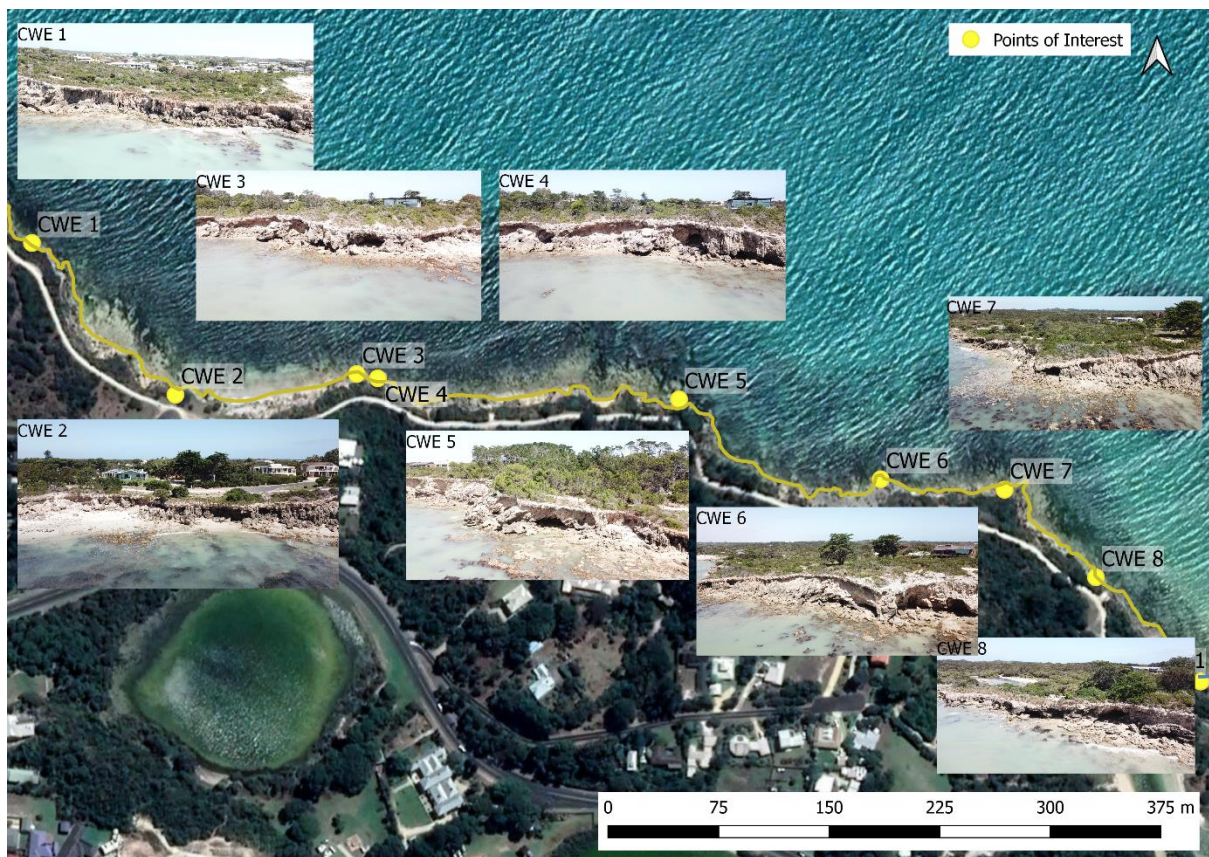
Figure 5: Points of interest (POIs) along the Coastal Walk South coastal unit

Coastal Unit	Coastal Walk East
Minimum Monitoring	Level 2
Monitoring Purpose	<p>To confirm the extent of the area at risk due to failure of the undercut feature near the end of McIntyre St, and define exclusion zone for public access if necessary.</p> <p>To improve estimation of likelihood of failure/erosion events and identify changes that may require management action.</p>
Monitoring Program & Actions	
<i>3D survey</i>	<p>A detailed survey to allow the quantitative geotechnical analysis of likelihood and potential extent of failure associated with the undercut adjacent to McIntyre St.</p> <p>Extent: measurement of the extent of the large cavity at McIntyre St turning area to establish the length, depth and extent of the specific undercut features for risk assessment, Point of Interest CW2 (Figure 5).</p> <p>Frequency: initial one-off to inform failure analysis and risk assessment.</p> <p>Resources: Commercial contract.</p>

Immediate Actions	<p>Installation of warning signs along coastal walk for cliff hazard and failure</p> <p>Installation of fencing at McIntyre St turning area to limit access to the cliff edge.</p>

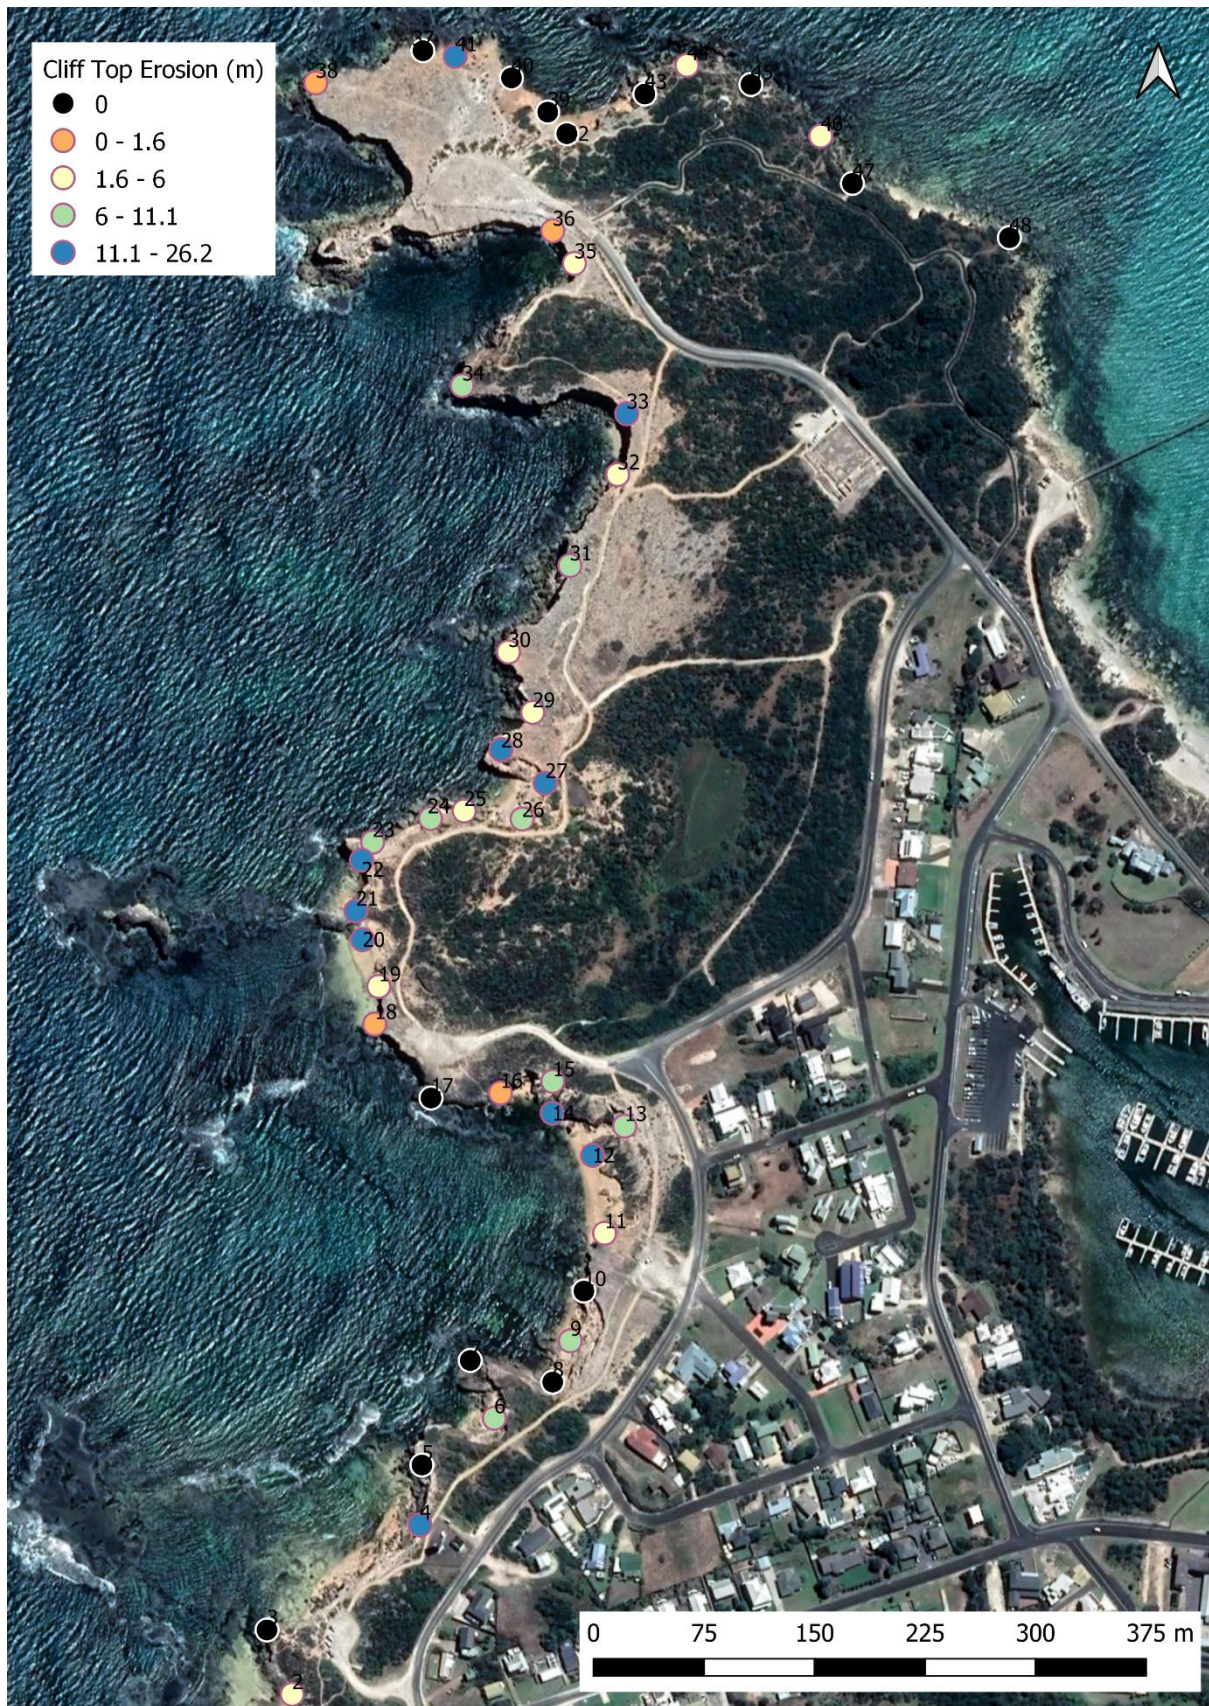
Figure 5: Measured cliff top erosion between 1986 and 1987 (Fotheringham, 2009)

Fotheringham (2009) provides a quantitative comparison between the cliff line at Cape Dombey from an 1896 survey and a repeat survey in 1987. The measured erosion of the cliff line at different locations is shown in Figure 5. The numbers refer to the measurement sites in Table 1 of Fotheringham (2009). The locations are indicative, the spatial references for each measurement location have been requested from DEW.

These measurements provide an indication of the long-term rate of change of the cliff line, with a maximum recession rate of 0.26m/year. As the author notes, it is important to consider the landform characteristics (embayment, promontory, straight) and wave exposure and the wide variation in erosion rates reflects these differences along with the variable resistance of the rock material. The presence of a reef at the base of the cliff also provides local protection and reduces the wave impacts at the toe.

The highest erosion rates were noted at sites 20 and 22, near Doorway Rock.

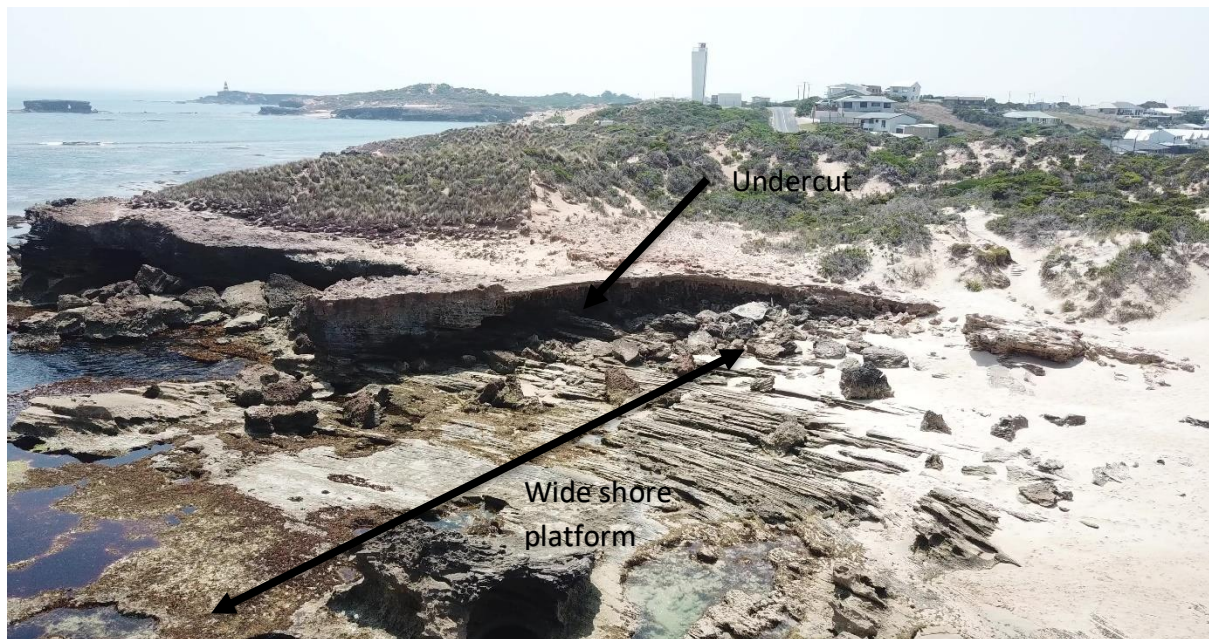
Figure 10: Example of shore platform and undercut cliffs

Figure 11 shows the location of a recent failure of sections of overhanging calcrete adjacent to the southern carpark. The height of the overhangs is around 6-7m above the beach below. Unfortunately, the dimensions of the failure blocks cannot be determined from the imagery.

The undercut extends some distance beneath the cliff edge and Tonkin (2018) estimated it could extend towards as far as the carpark although the exact extent is unknown. The recent failure confirms the weakness of thin remaining calcrete layer and the significant erosion hazard at this location.

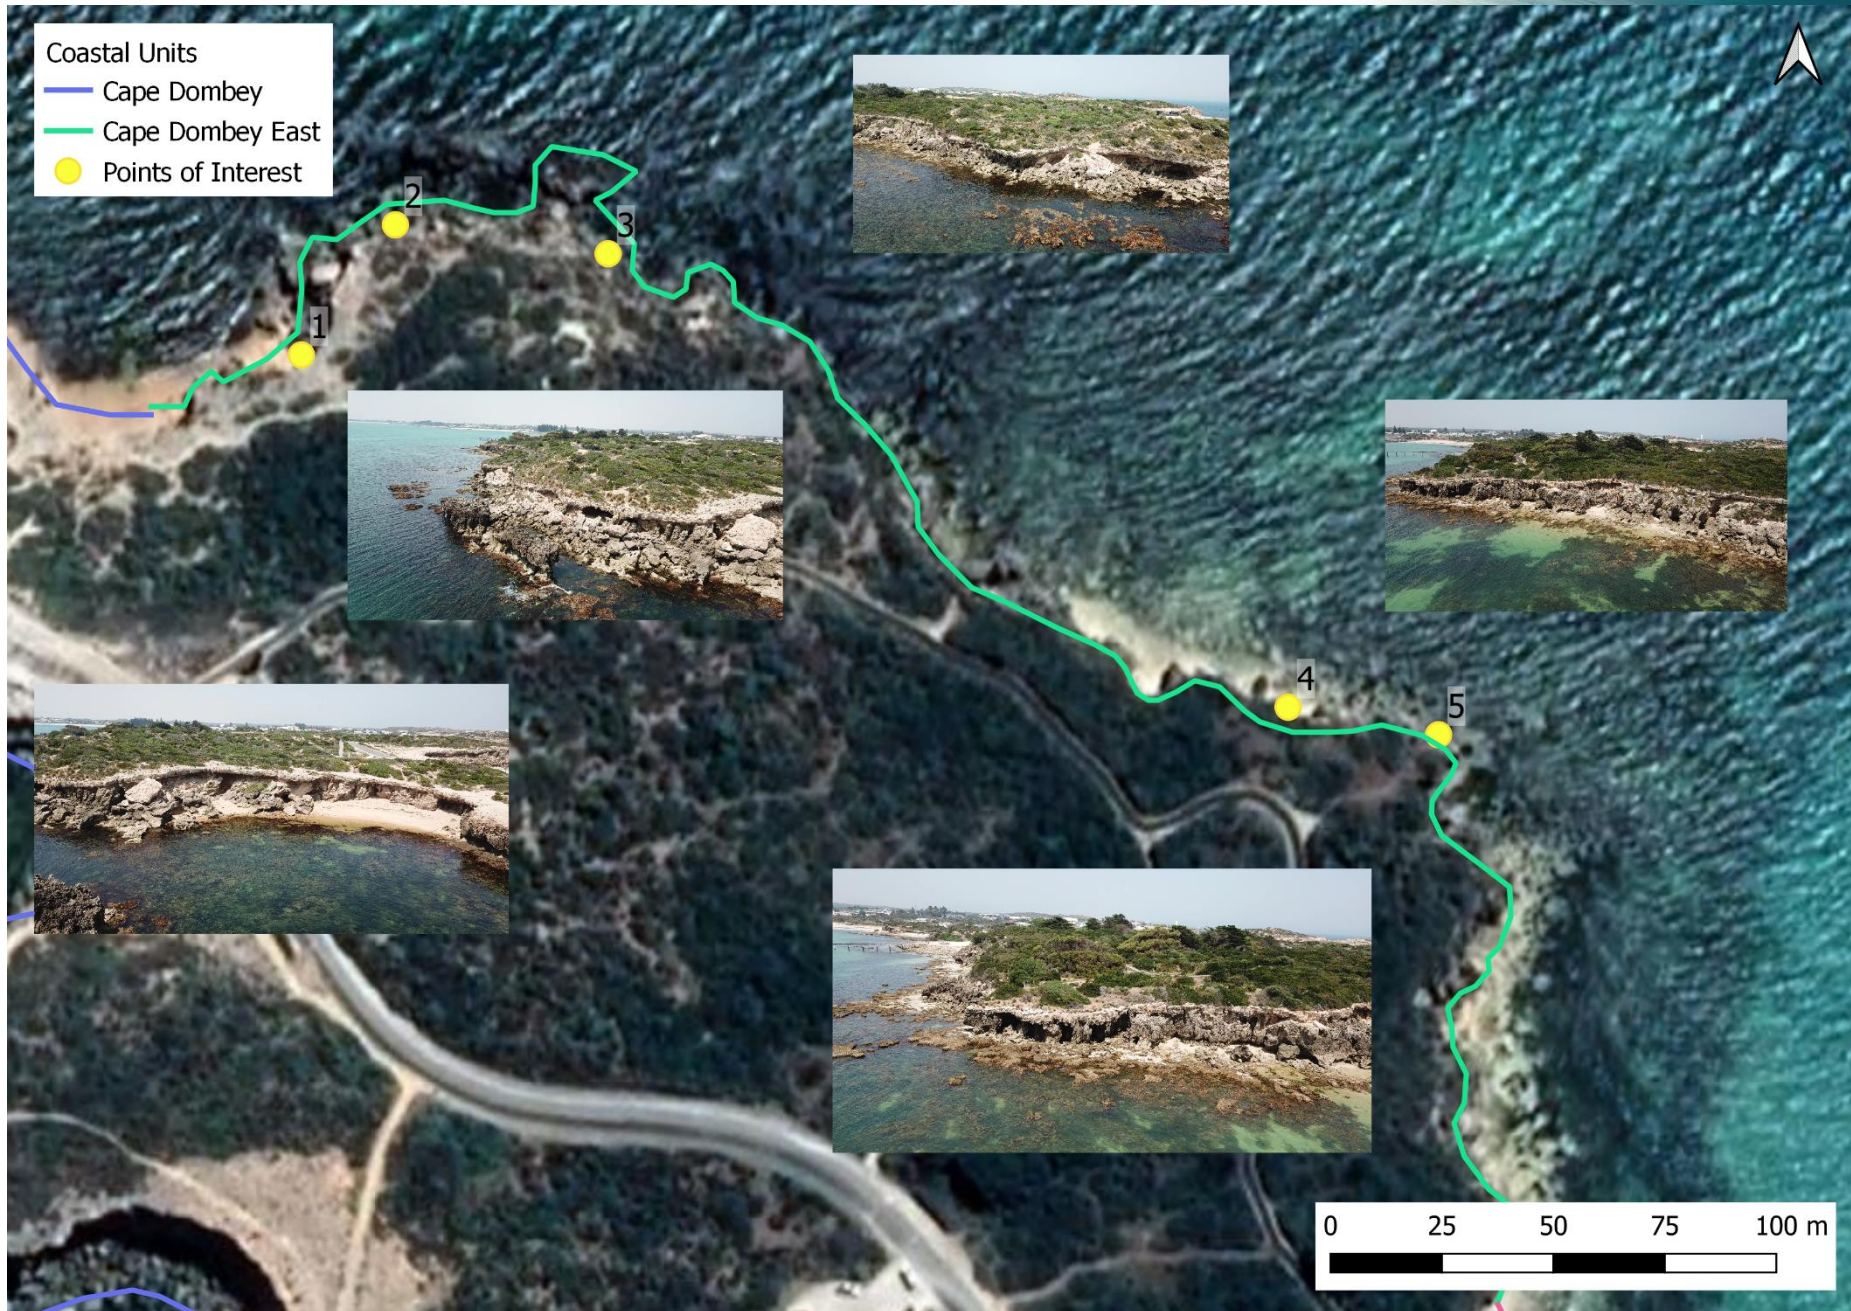
Figure 18: Points of interest Cape Dombey East coastal unit

Five points of interest were identified from the drone imagery, as shown in Figure 29. These are locations where there is cave or an undercut feature that may be in the vicinity of an access track (formal or informal), although they are generally > 10m away.

These locations provide reference points for comparison with future drone survey to provide information on the frequency of failures.

Additional warning signage would be warranted along the coastal walk to encourage walkers to remain on the path and avoid walking near the cliff edge.

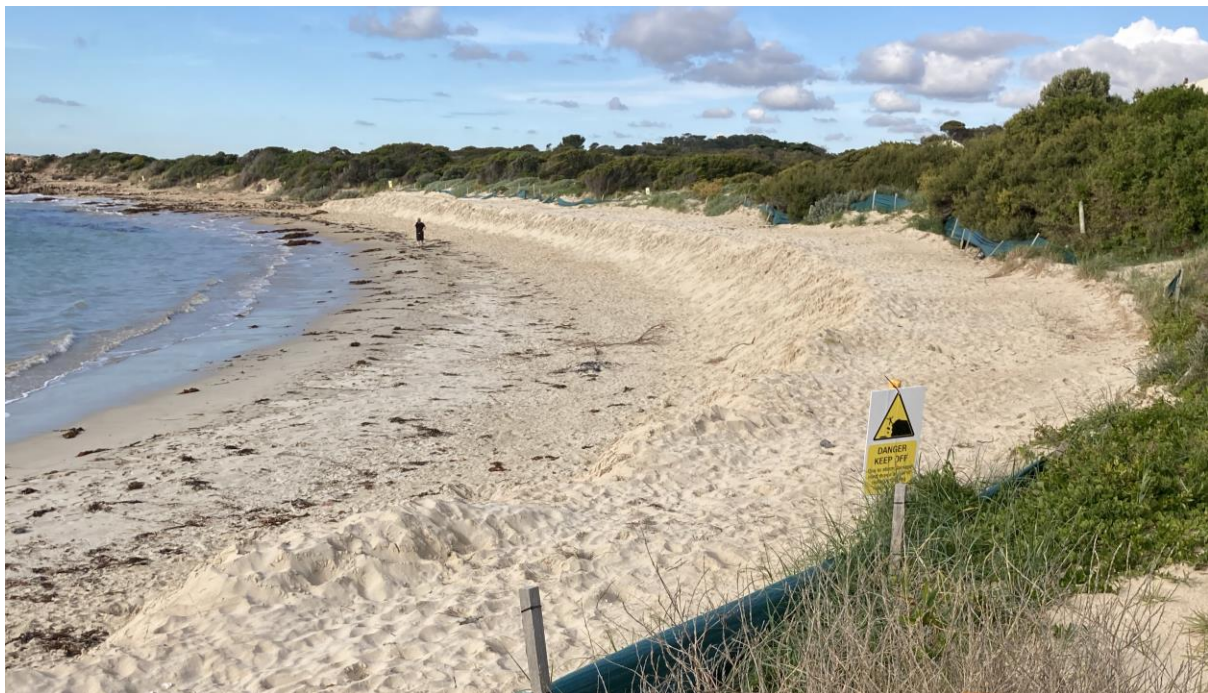
Beach nourishment was undertaken in June 2020 to increase the available sand buffer, Figure 27.

Figure 27: View looking east along Hoopers Beach showing the June 2020 renourishment

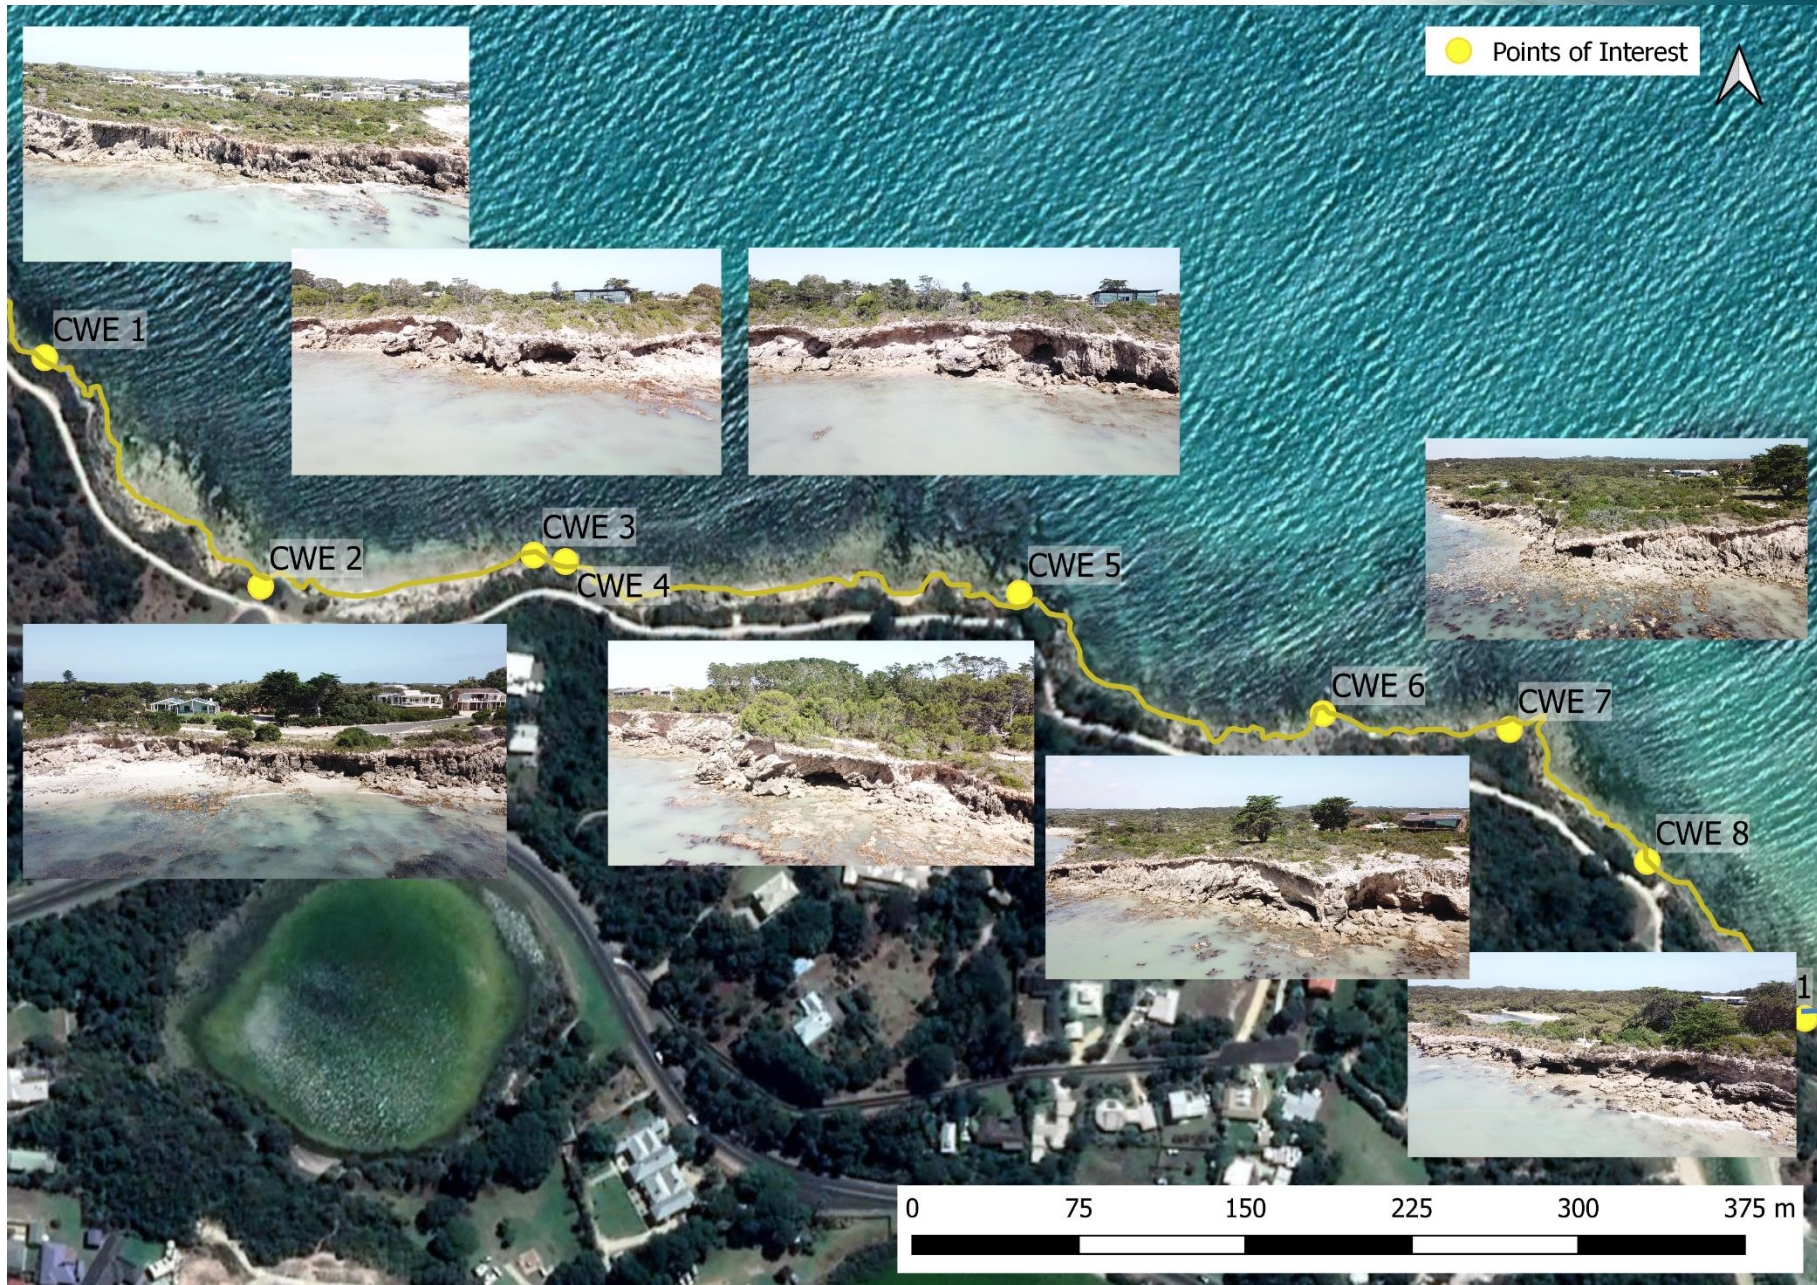
Figure 29: Points of interest along the Coastal Walk East coastal unit

Eight points of interest were identified from the drone imagery, as shown in Figure 29. These are locations where there is cave or an undercut feature that may be within 5-10m of the coastal path. The turning bay at the end of McIntyre Street is also approx. 10m from the cliff edge (CWE 2). The depth of the undercut feature cannot be determined from the aerial imagery.

These locations provide reference points for comparison with future drone survey to provide information on the frequency of failures.

Additional warning signage would be warranted along the coastal walk to encourage walkers to remain on the path and avoid walking near the cliff edge. Additional signage at McIntyre Street is also recommended.

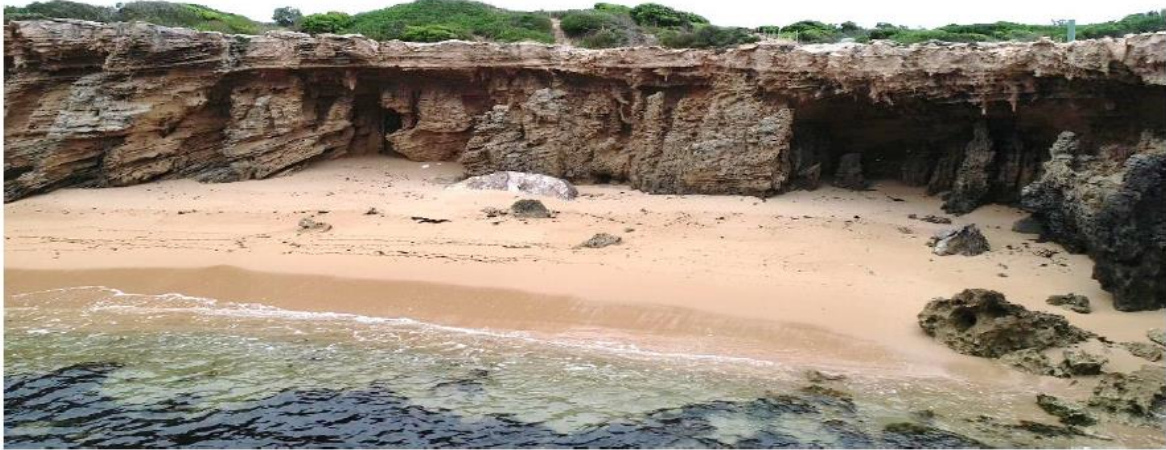
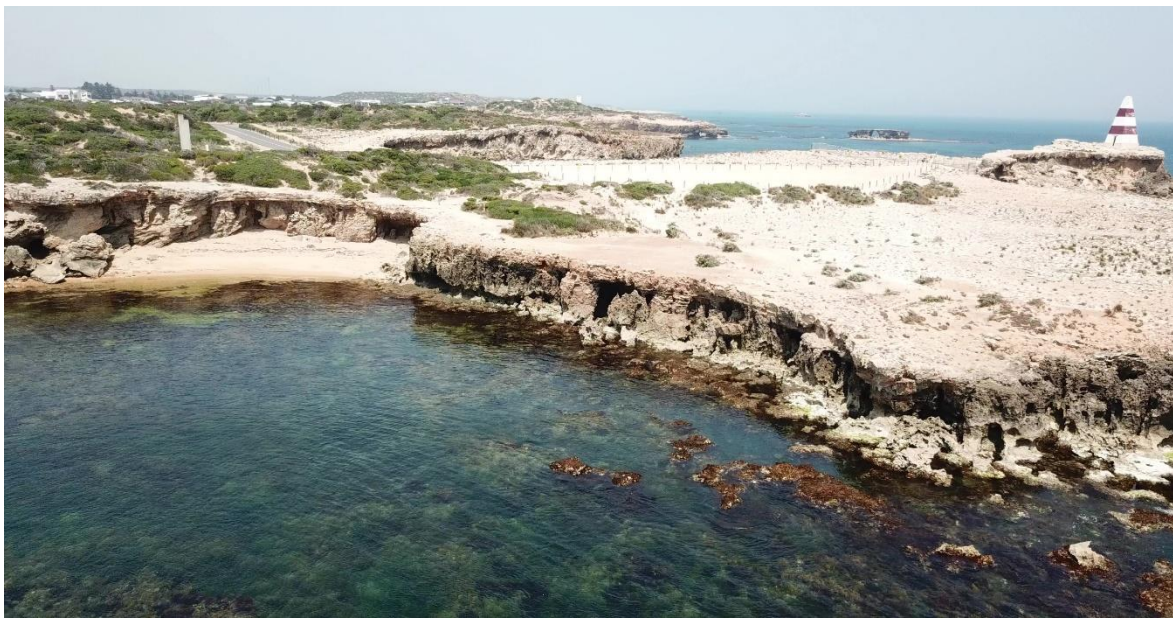
Risk Zone 1 - Cliff Overhang (right side)

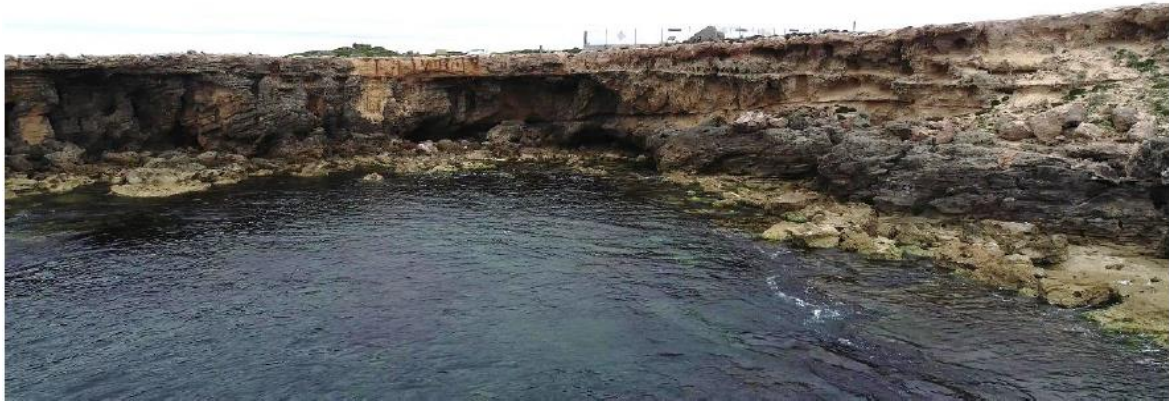
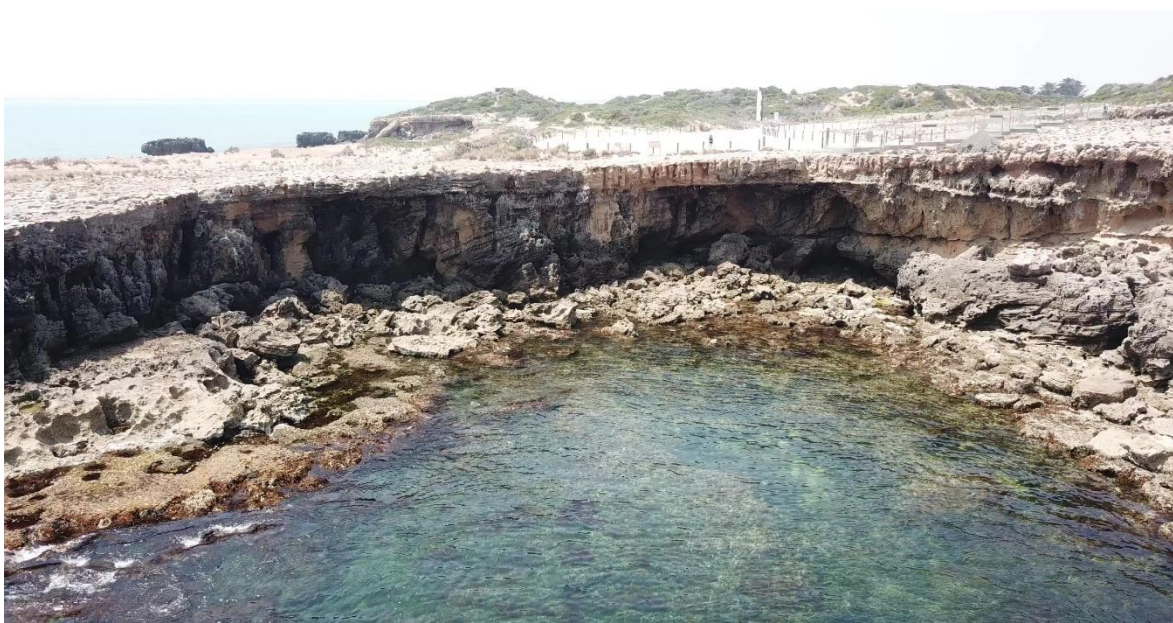
No changes in the condition of the cliffs was observed between the 2018 and 2020 imagery. It was not possible to determine any additional information on the size and depth of the undercut features in the 3 locations.

Risk Zone 2 - Obelisk Main Car Park North Side

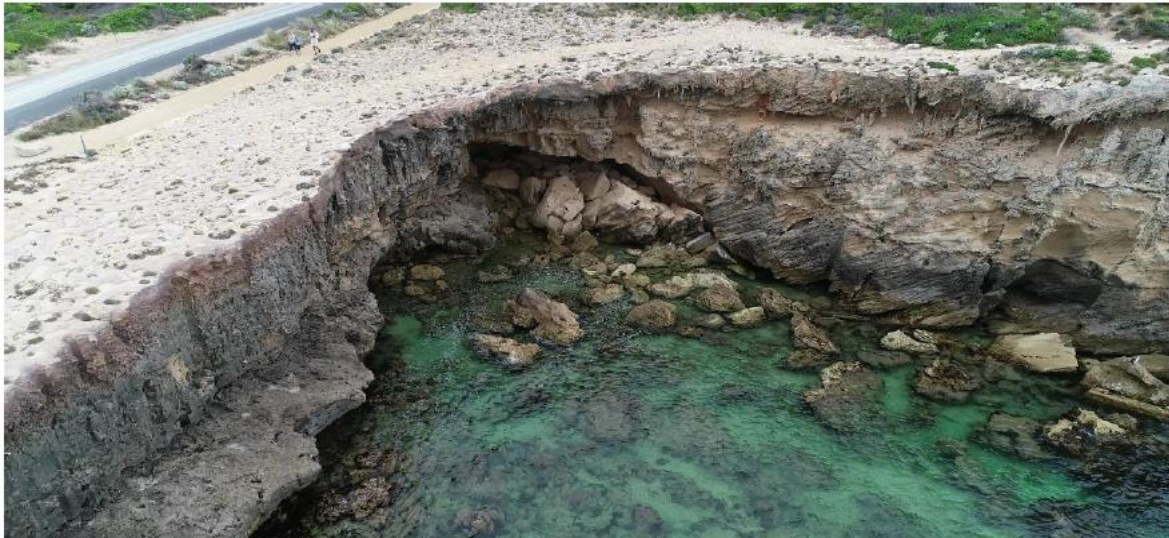
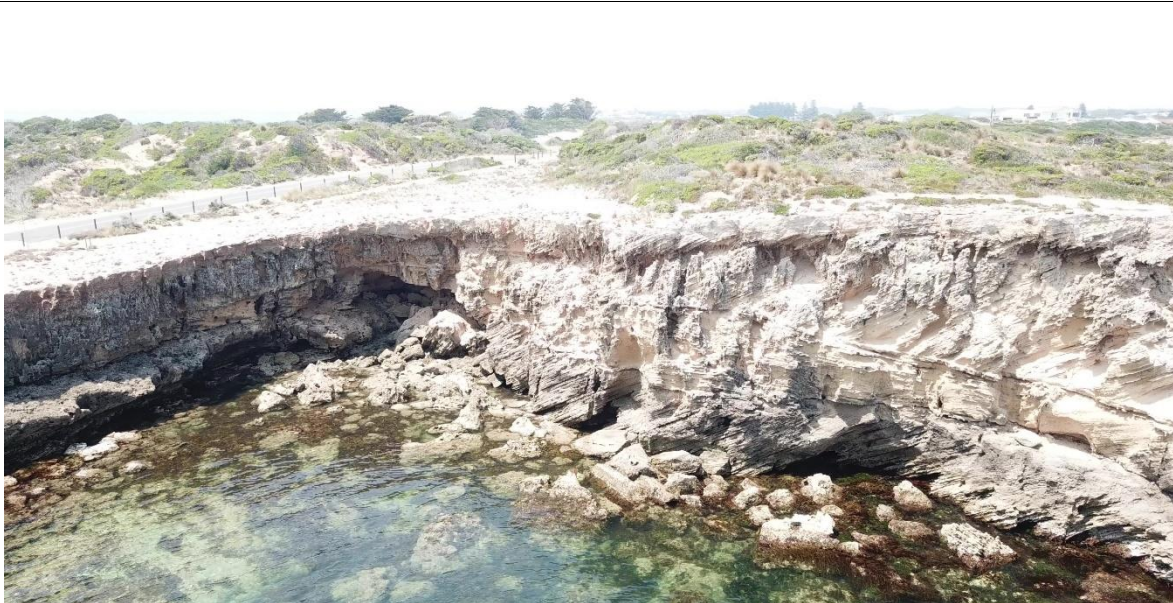
Risk Zone 4 - Obelisk Main Carpark Entrance

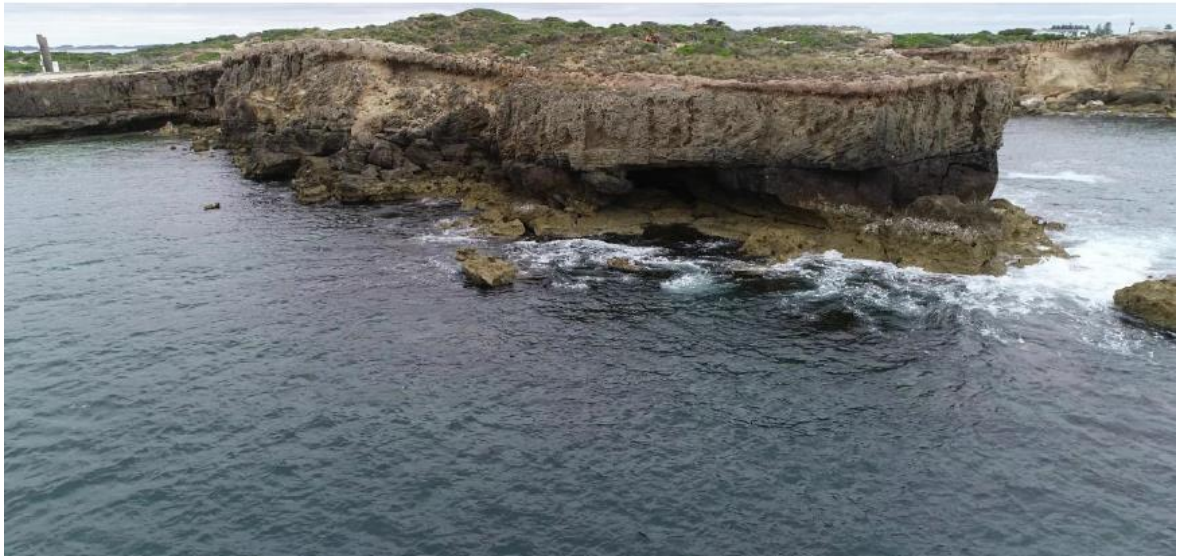
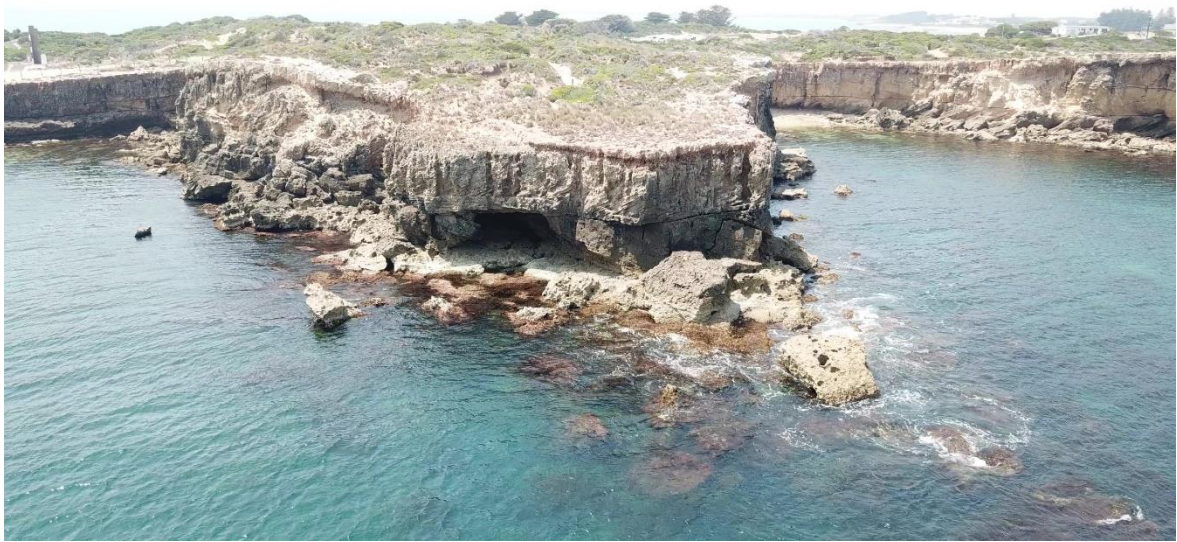
Risk Zone 5 - Cliff Undercutting

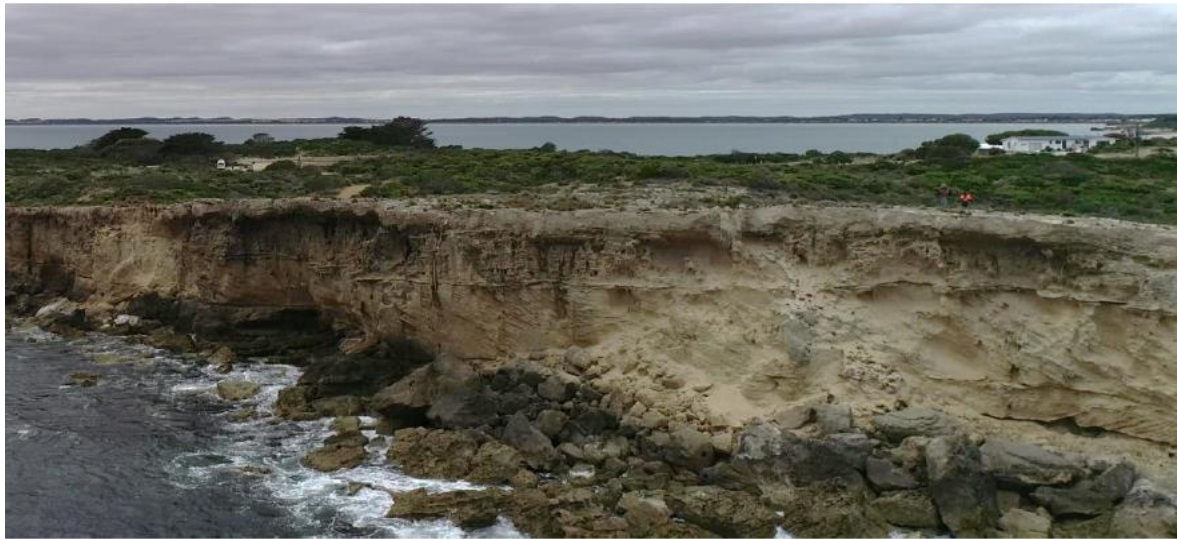
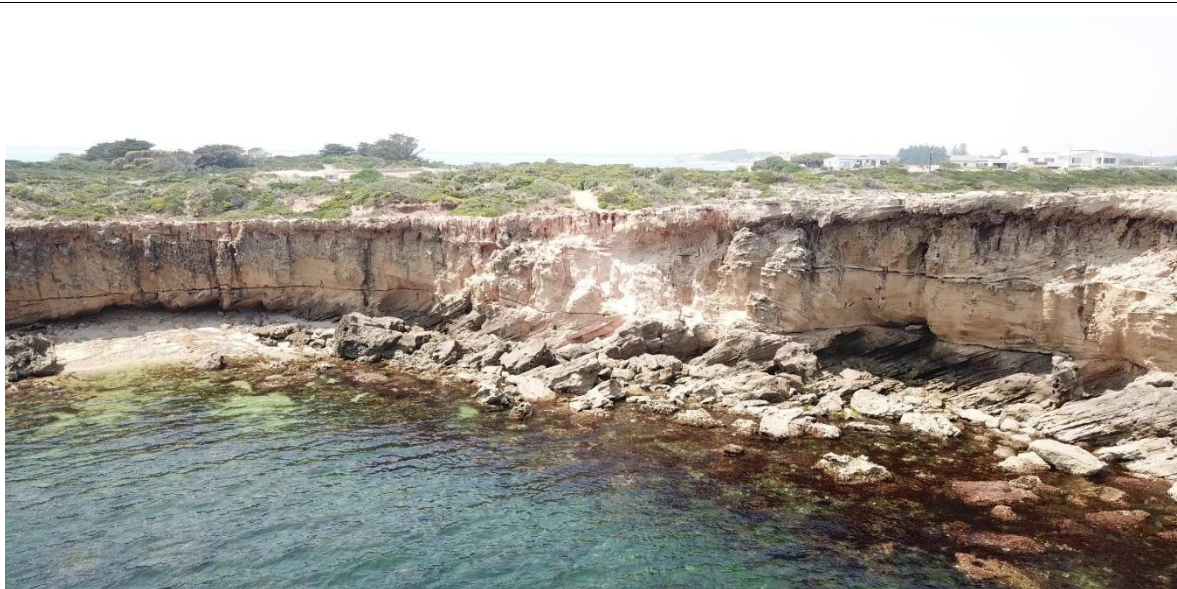
Risk Zone 6 - Cliff Undercutting (right side)

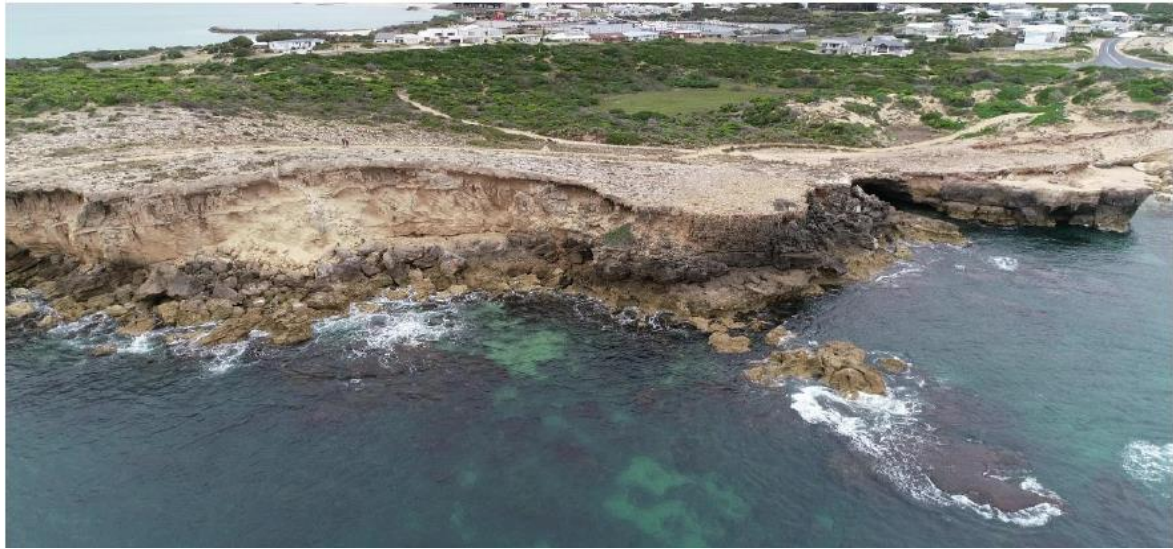
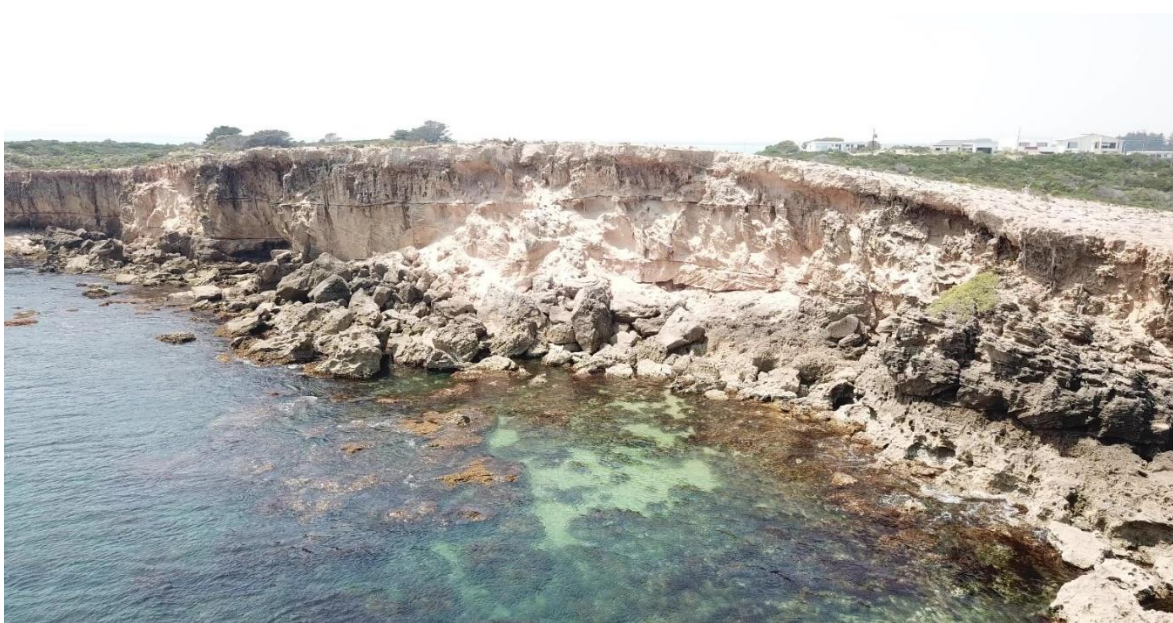
Risk Zone 7 - Cliff Overhang

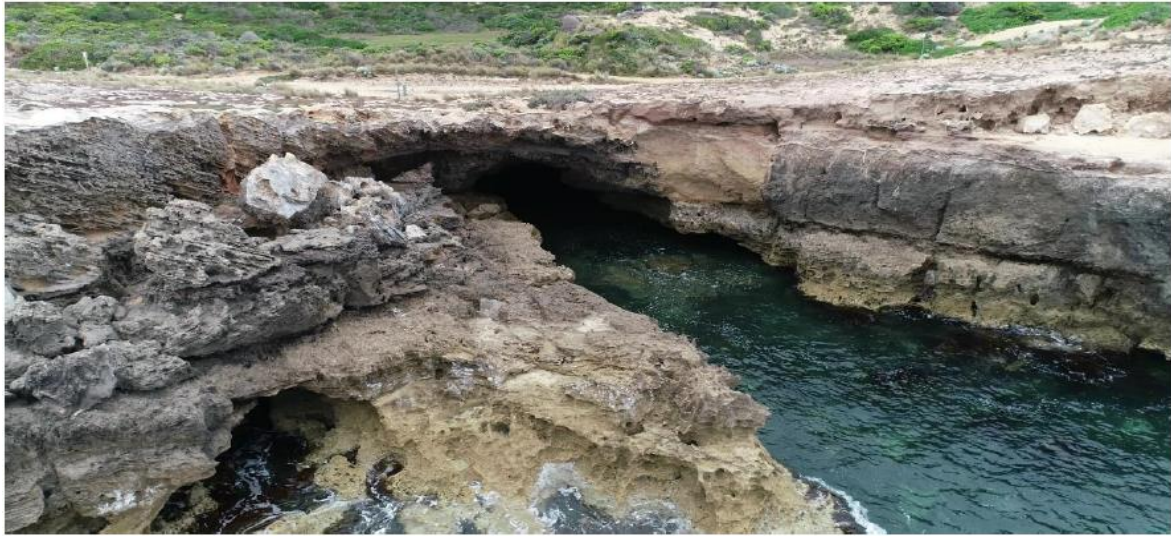
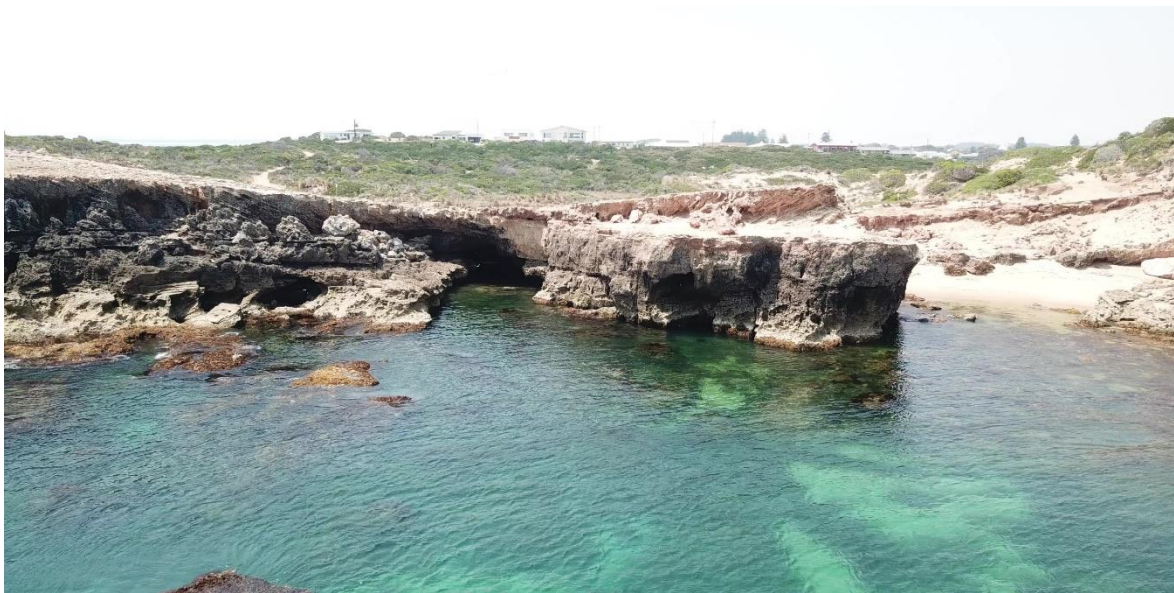
Risk Zone 8 - Blow Hole Undercutting Cliff Face

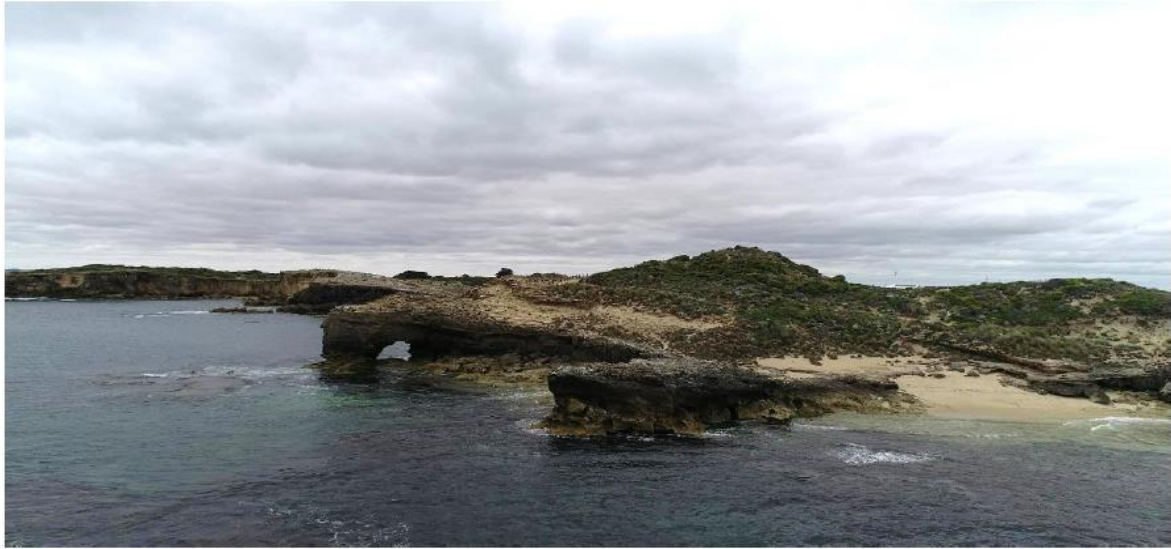
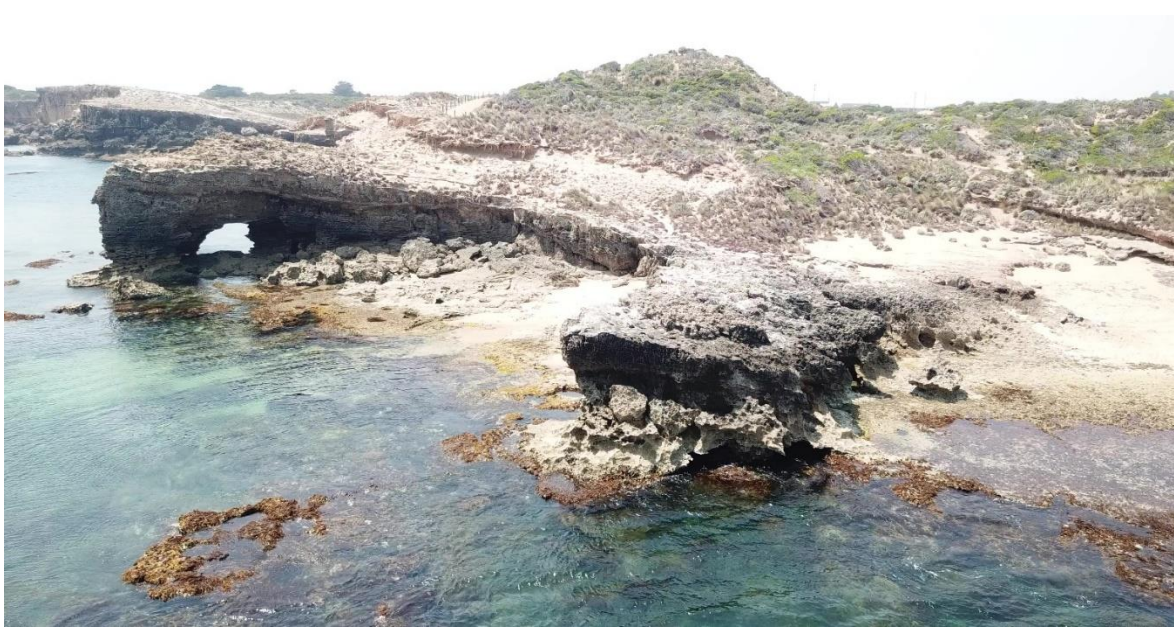
Risk Zone 9 - Doorway Rock

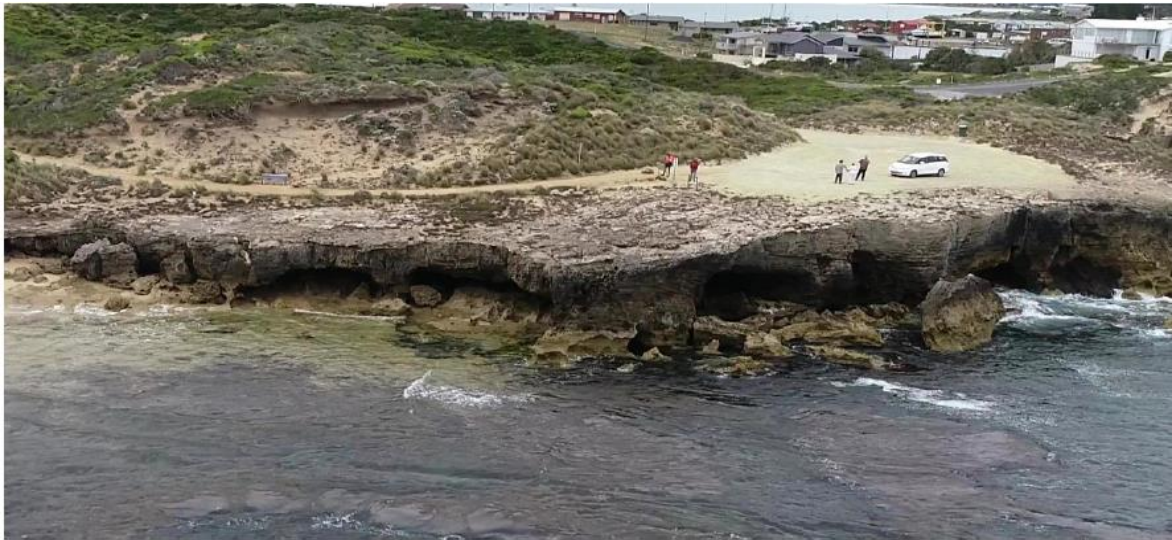
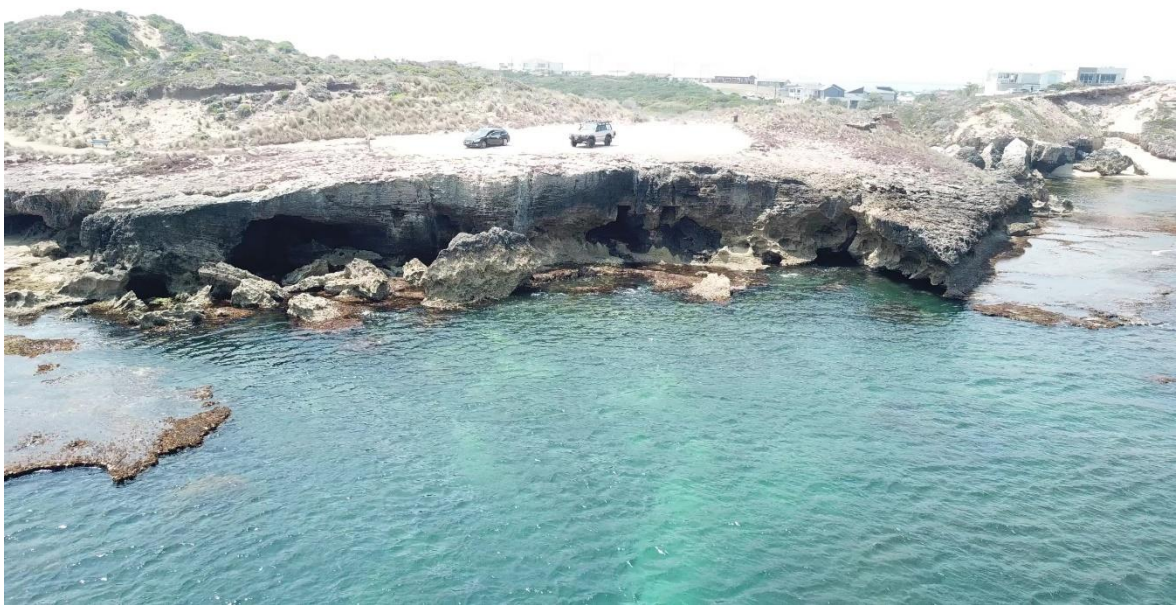
Risk Zone 10 - Undercutting of Cliff (north side of carpark) Carpark 2
