Robe Coastline Monitoring Roadmap

Prepared for the
Robe District Council
July 2020

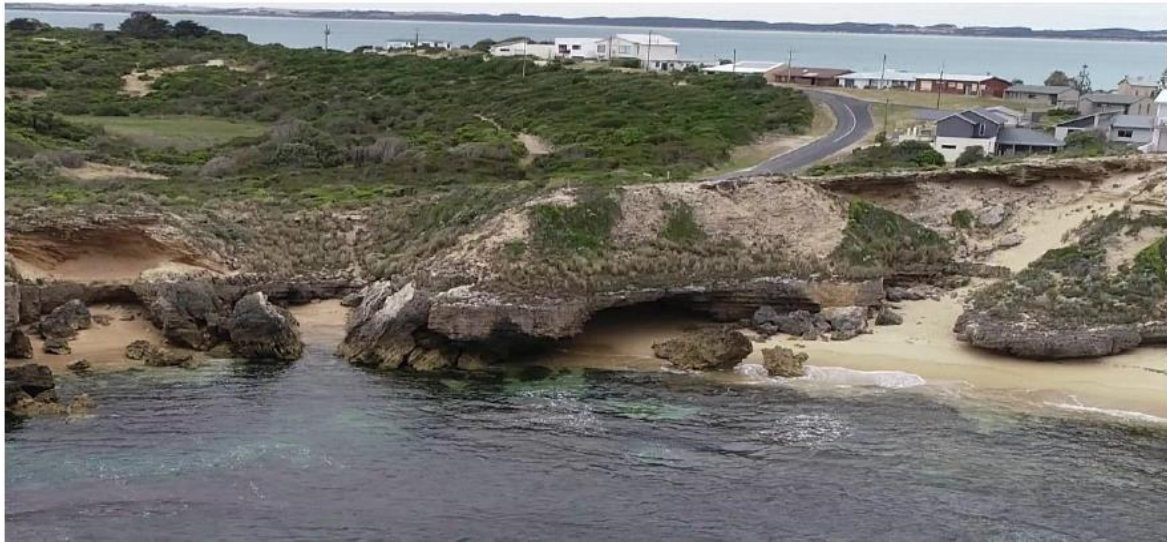
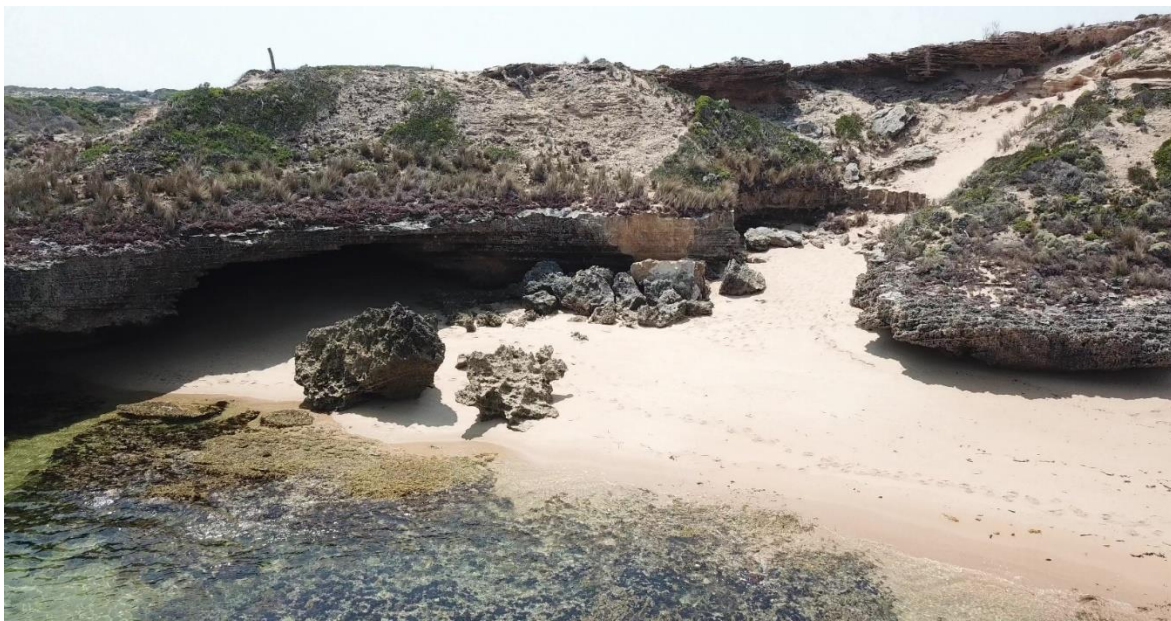
Risk Zone 11 - Undercut of Cliff Face with large soil mass above

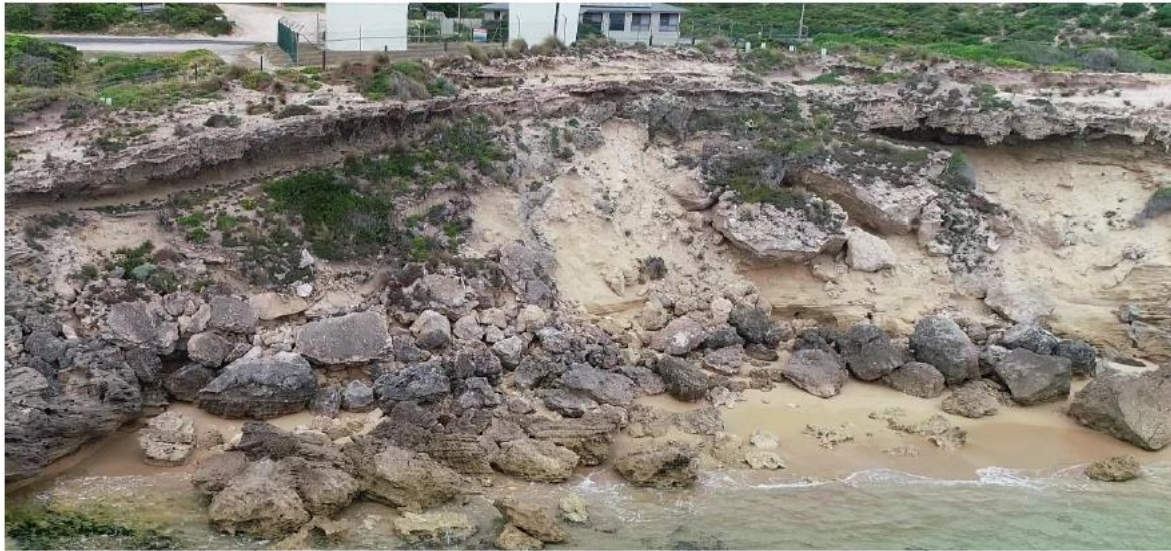
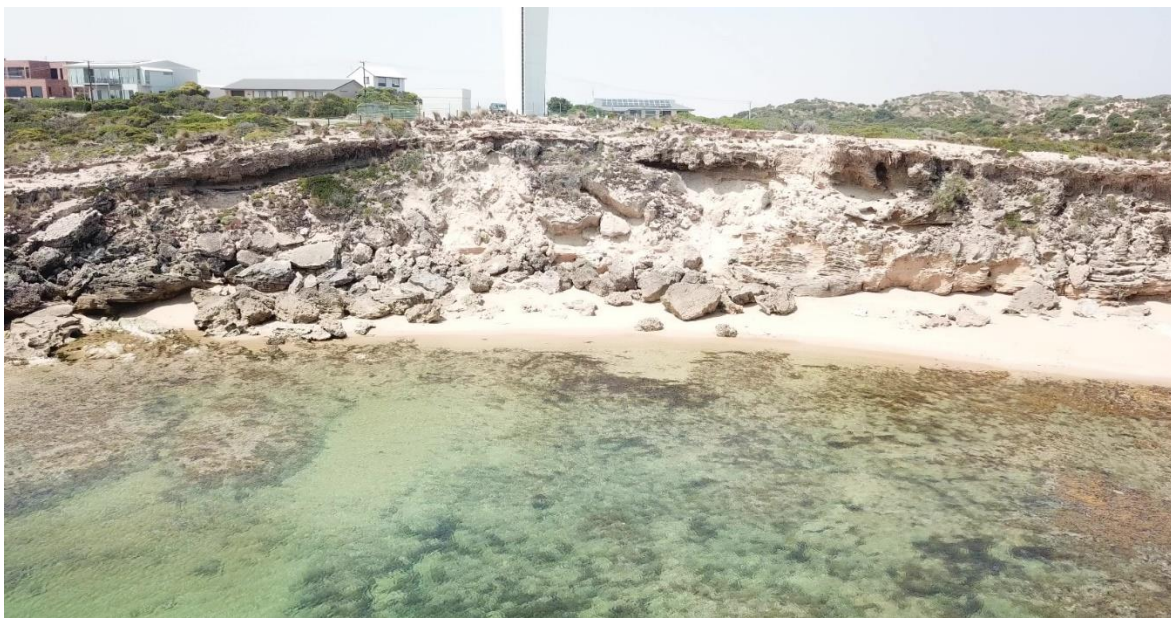
Risk Zone 12 - Overhanging Cliff Face

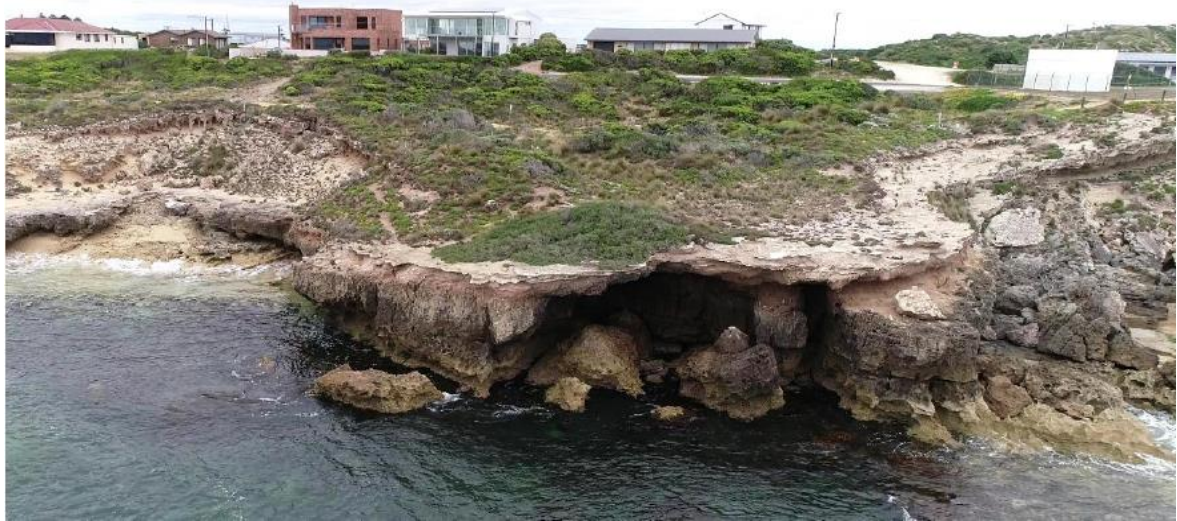
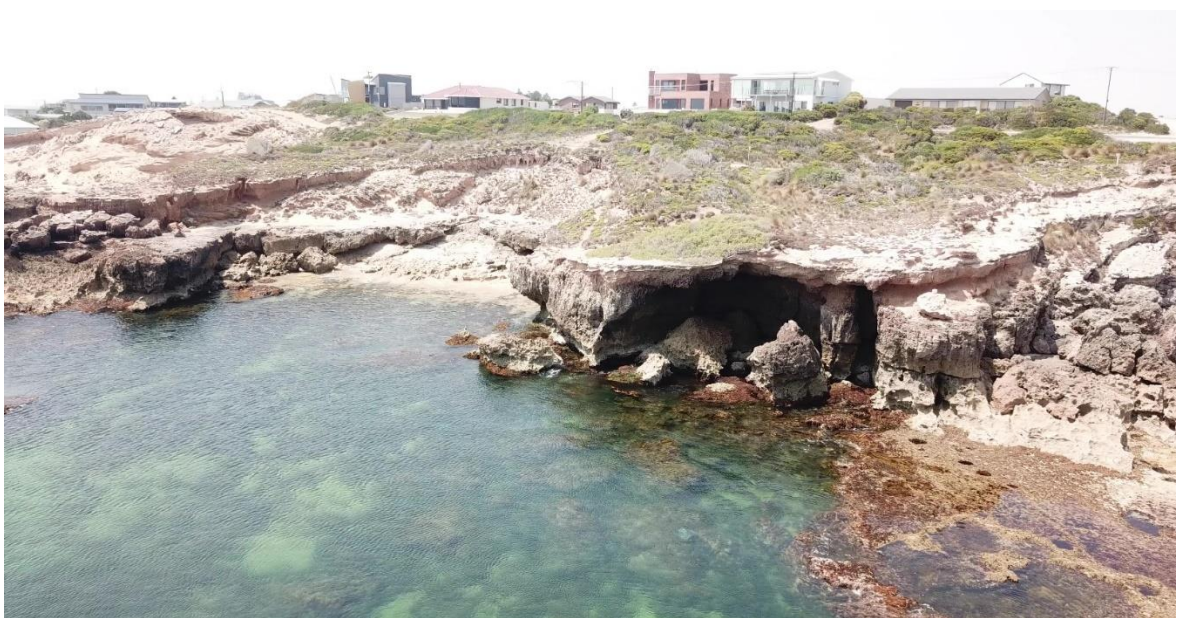
Risk Zone 13 - Undercutting of Cliff

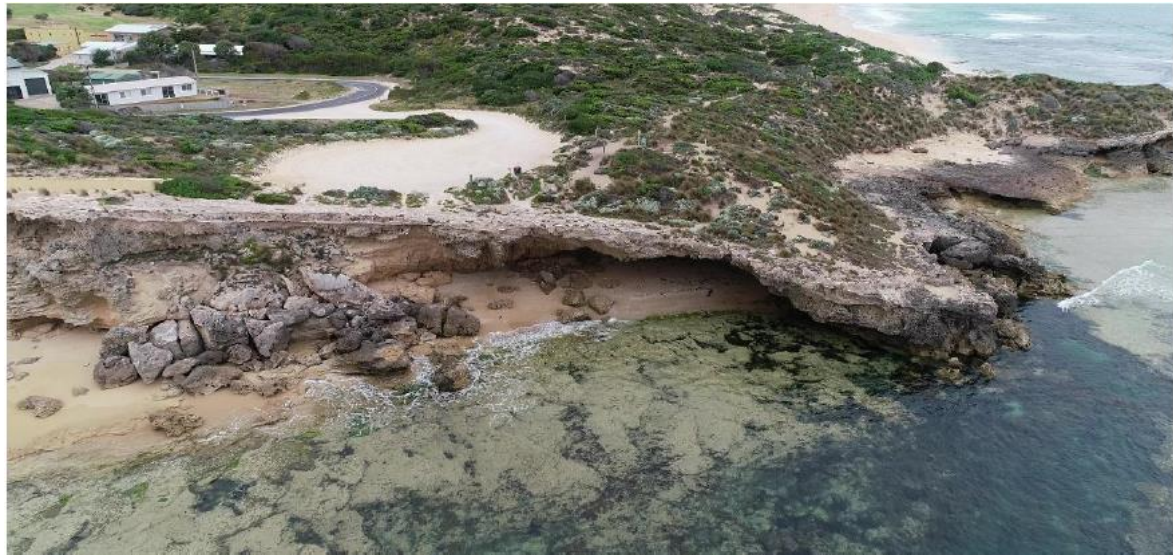
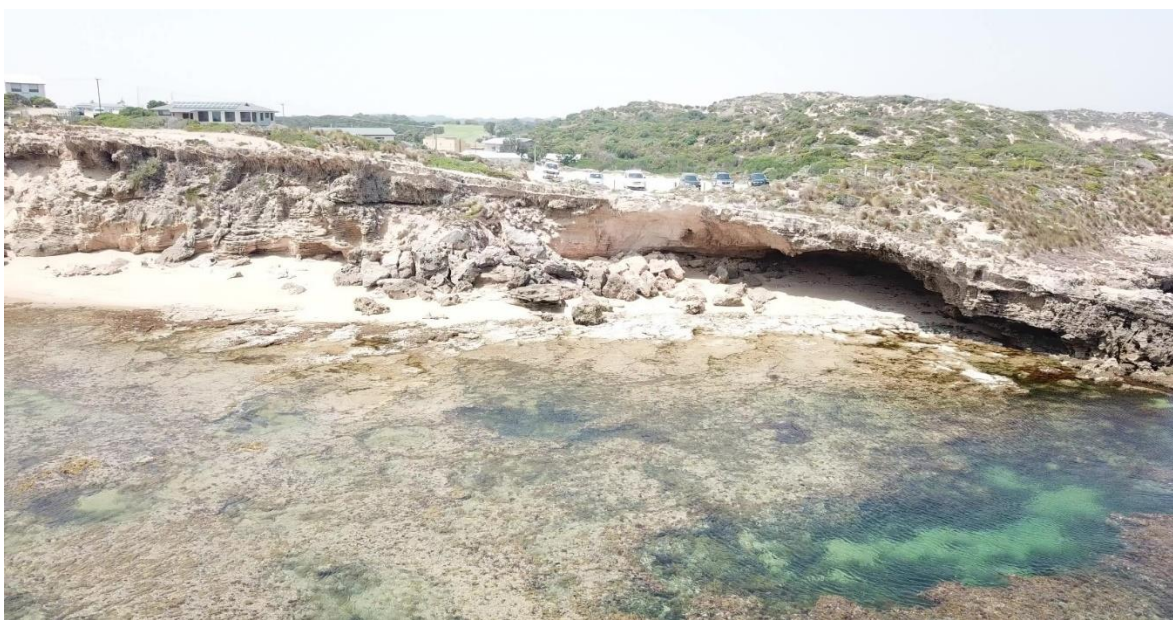
Risk Zone 14 - Obelisk Nature Walk Southern Carpark - Undercutting of Cliff
